Date: 30 August 2023
Project No: LTC21220-A
Revision: B

Ngai Tahu Property
115 Eureka Street, Aranui
Attention: Simon Tucker

**RE: SHALLOW SOIL TEST REPORT
FUTURE RESIDENTIAL FOUNDATIONS
LOT 13, 115 EUREKA STREET, ARANUI**

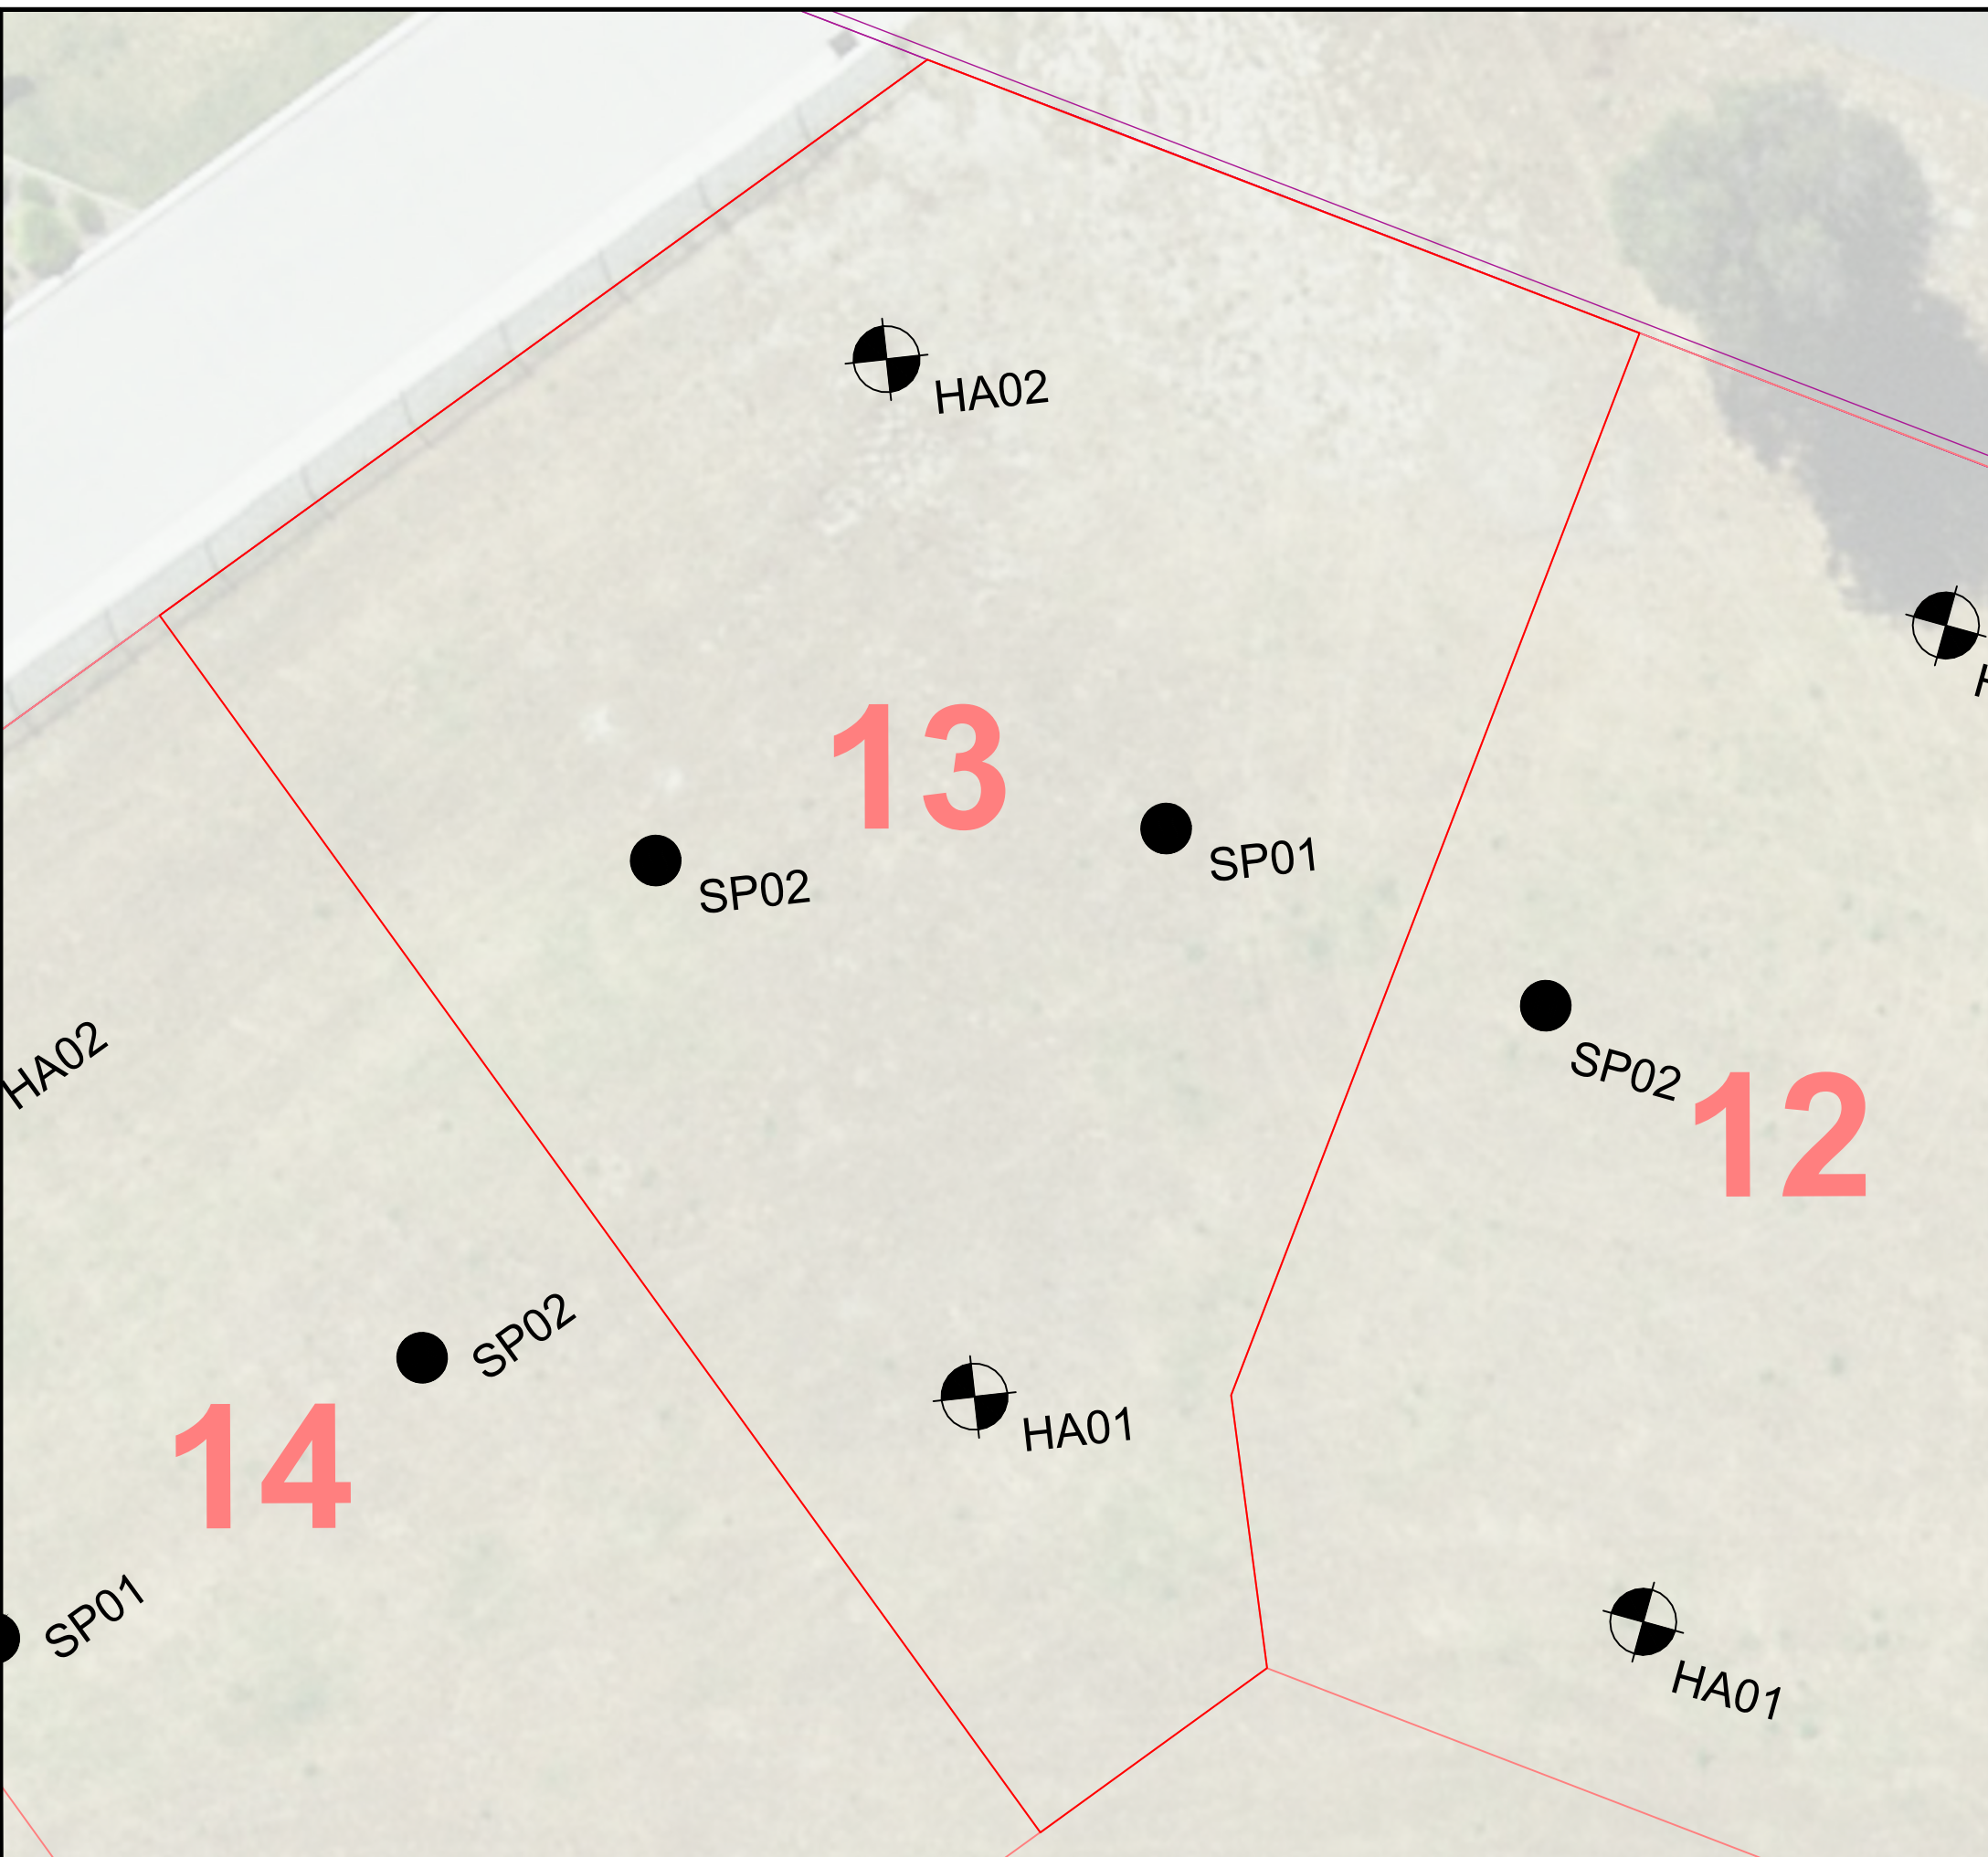
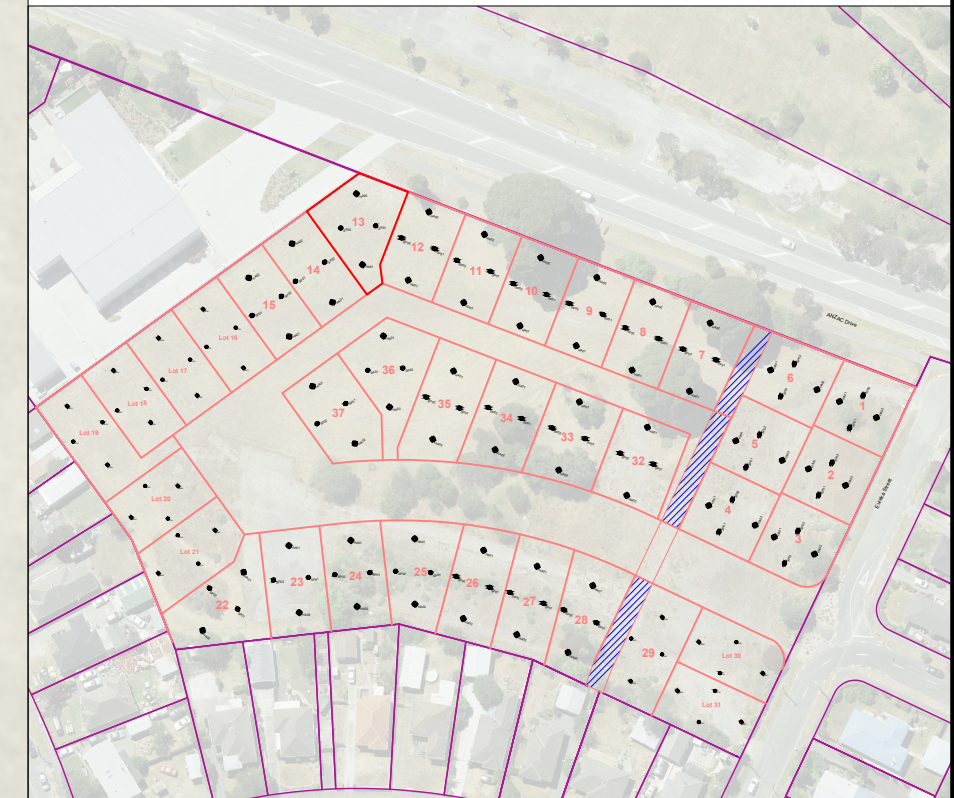
Drawing No: Lot 13/TLP	Drawn by: RM	Date: 30 August 2023
Scale: 1: 125 (A3) 1: 2000 (A3)	Checked by: D Wilson	Revision: C
Filename: LTC21220 - A - Drawings.dwg

LandTech investigated the site on 24 May 2023, conducting two hand augers with corresponding Scala Penetrometer tests (SPs) and two additional SPs. The locations of the hand auger and SPs were measured using inferred lot boundaries and are approximate only. The test locations are shown on our LandTech *Test Location Plan*, Drawing No. Lot 13/ TLP, attached to this report.

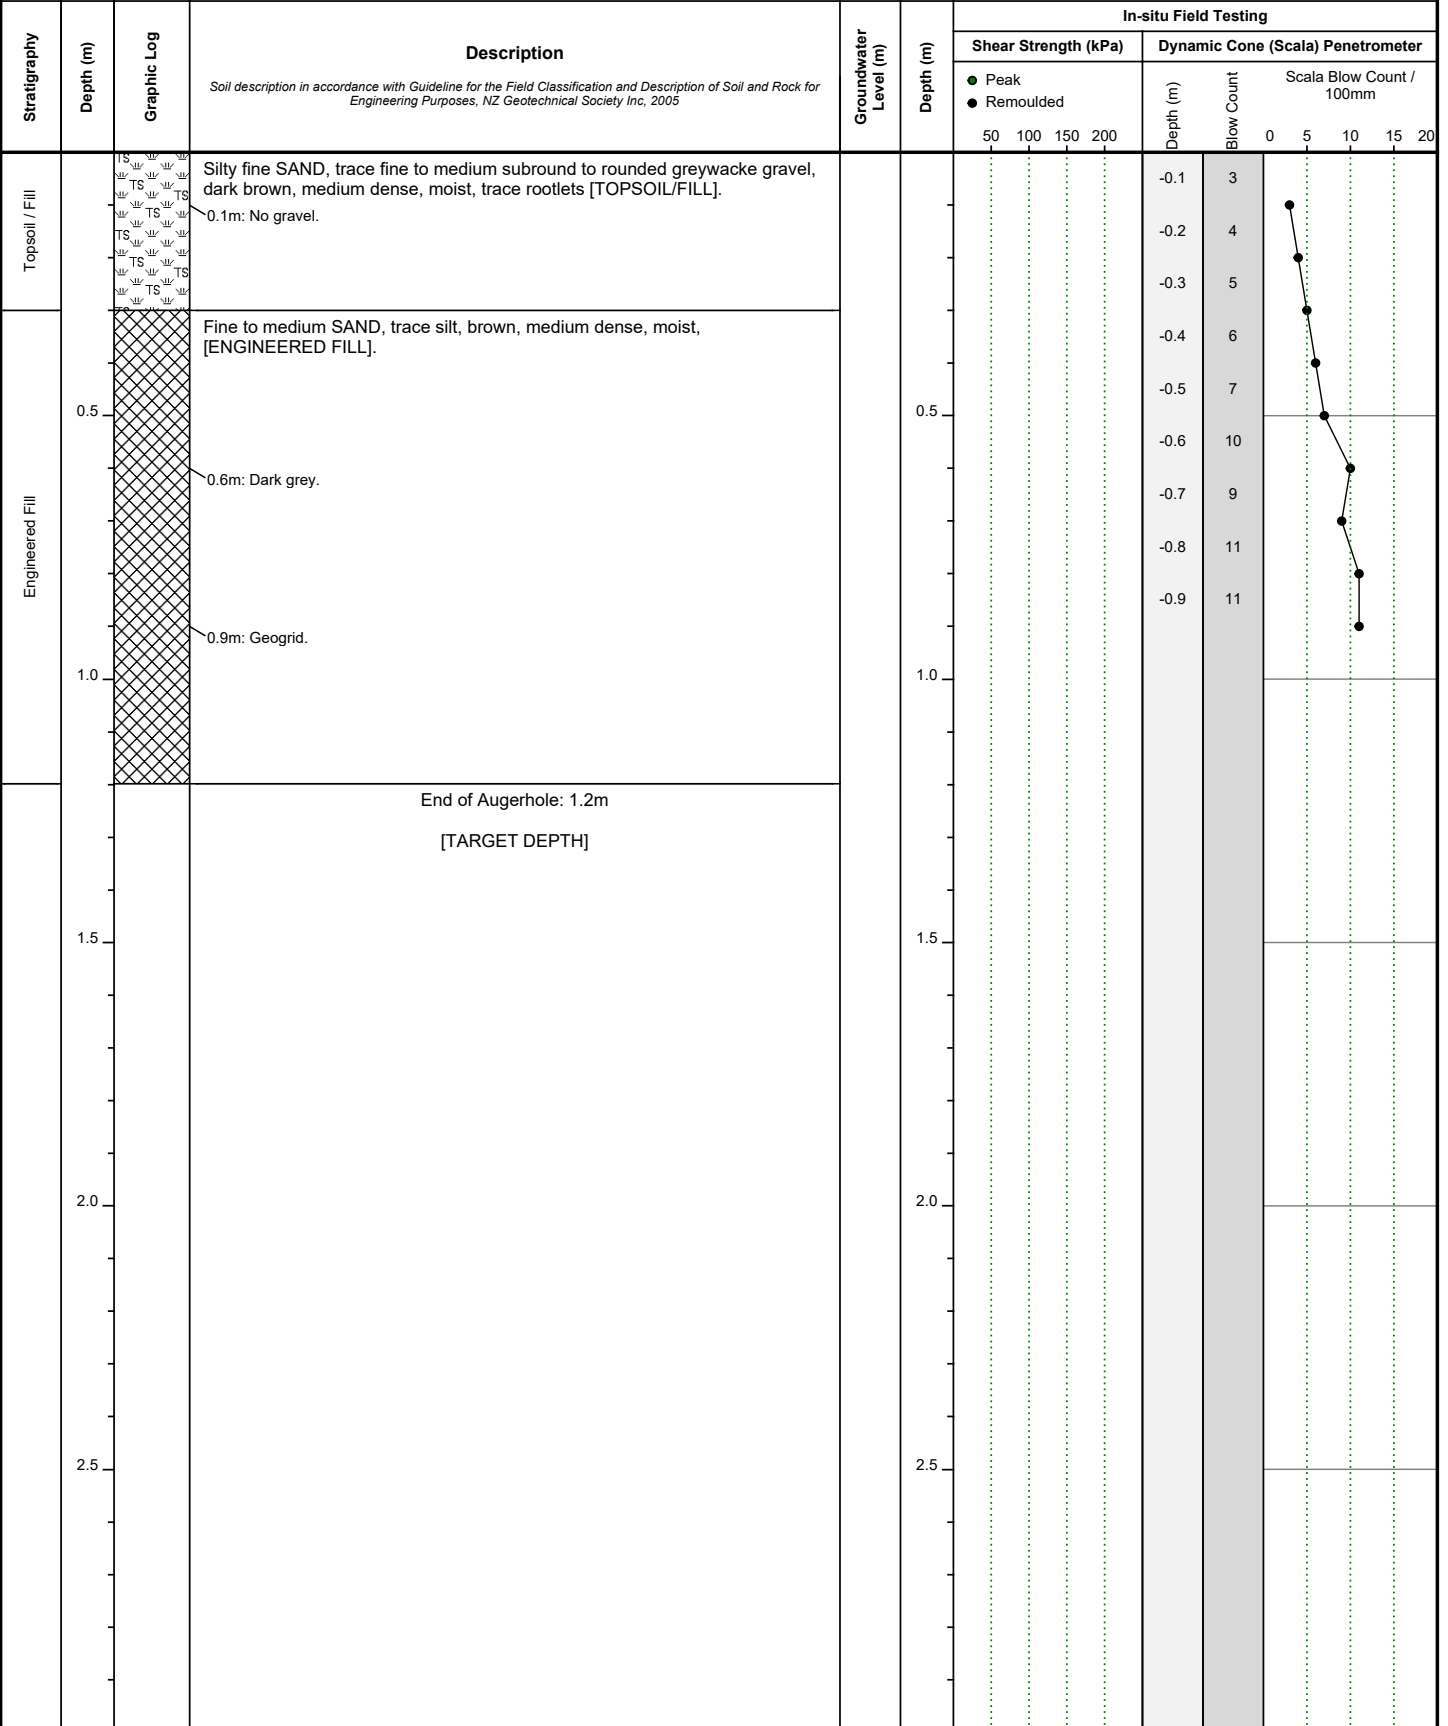
Augerhole No.: LOT 13 - HA01

Topsoil was encountered within the hand augers from the ground surface to 0.3m depth, which was typically a dark brown silty sand material with a trace of gravel. Engineered fill was encountered below the topsoil to the base of auger holes, which was a compacted brown sand material with a trace of silt. The hand augers were terminated at 1.2m depth below ground level to avoid damage to the geotextile layer which was installed at 1.5m depth below ground level. Groundwater was not encountered during testing.

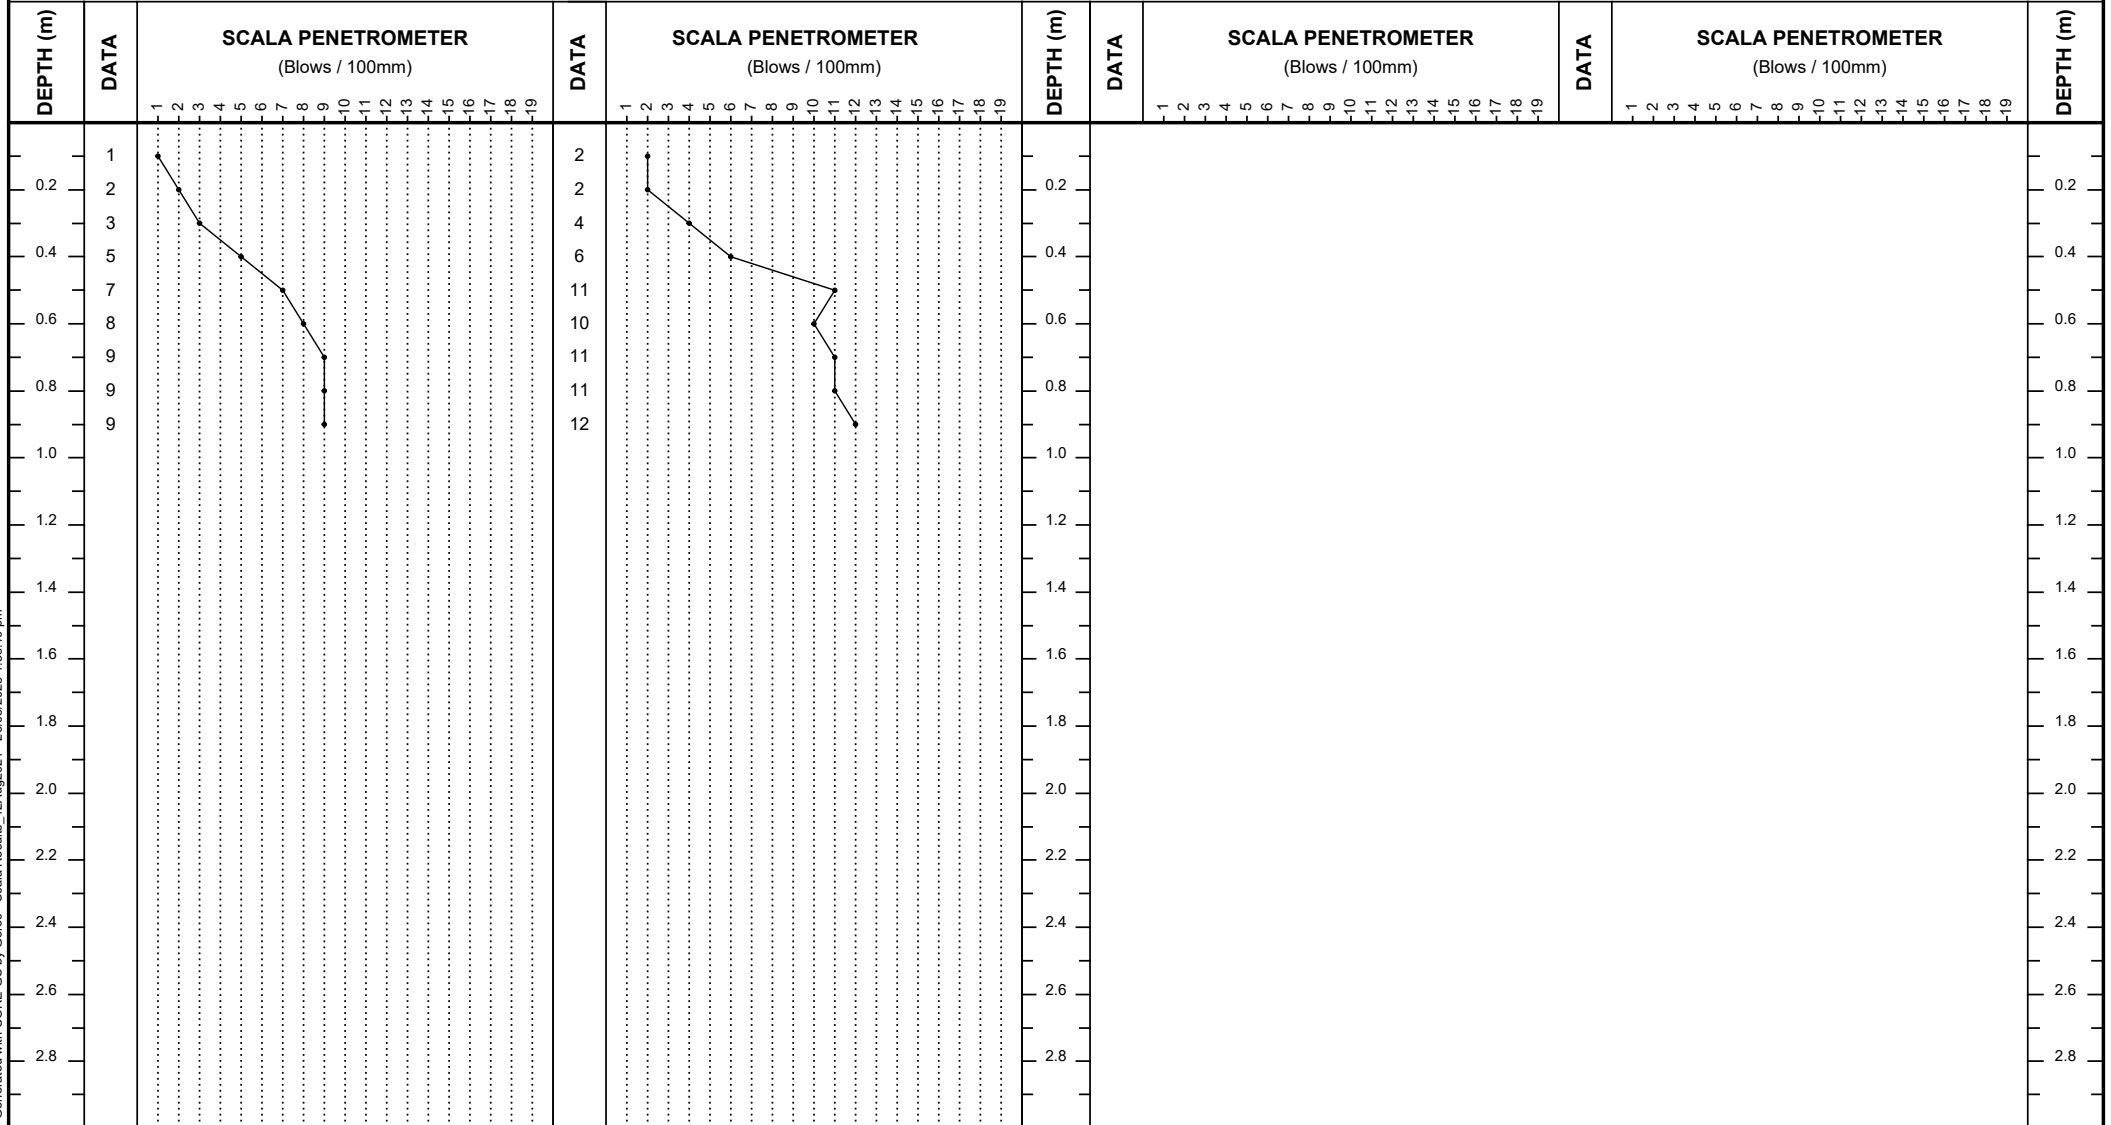
LOT 13- SP01

SPs at each of the four locations returned results between 3 and 12 blows per 100mm penetration below the topsoil and within the engineered fill layer. SPs were terminated at 0.9m depth to confirm near surface bearing capacities, and to avoid damage to the geogrids and geotextile. In addition, the density of the engineered fill and bearing capacity of its underlying subgrade have been confirmed via extensive geotechnical inspection and fill compaction testing during subdivision earthworks.
