Date: 30 August 2023
Project No: LTC21220-A
Revision: B

Ngai Tahu Property
115 Eureka Street, Aranui
Attention: Simon Tucker

**RE: SHALLOW SOIL TEST REPORT
FUTURE RESIDENTIAL FOUNDATIONS
LOT 14, 115 EUREKA STREET, ARANUI**

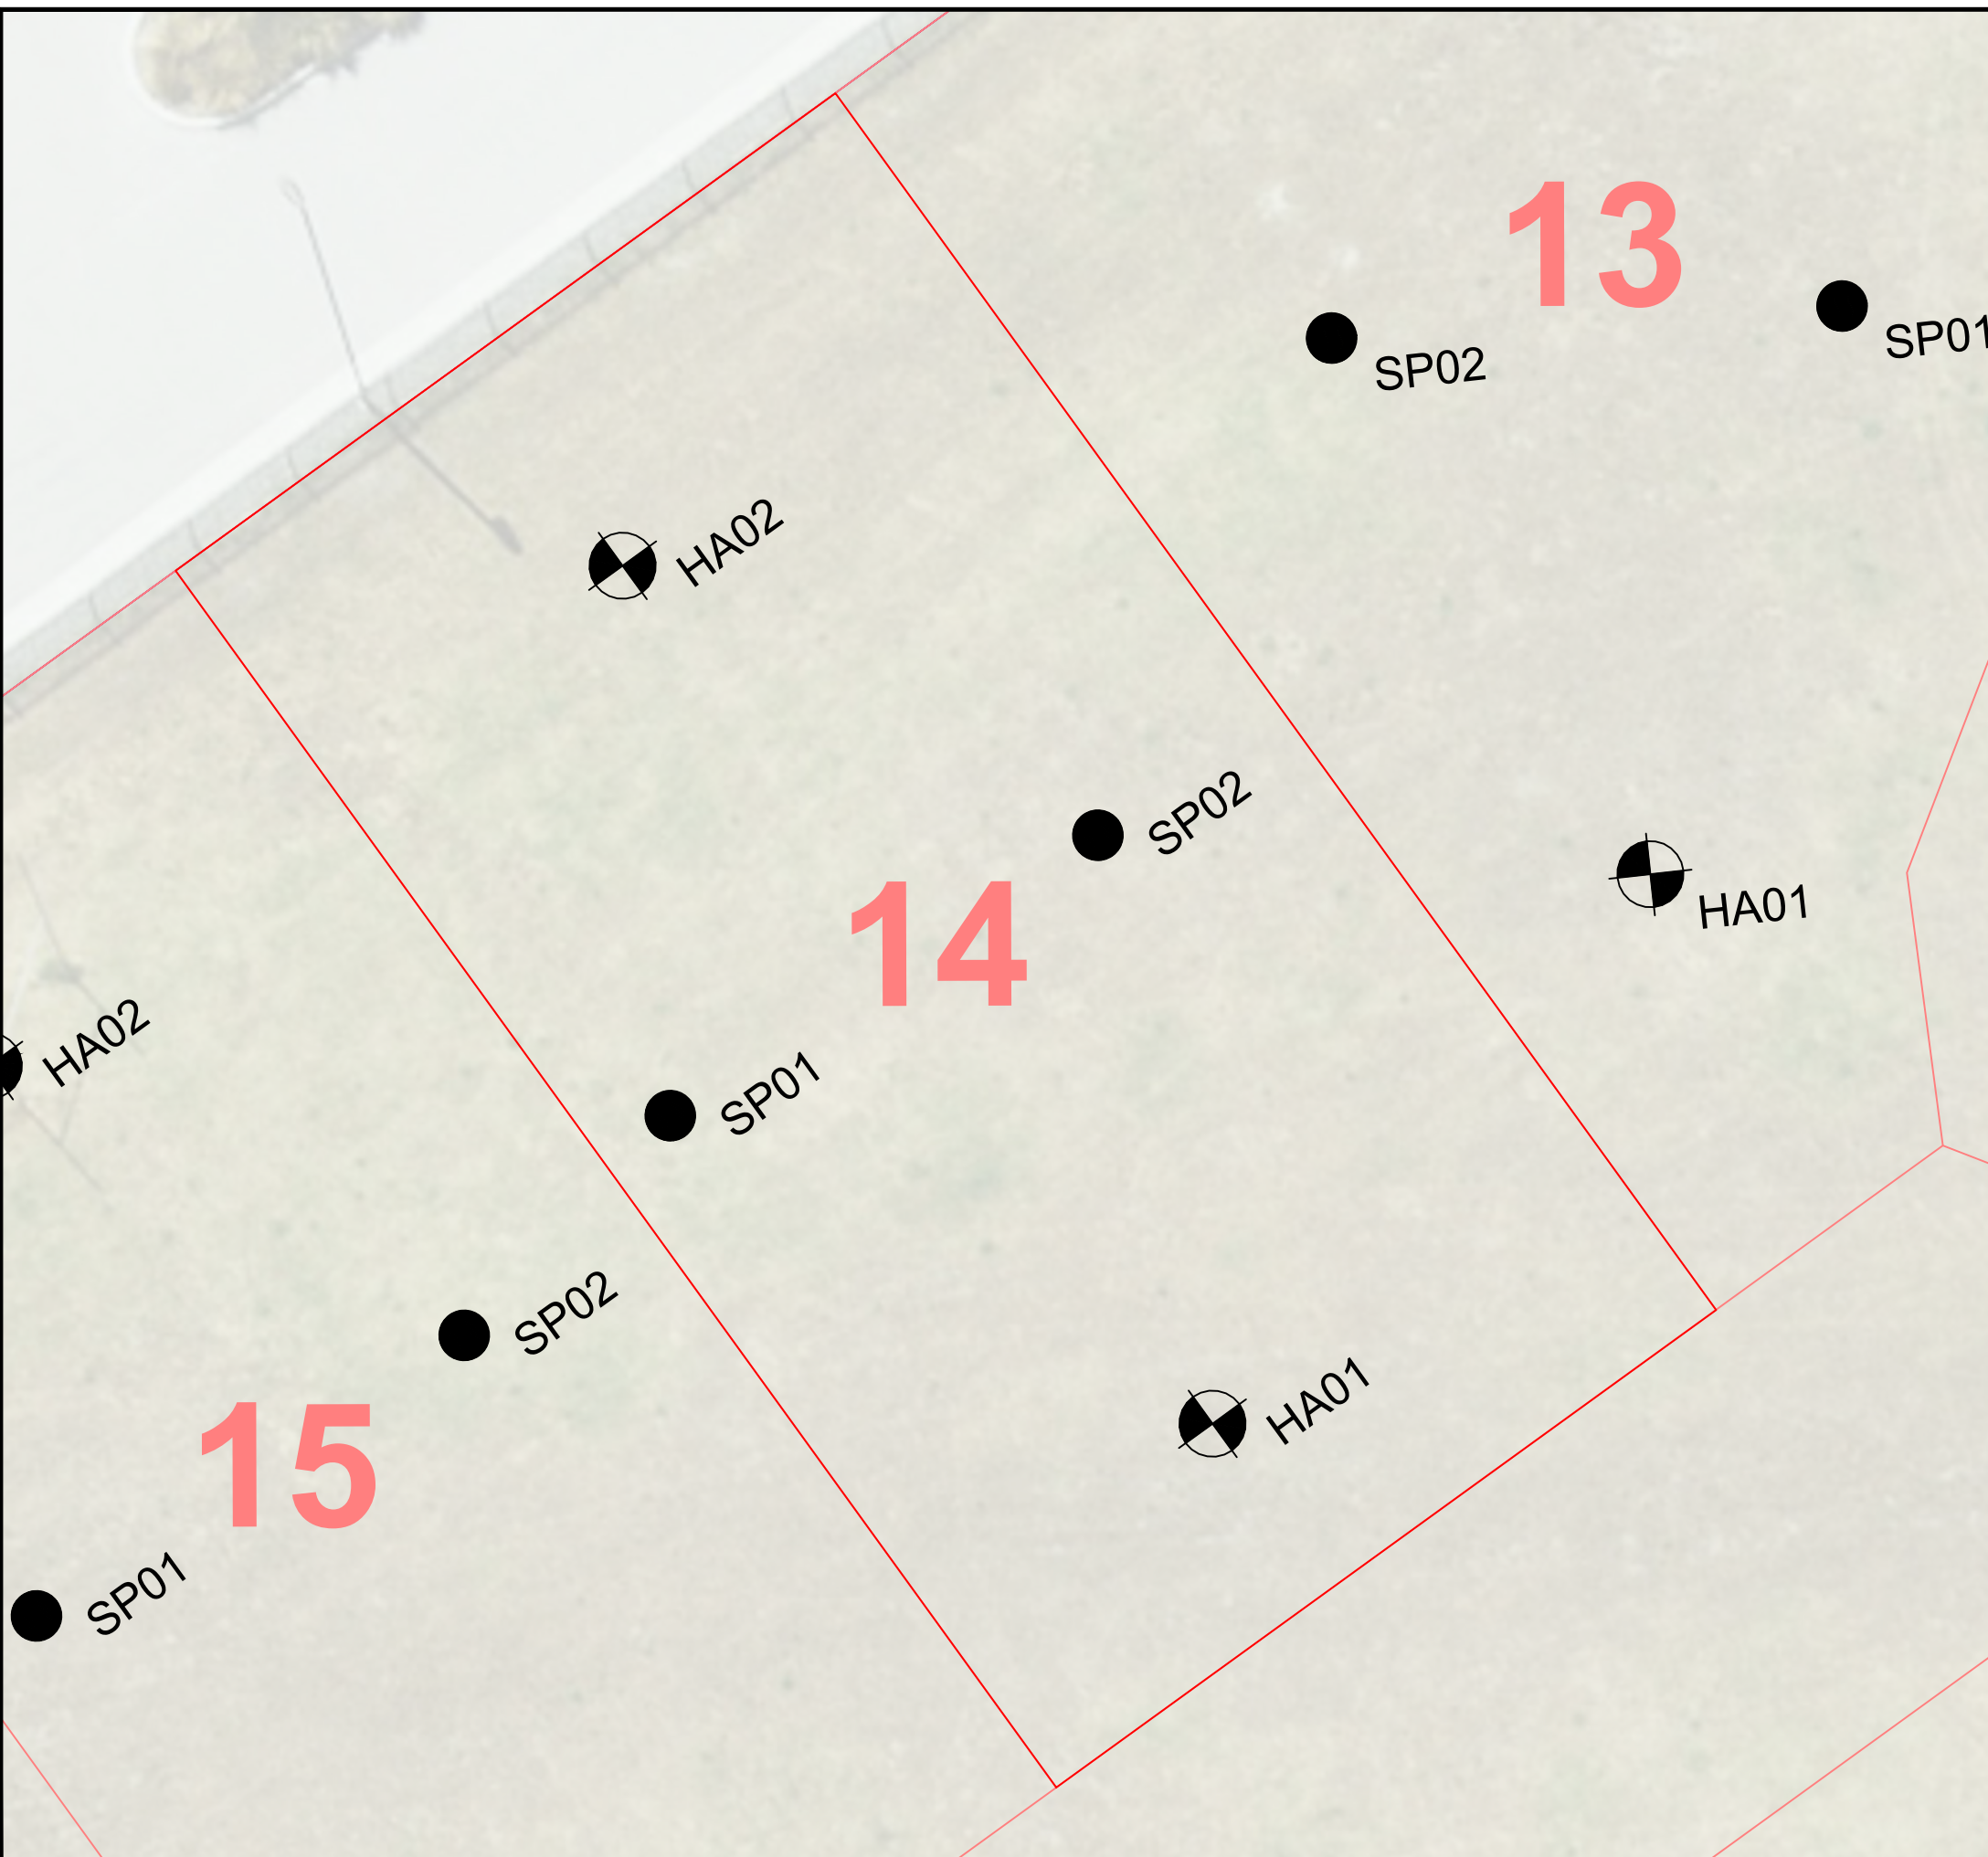
Test Location Plan
 Lot 14, 115 Eureka Street,
 ARANUI, CHRISTCHURCH

LandTech investigated the site on 24 May 2023, conducting two hand augers with corresponding Scala Penetrometer tests (SPs) and two additional SPs. The locations of the hand auger and SPs were measured using inferred lot boundaries and are approximate only. The test locations are shown on our LandTech *Test Location Plan*, Drawing No. Lot 14/ TLP, attached to this report.

The ground improvement could not extend all the way up to the northwestern boundary of the lot on account of temporary batters of approximately 1V :1H being formed down from the boundaries during construction to allow for the formation of the engineered fill raft. Therefore, a no-build setback to the greater of 2.0m, the depth of ground remediation, or the sum of the permanent cut face (existing ground level to finished ground level) plus the depth of ground remediation along these boundaries, shall be created along the corresponding boundaries. With reference to the Davie Lovell-Smith As-Built Earthworks Plans completed for the subdivision, the maximum depth of ground remediation was 1.4m, while the maximum permanent cut face is 0.4m high along some of the boundaries. Therefore, the 2.0m no-build setback governs along these boundaries to external neighbouring properties.

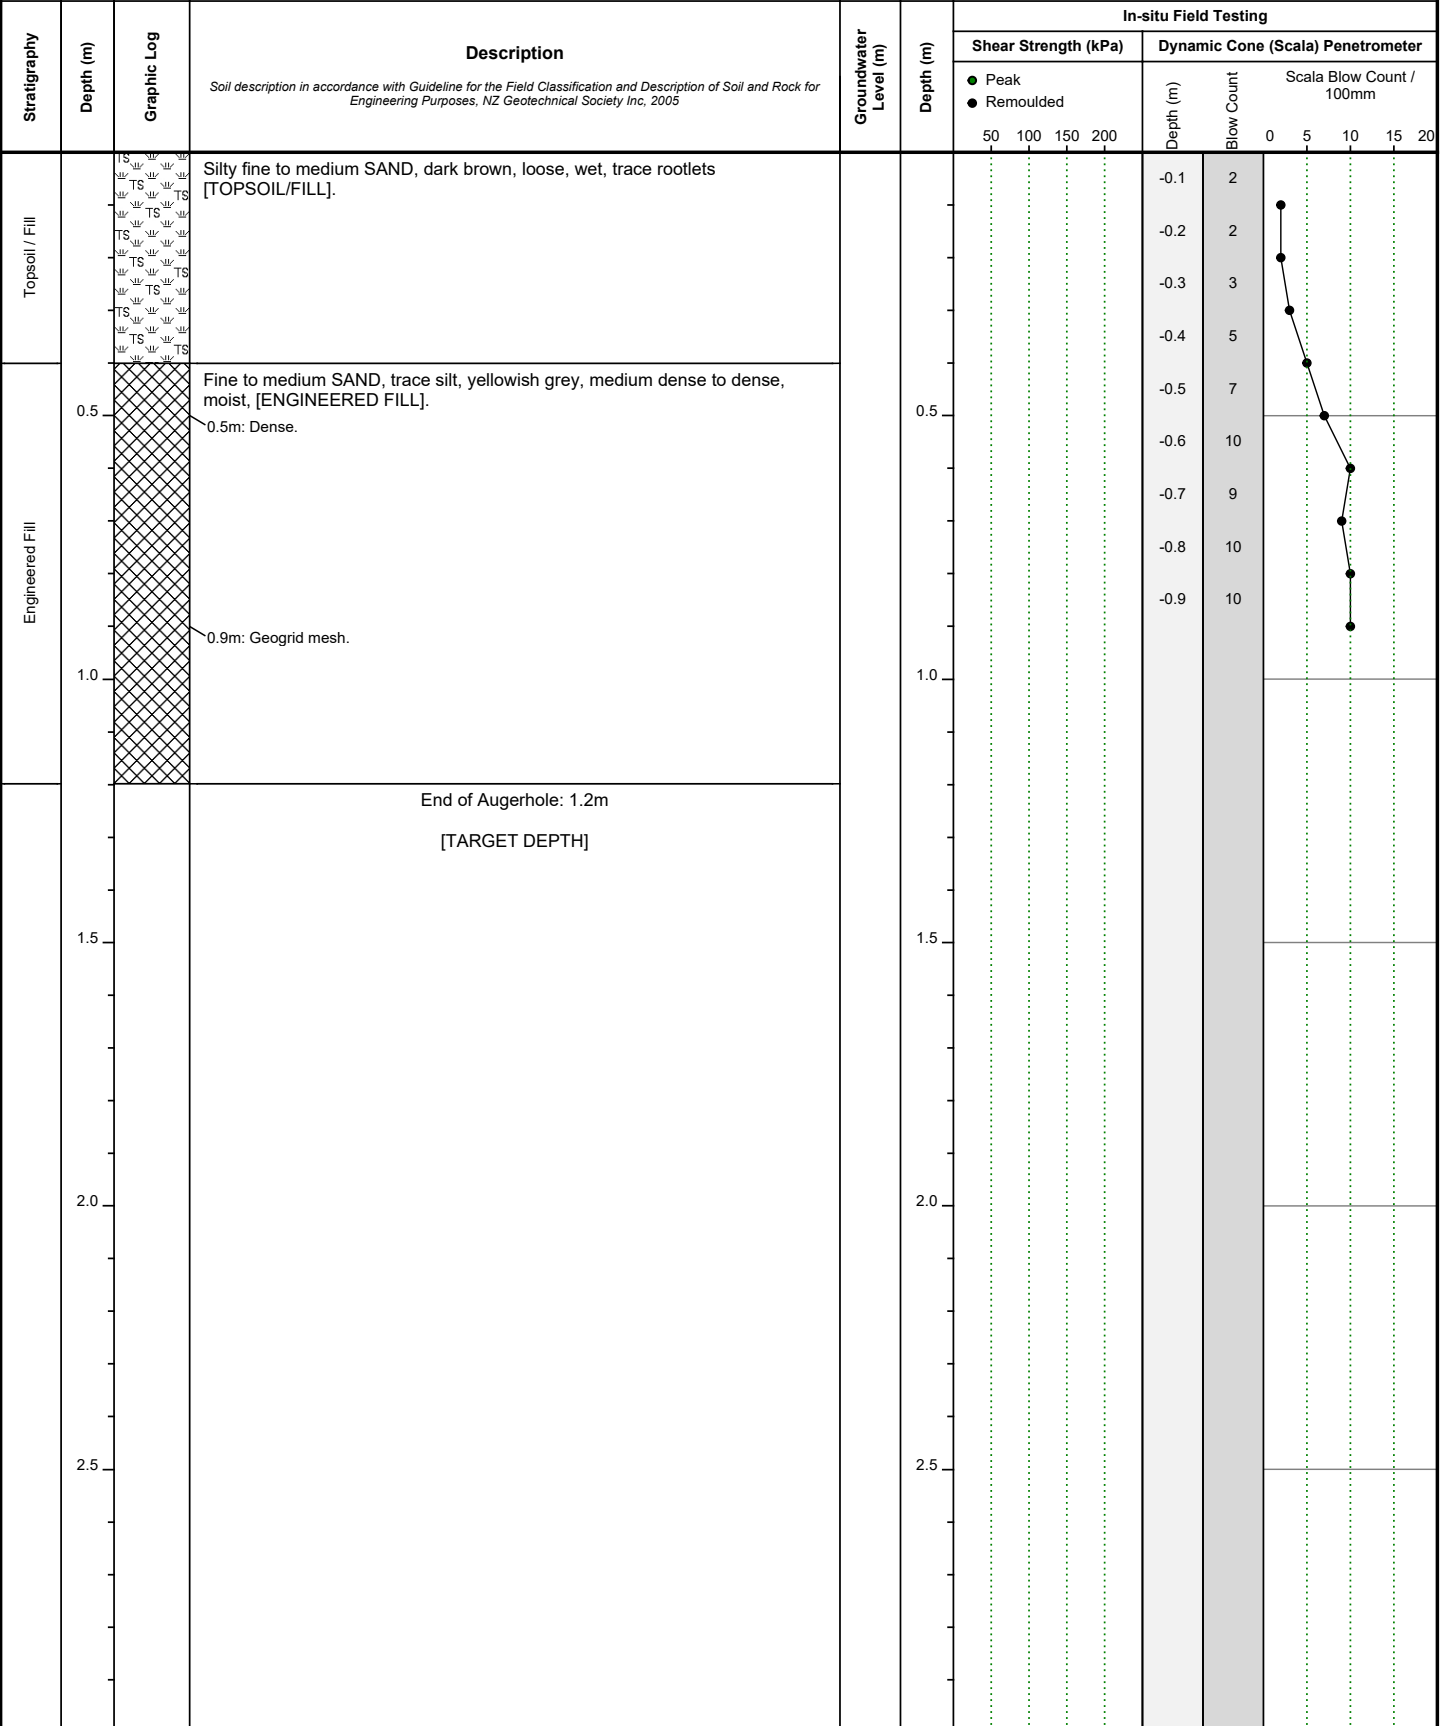
Augerhole No.: LOT 14 - HA01

Topsoil was encountered within the hand augers from the ground surface to 0.4m depth, which was typically a dark brown silty sand material with a trace of gravel. Engineered fill was encountered below the topsoil to the base of auger holes, which was a compacted yellowish grey sand material with a trace of silt. The hand augers were terminated at 1.2m depth below ground level to avoid damage to the geotextile layer which was installed at 1.5m depth below ground level. Groundwater was not encountered during testing.

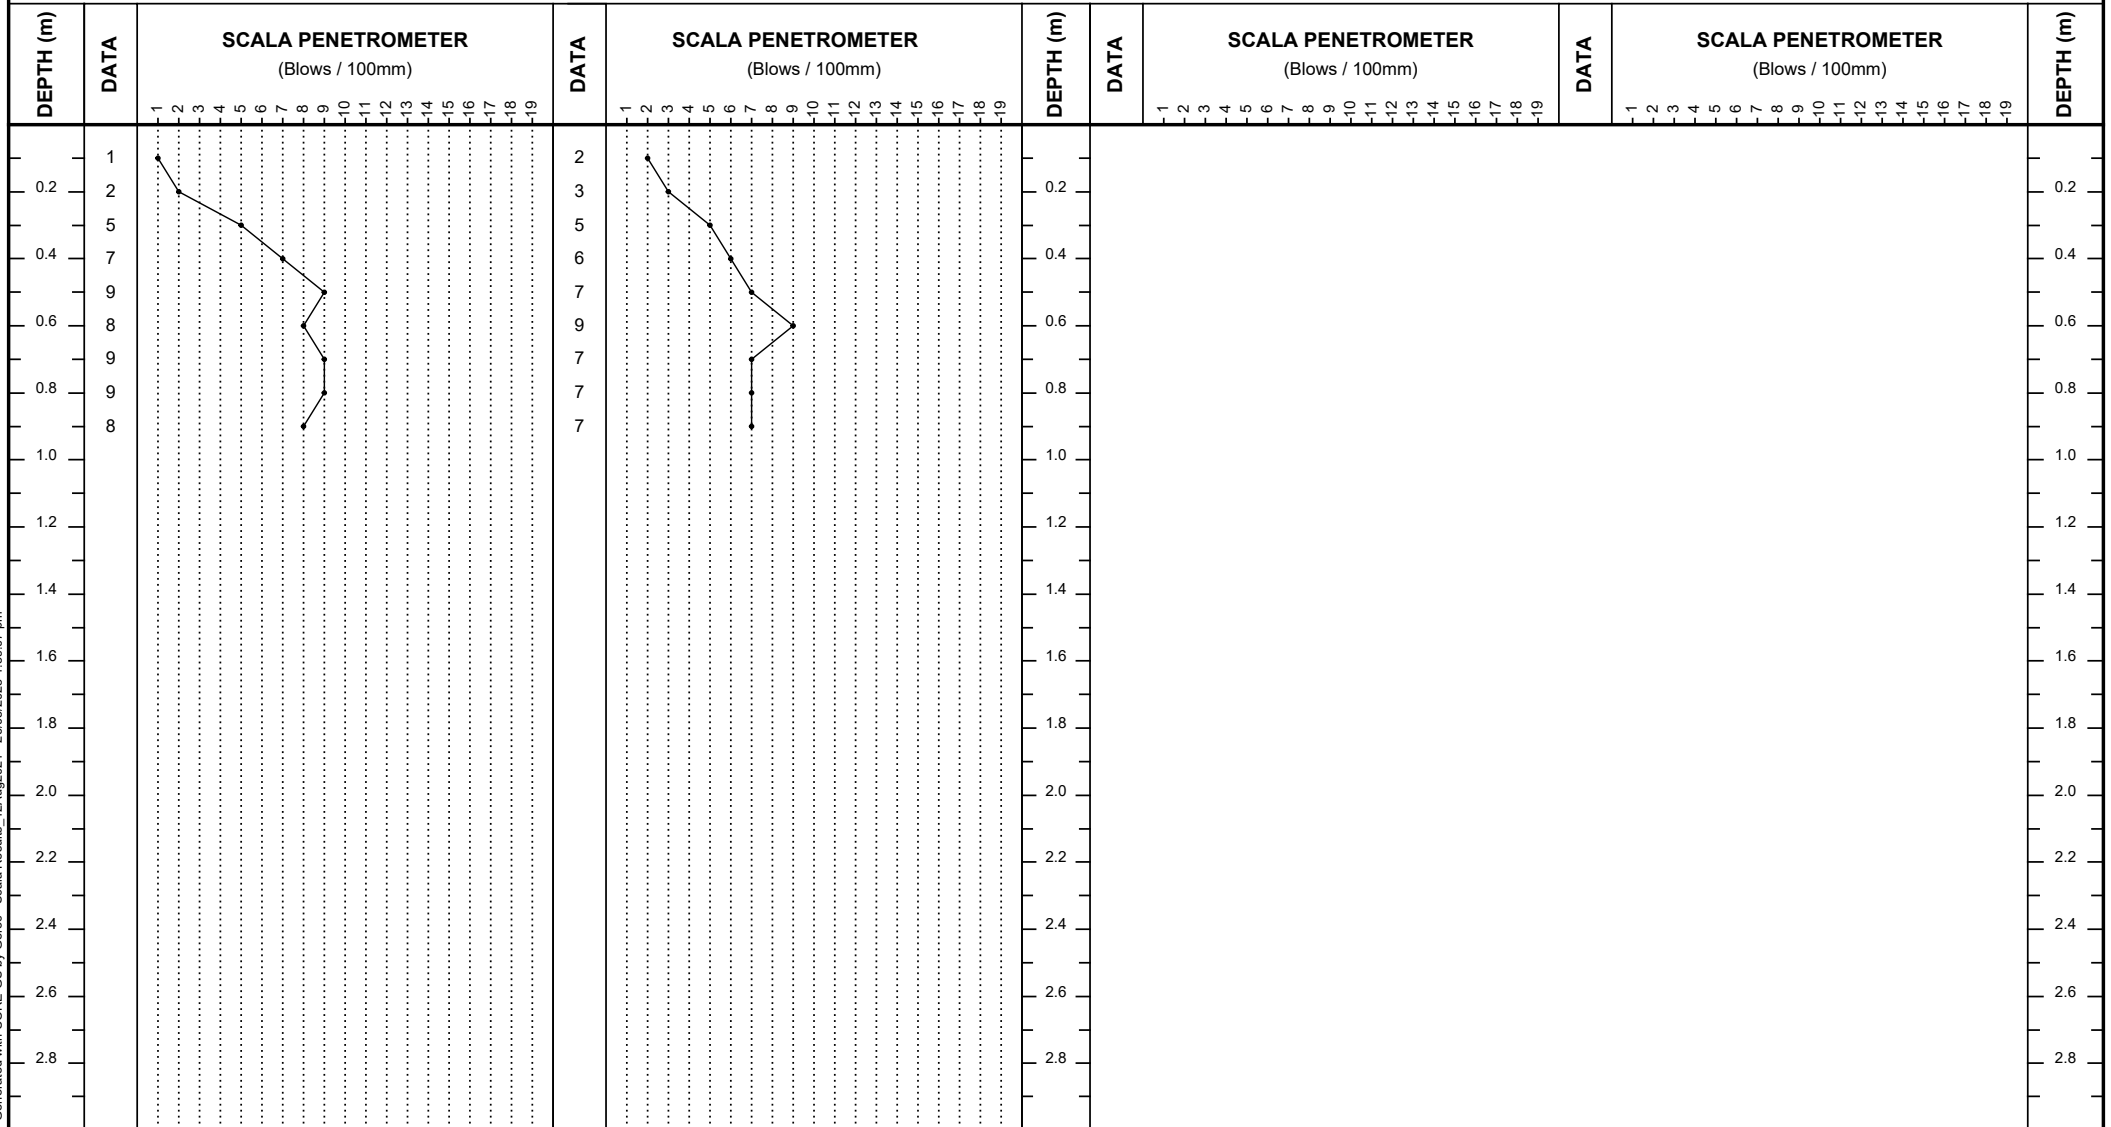
LOT 14- SP01

SPs at each of the four locations returned results between 5 and 10 blows per 100mm penetration below the topsoil and within the engineered fill layer. SPs were terminated at 0.9m depth to confirm near surface bearing capacities, and to avoid damage to the geogrids and geotextile. In addition, the density of the engineered fill and bearing capacity of its underlying subgrade have been confirmed via extensive geotechnical inspection and fill compaction testing during subdivision earthworks.

All foundations must be embedded to a minimum depth of 0.4m below ground level, where an Ultimate Bearing Capacity of 200kPa and a strength reduction factor of (ϕ_s) 0.5 is available. Foundations excavations should expose engineered fill of appropriate bearing capacity. All topsoil and unsuitable materials should be removed below foundations and floor slab areas, and where required layers of compacted hardfill should be placed to the underside of foundations.
