Date: 30 August 2023
Project No: LTC21220-A
Revision: B

**RE: SHALLOW SOIL TEST REPORT
FUTURE RESIDENTIAL FOUNDATIONS
LOT 20, 115 EUREKA STREET, ARANUI**

Test Location Plan
 Lot 20, 115 Eureka Street,
 ARANUI, CHRISTCHURCH

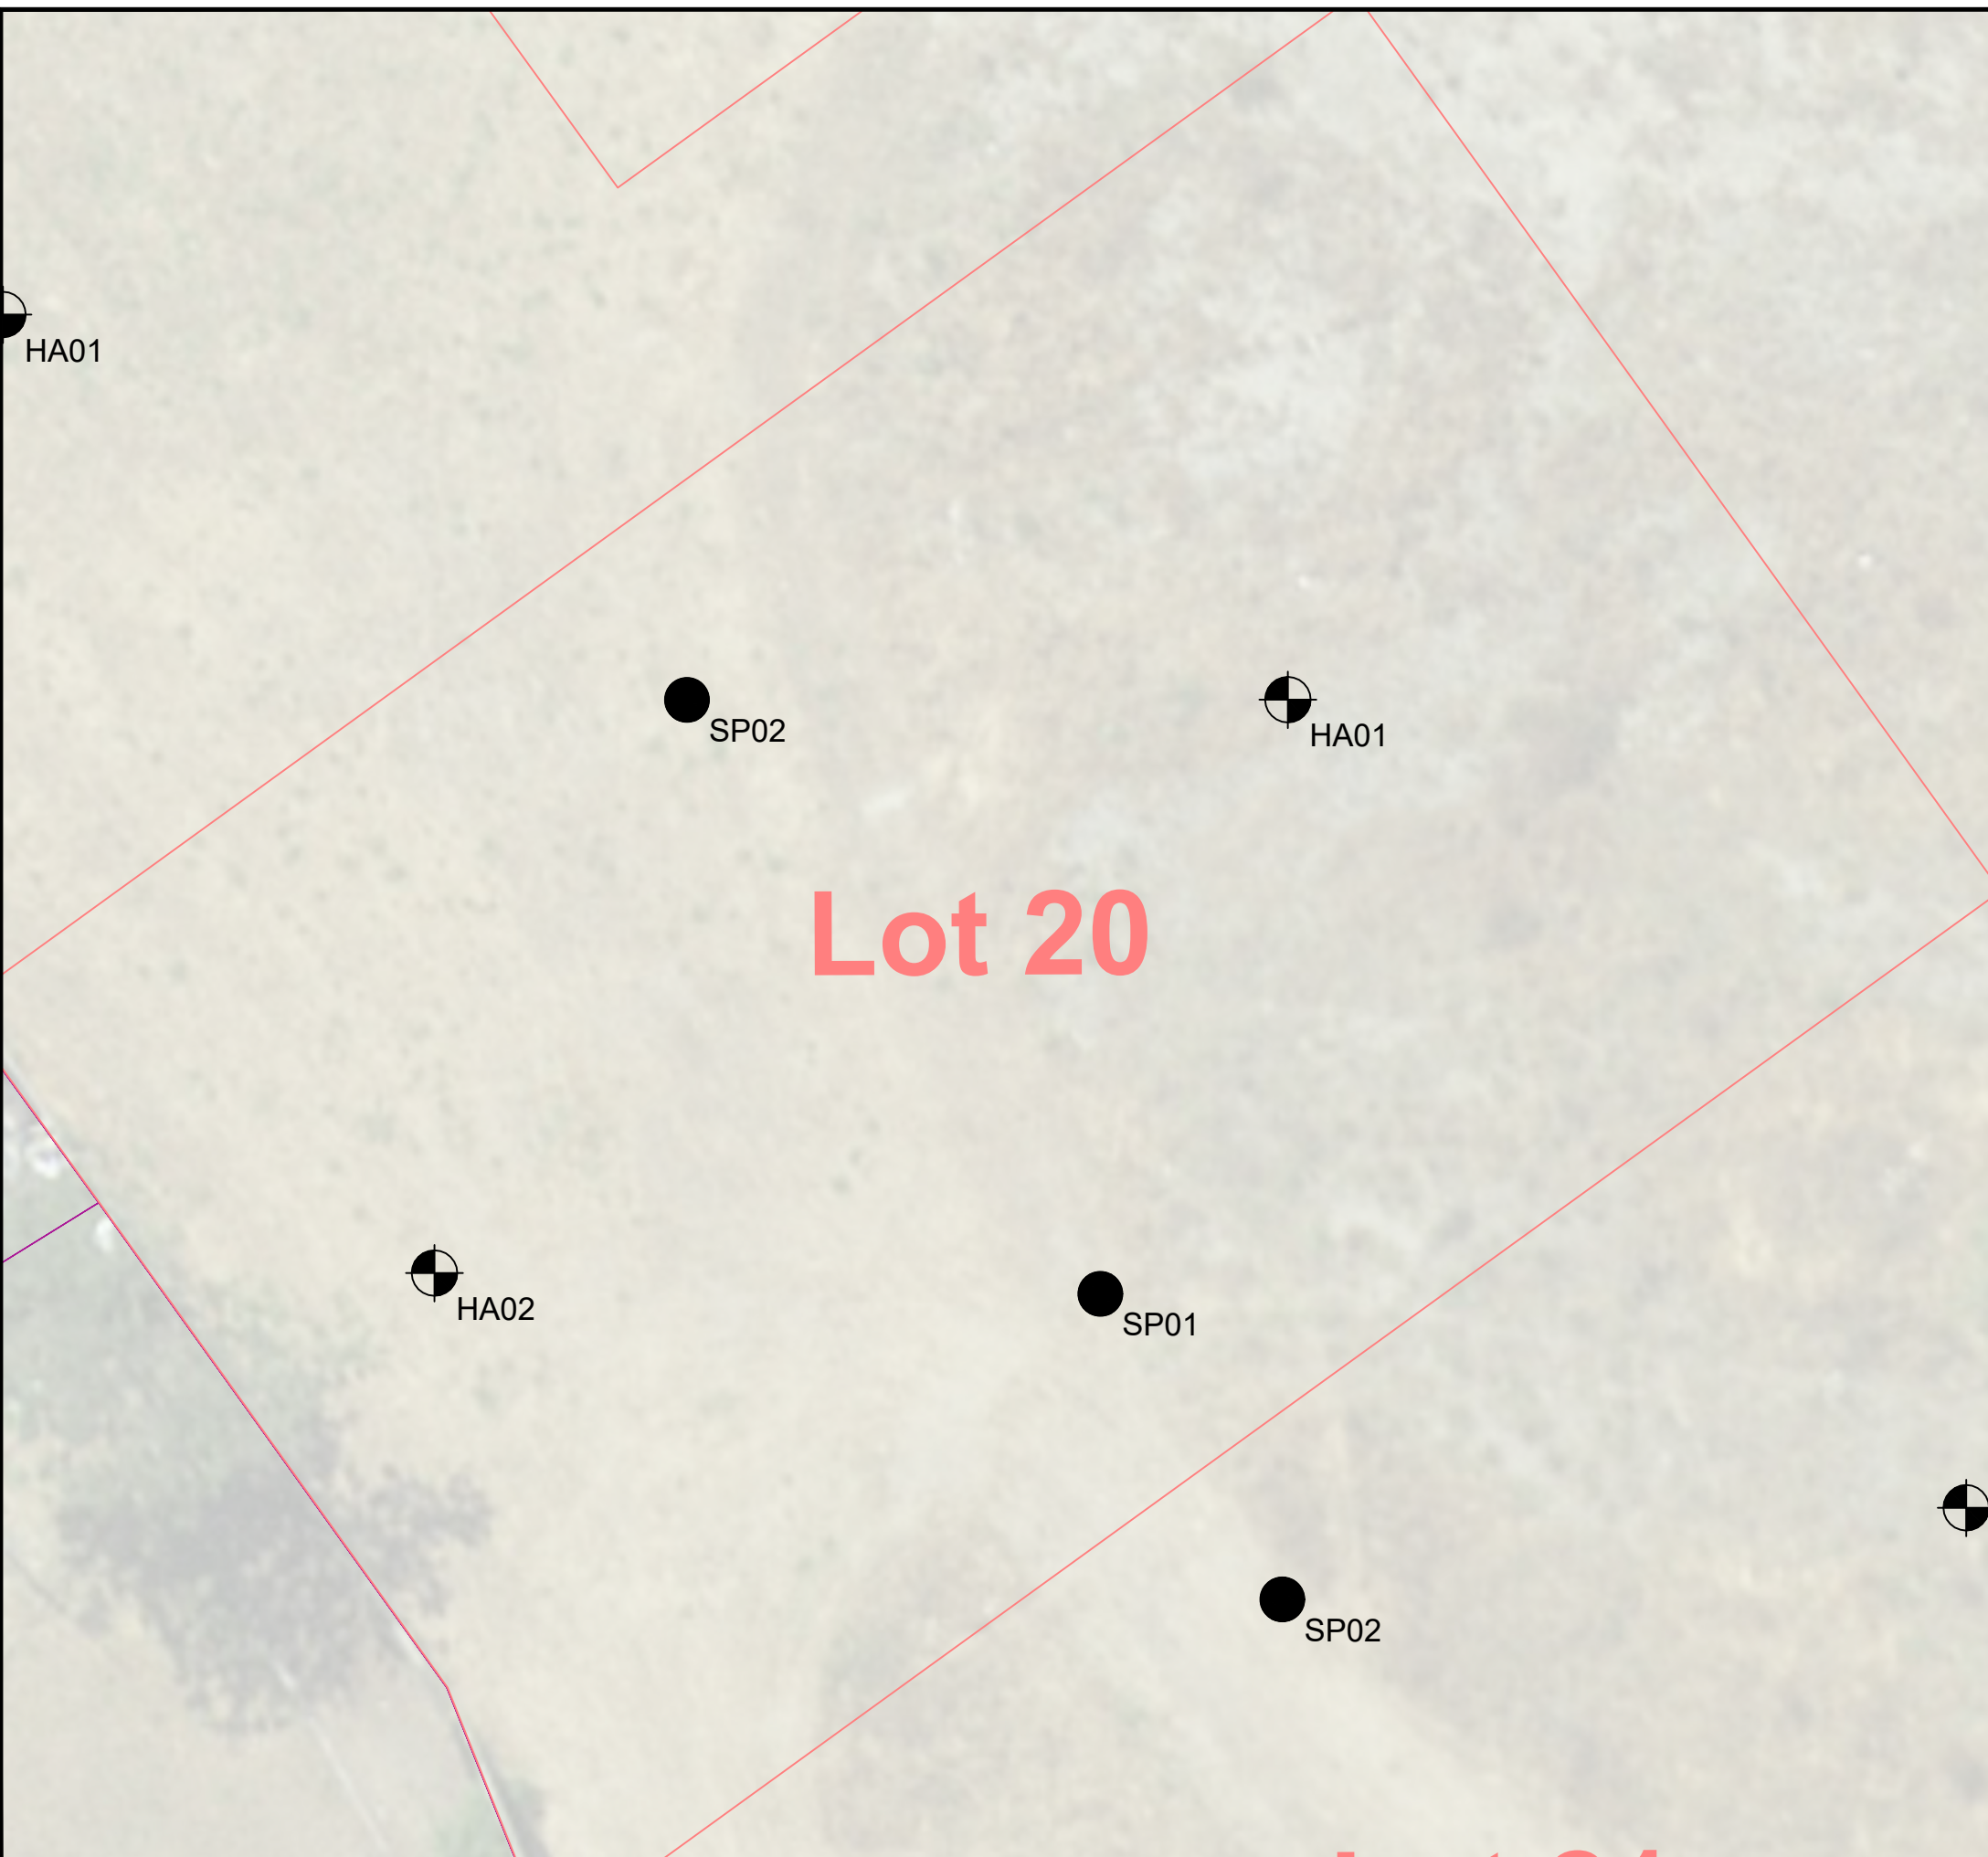
LandTech investigated the site on 27 April 2023, conducting two hand augers with corresponding Scala Penetrometer tests (SPs) and two additional SPs. The locations of the hand auger and SPs were measured using inferred lot boundaries and are approximate only. The test locations are shown on our LandTech *Test Location Plan*, Drawing No. Lot 20/ TLP, attached to this report.

The ground improvement could not extend all the way up to the southwestern boundary of the lot on account of temporary batters of approximately 1V :1H being formed down from the boundaries during construction to allow for the formation of the engineered fill raft. Therefore, a no-build setback to the greater of 2.0m, the depth of ground remediation, or the sum of the permanent cut face (existing ground level to finished ground level) plus the depth of ground remediation along these boundaries, shall be created along the corresponding boundaries. With reference to the Davie Lovell-Smith As-Built Earthworks Plans completed for the subdivision, the maximum depth of ground remediation was 1.4m, while the maximum permanent cut face is 0.4m high along some of the boundaries. Therefore, the 2.0m no-build setback governs along these boundaries to external neighbouring properties.

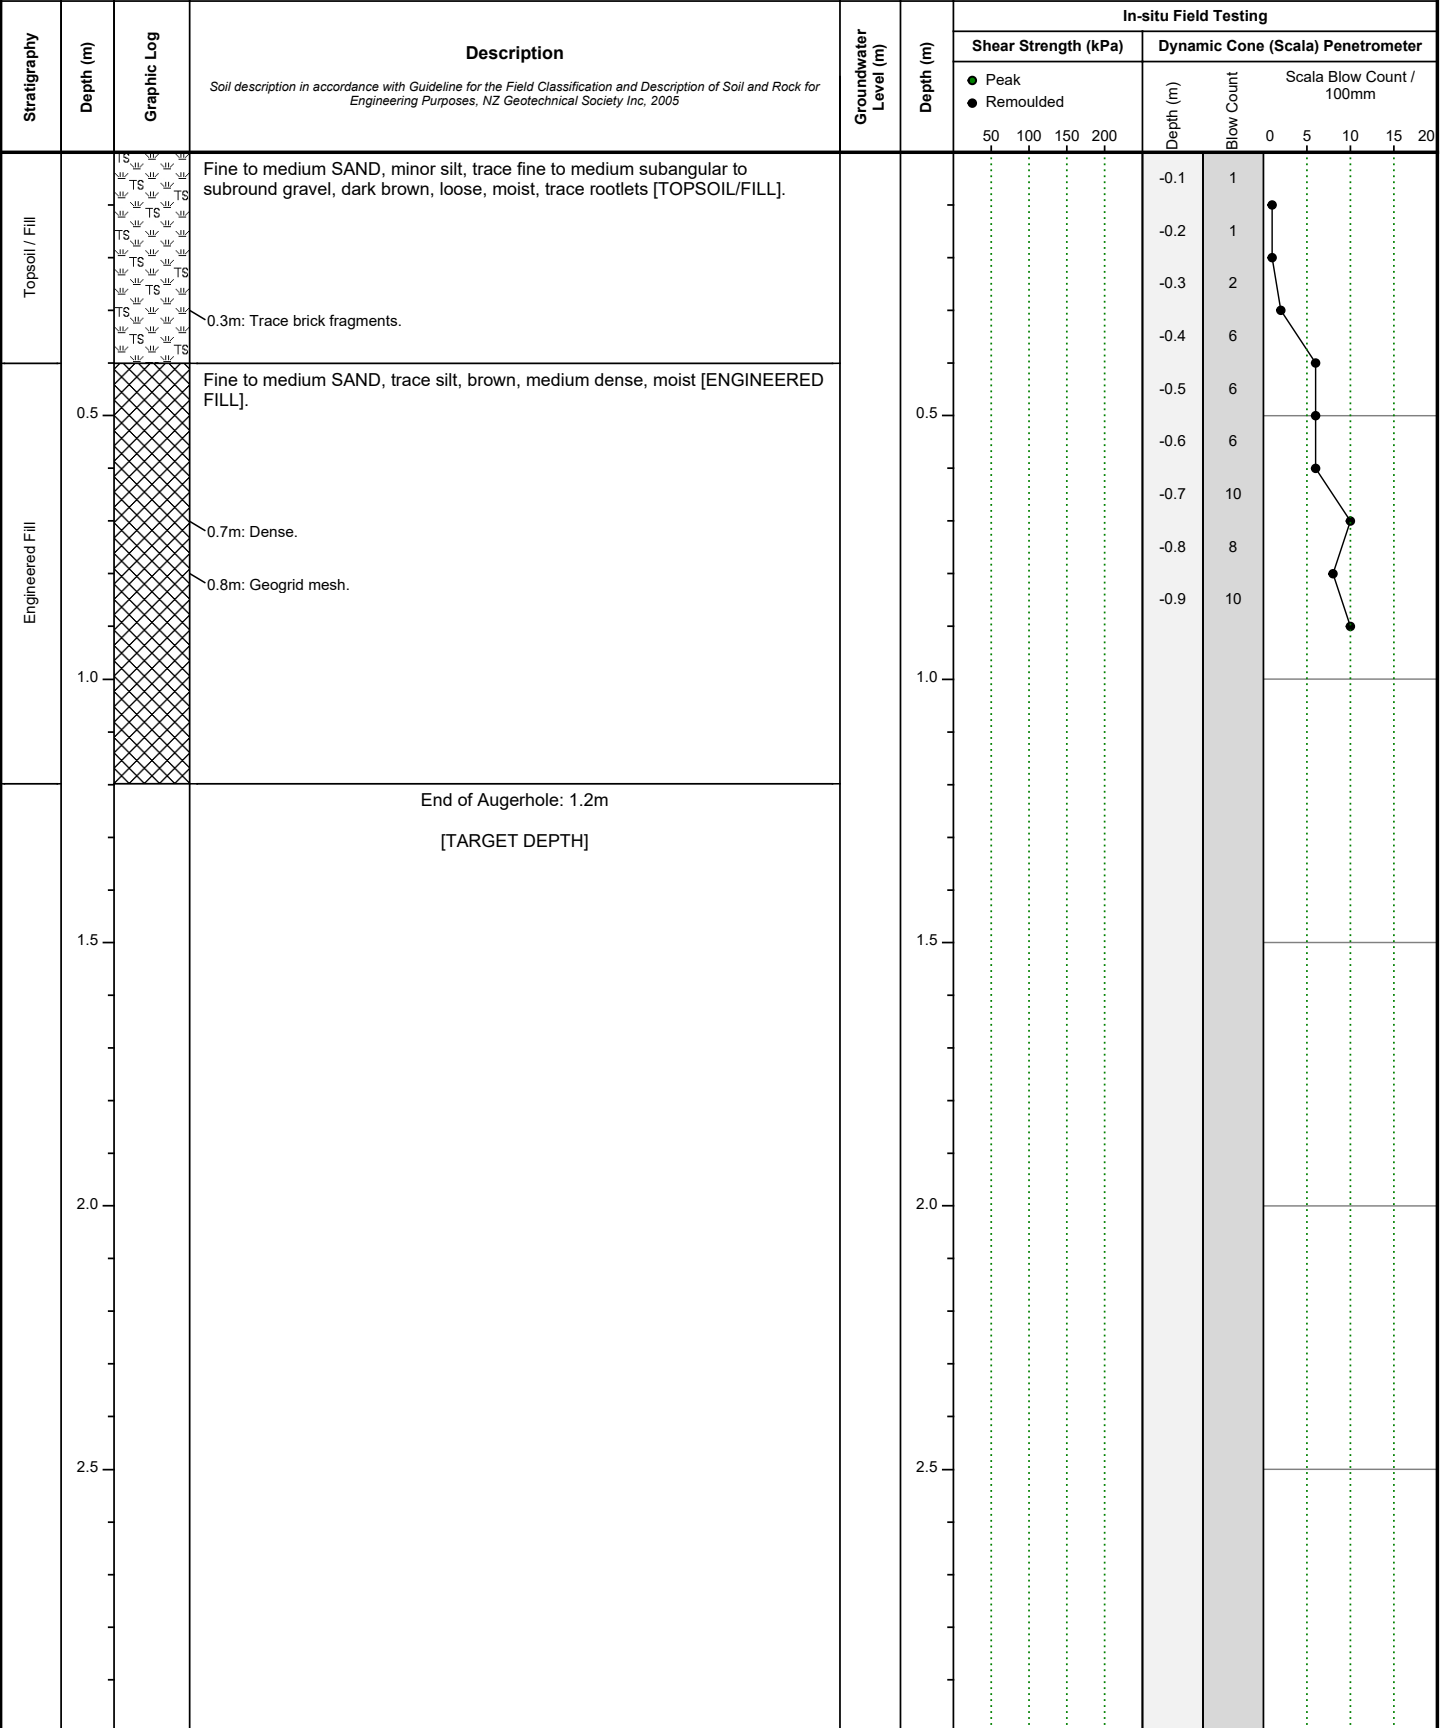
Augerhole No.: LOT 20 - HA01

Topsoil was encountered within the hand augers from the ground surface to between 0.3m and 0.4m depths, which was typically a dark brown minor to some silt and sand material with trace gravel. Engineered fill was encountered below the topsoil to the base of auger holes, which was a compacted brown sand with trace of silt material. The hand augers were terminated at 1.2m depth below ground level to avoid damage to the geotextile layer which was installed at 1.5m depth below ground level. Groundwater was not encountered during testing.

Target depth achieved.

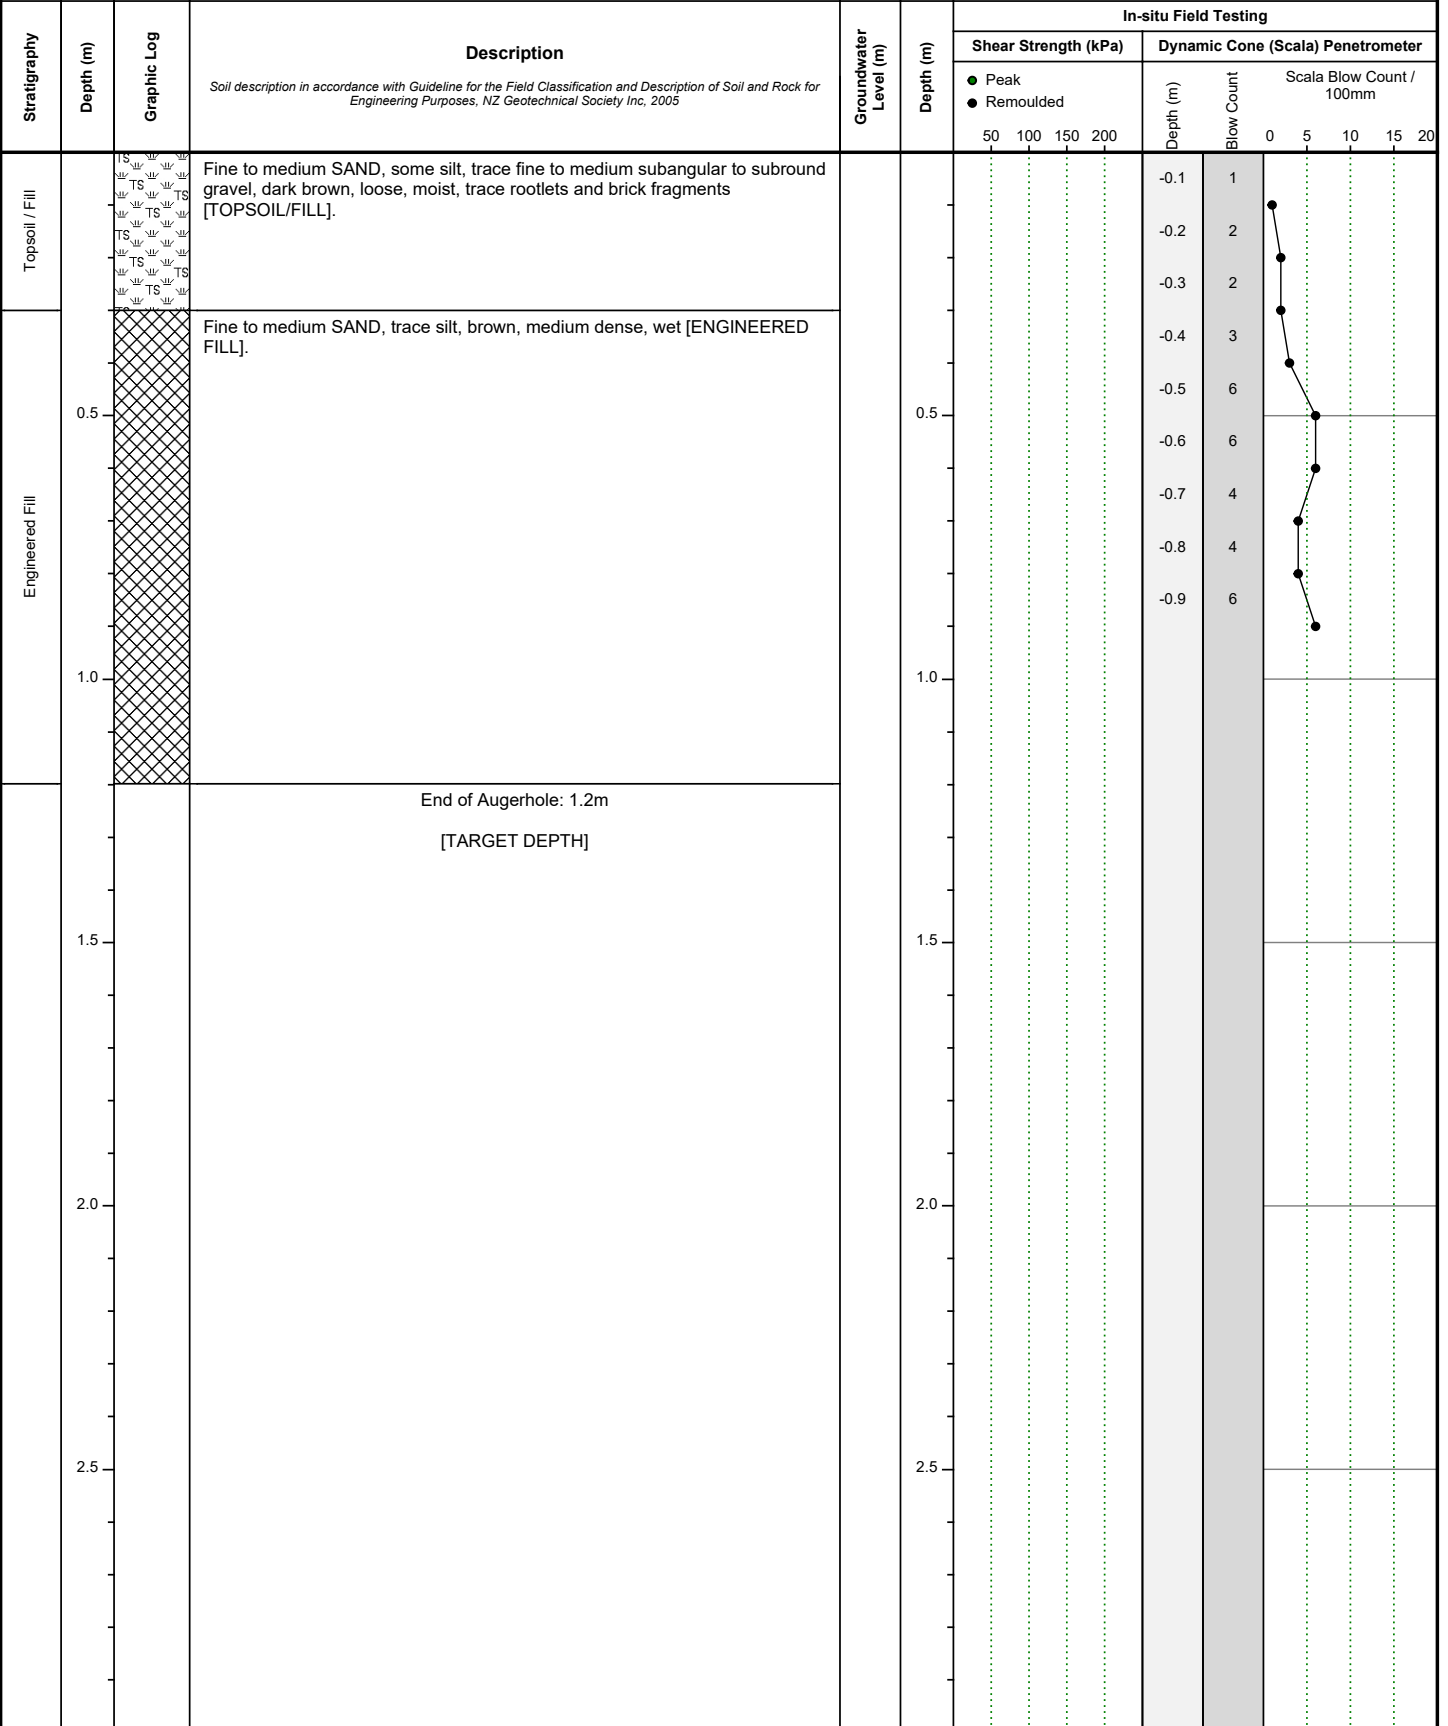
Augerhole No.: LOT 20 - HA02

Target depth achieved.

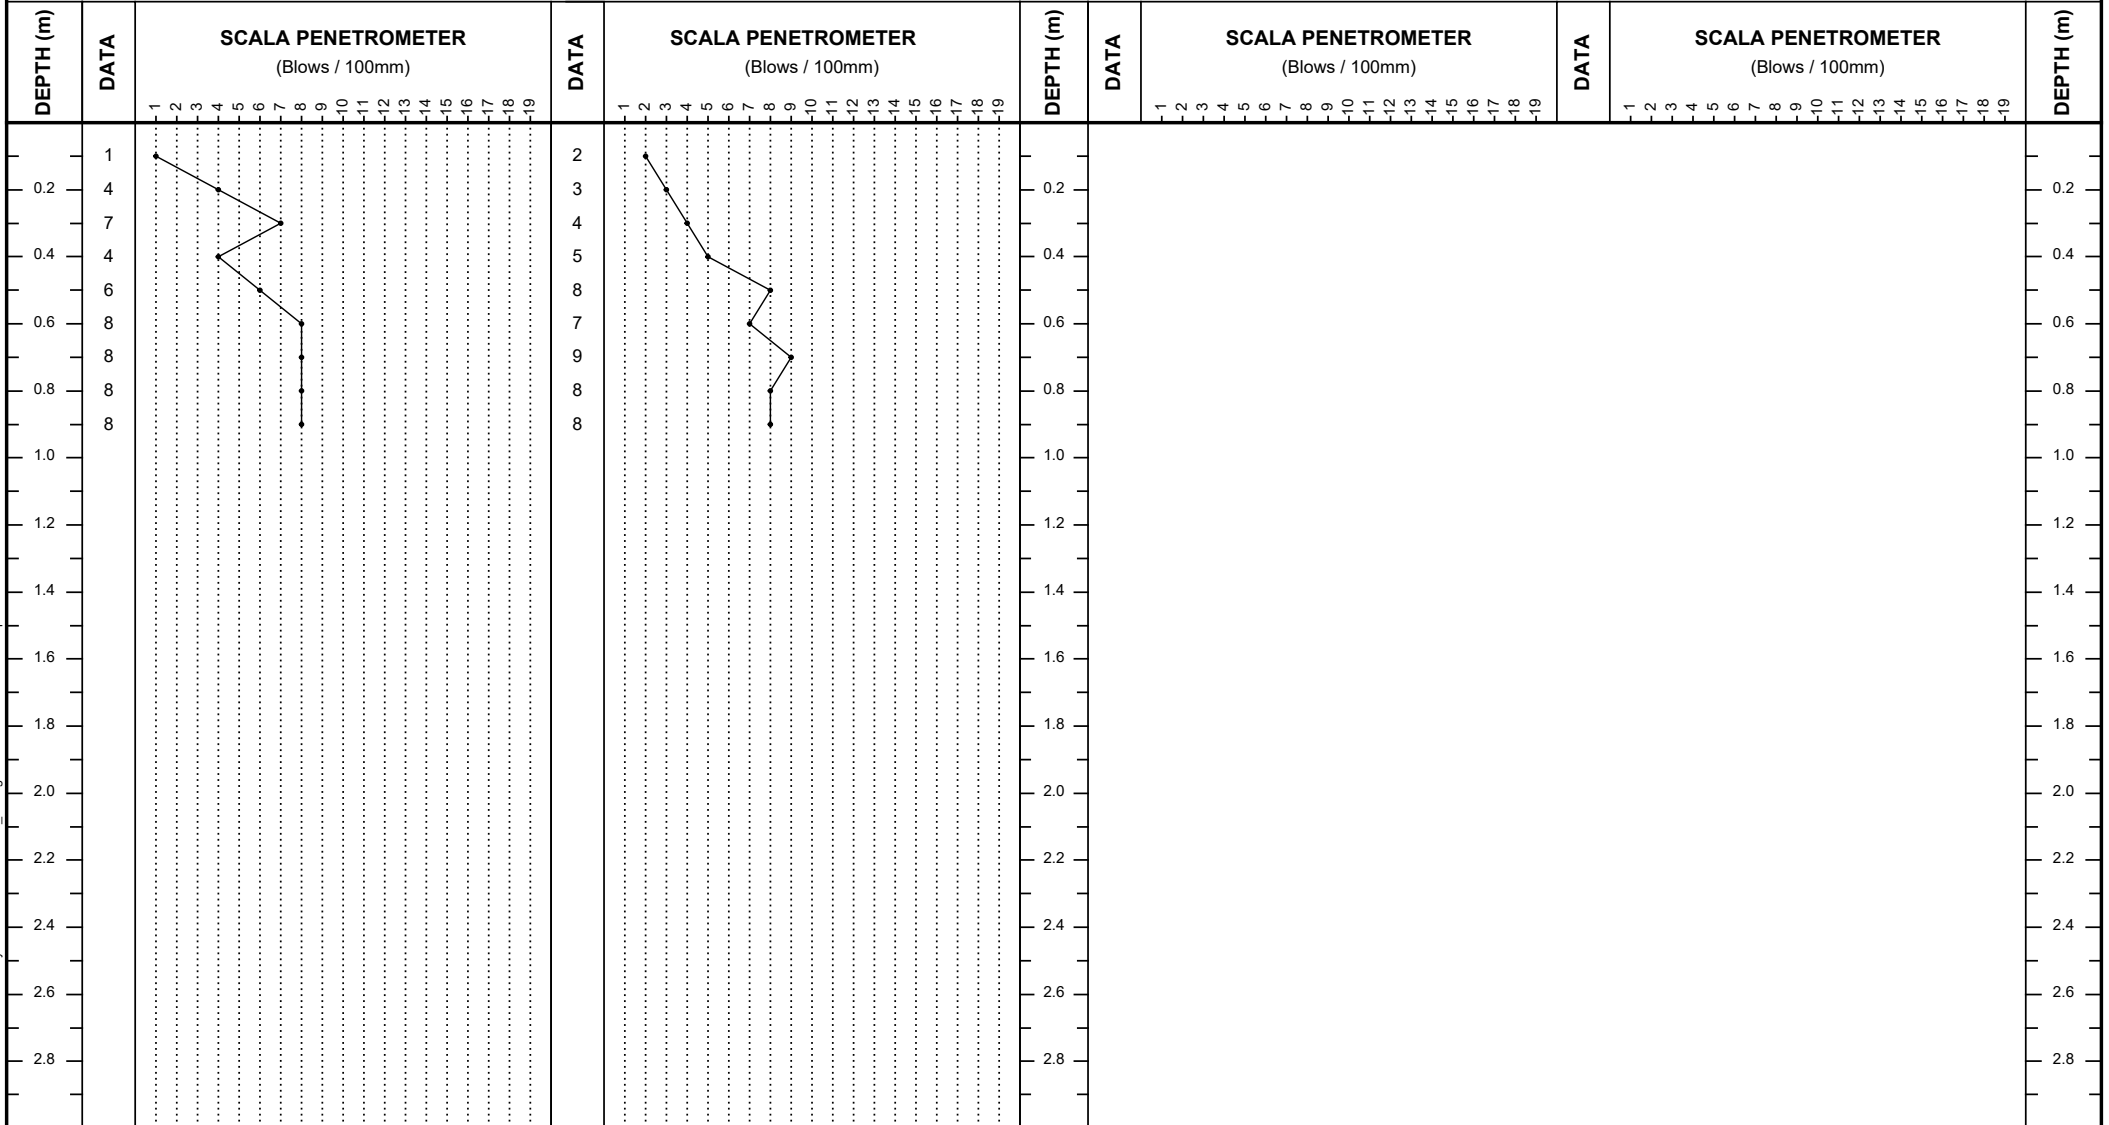
LOT 20 - SP01

SPs at each of the four locations returned results between 3 and 10 blows per 100mm penetration below the topsoil and within the engineered fill layer. SPs were terminated at 0.9m depth to confirm near surface bearing capacities, and to avoid damage to the geogrids and geotextile. In addition, the density of the engineered fill and bearing capacity of its underlying subgrade have been confirmed via extensive geotechnical inspection and fill compaction testing during subdivision earthworks.

All foundations must be embedded to a minimum depth of 0.4m below ground level, where an Ultimate Bearing Capacity of 200kPa and a strength reduction factor of (ϕ_s) 0.5 is available. Foundations excavations should expose engineered fill of appropriate bearing capacity. All topsoil and unsuitable materials should be removed below foundations and floor slab areas, and where required layers of compacted hardfill should be placed to the underside of foundations.
