Date: 30 August 2023  
Project No: LTC21220-A  
Revision: B

**RE: SHALLOW SOIL TEST REPORT  
FUTURE RESIDENTIAL FOUNDATIONS  
LOT 21, 115 EUREKA STREET, ARANUI**

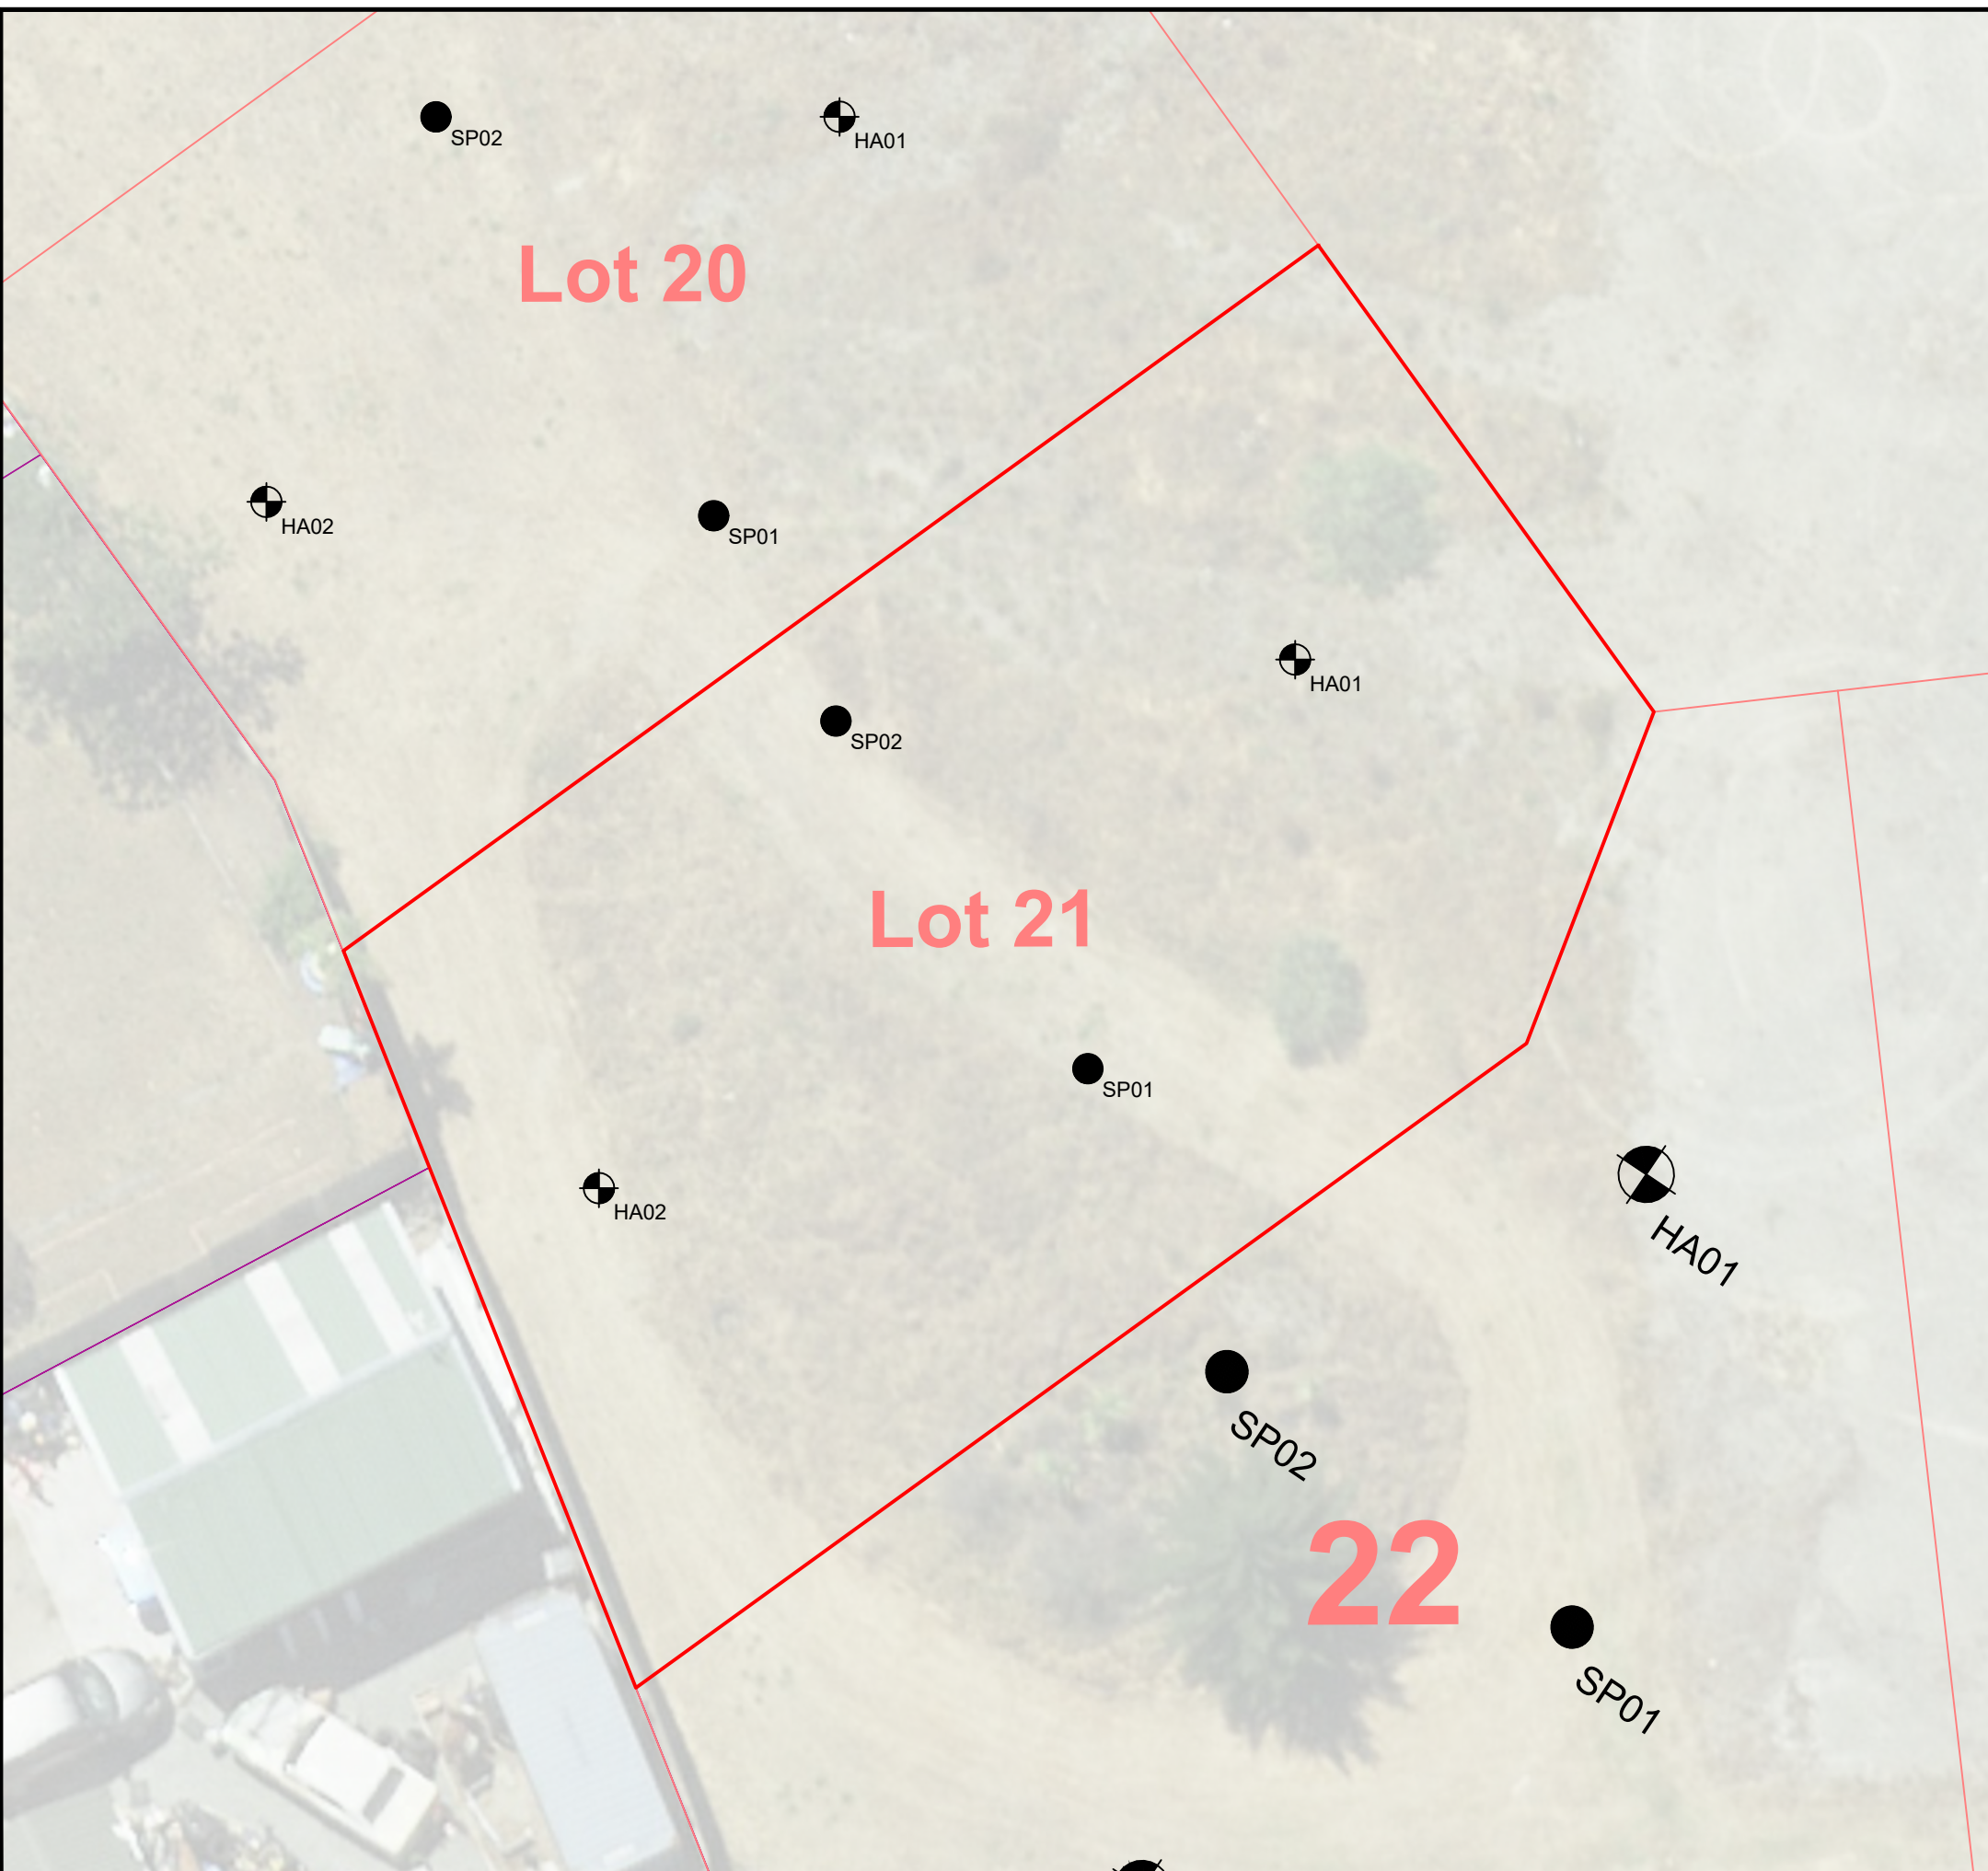
**Test Location Plan**  
 Lot 21, 115 Eureka Street,  
 ARANUI, CHRISTCHURCH

LandTech investigated the site on 23 March 2023, conducting two hand augers with corresponding Scala Penetrometer tests (SPs) and two additional SPs. The locations of the hand auger and SPs were measured using inferred lot boundaries and are approximate only. The test locations are shown on our LandTech *Test Location Plan*, Drawing No. Lot 21/ TLP, attached to this report.

The ground improvement could not extend all the way up to the southwestern boundary of the lot on account of temporary batters of approximately 1V :1H being formed down from the boundaries during construction to allow for the formation of the engineered fill raft. Therefore, a no-build setback to the greater of 2.0m, the depth of ground remediation, or the sum of the permanent cut face (existing ground level to finished ground level) plus the depth of ground remediation along these boundaries, shall be created along the corresponding boundaries. With reference to the Davie Lovell-Smith As-Built Earthworks Plans completed for the subdivision, the maximum depth of ground remediation was 1.4m, while the maximum permanent cut face is 0.4m high along some of the boundaries. Therefore, the 2.0m no-build setback governs along these boundaries to external neighbouring properties.

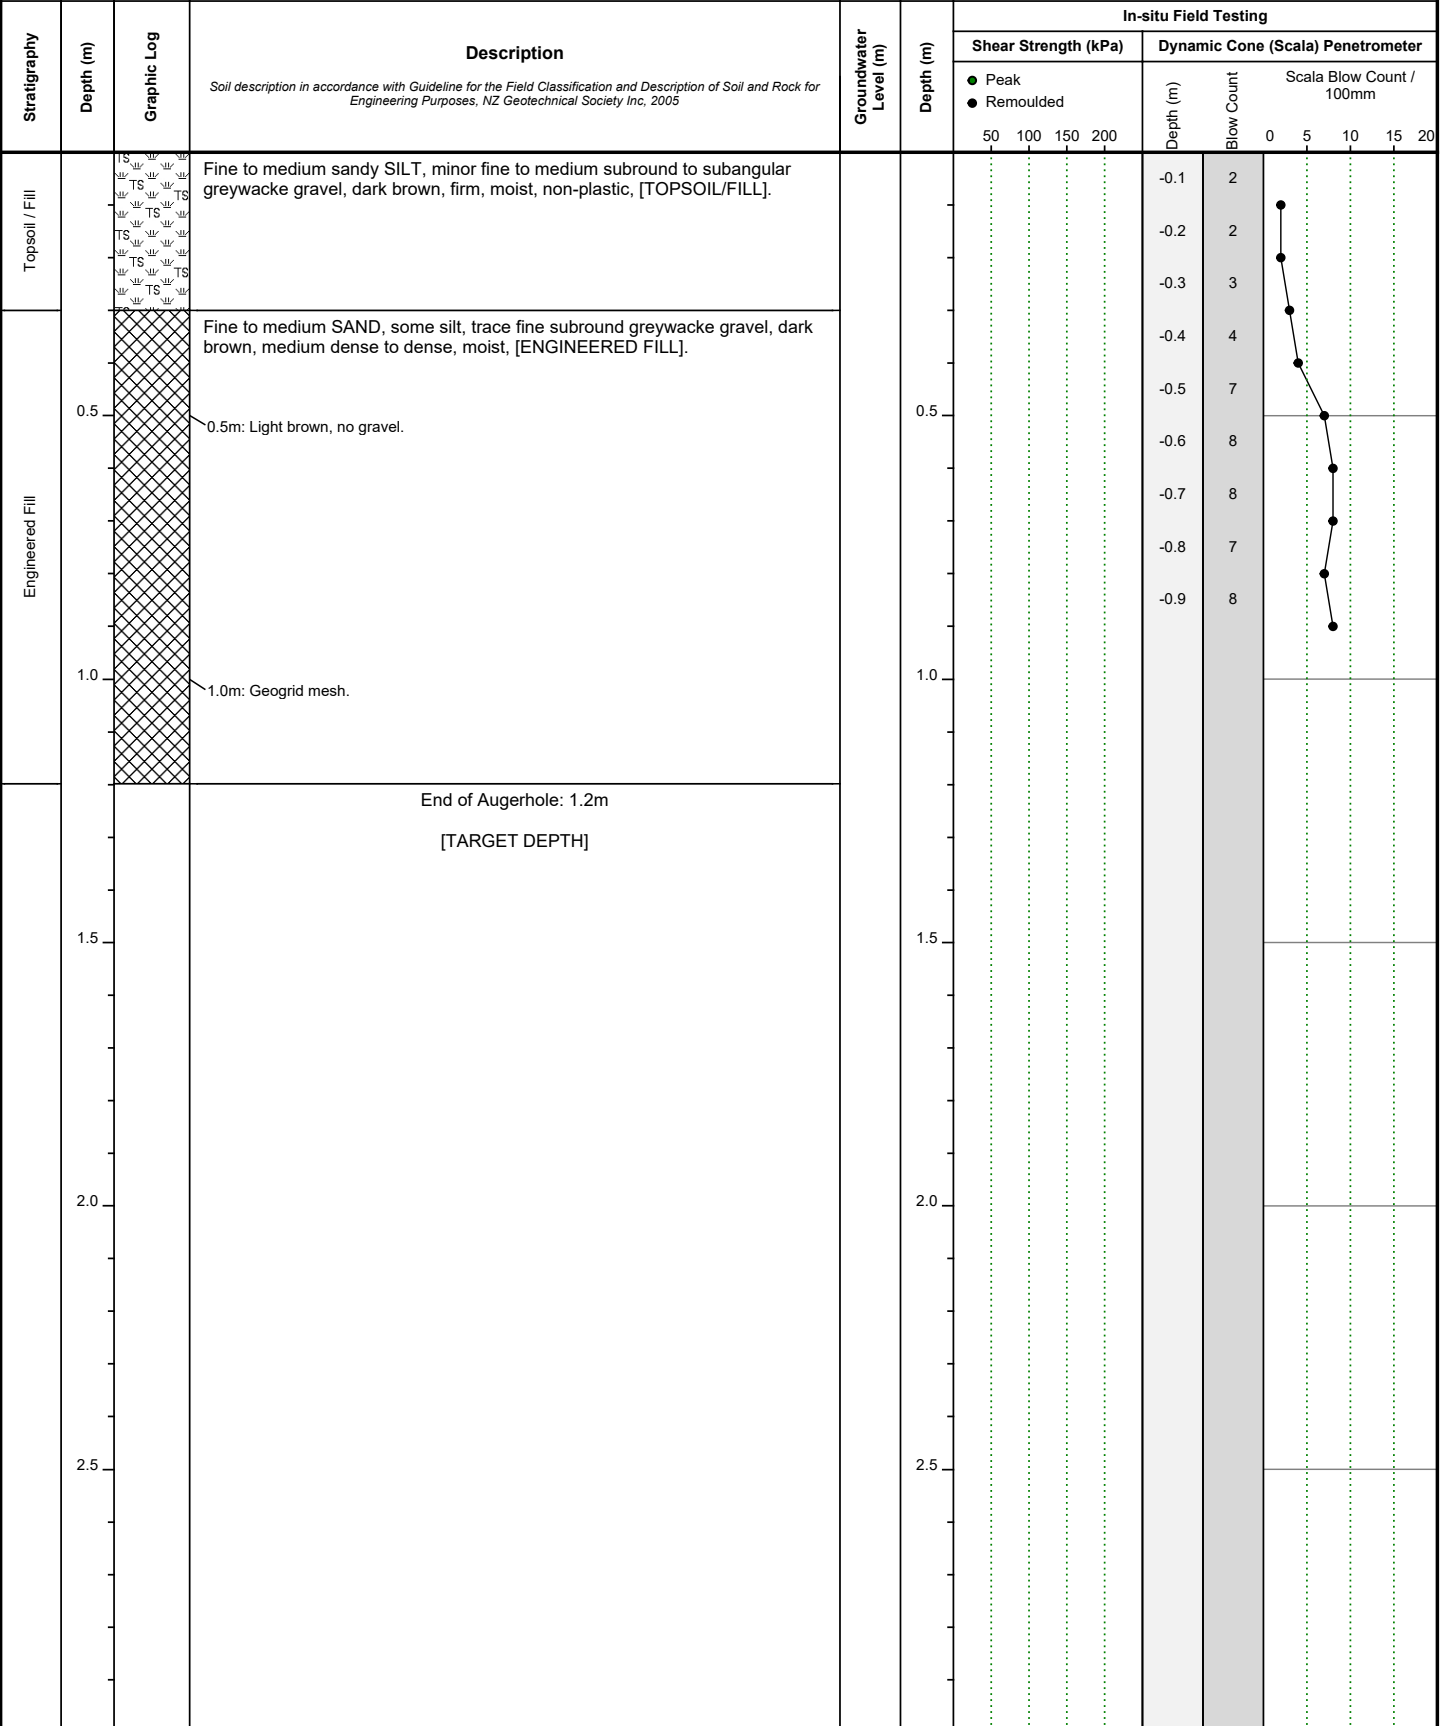
Augerhole No.: LOT 21- HA01

Target depth achieved.      In-situ testing in accordance with the following standards:  
 Scala Penetrometer Testing: NZS 4402:1988, Test 6.5.2, Dynamic Cone Penetrometer  
 Shear Vane Testing: Guideline for Hand Held Shear Vane Test, NZGS, August 2001

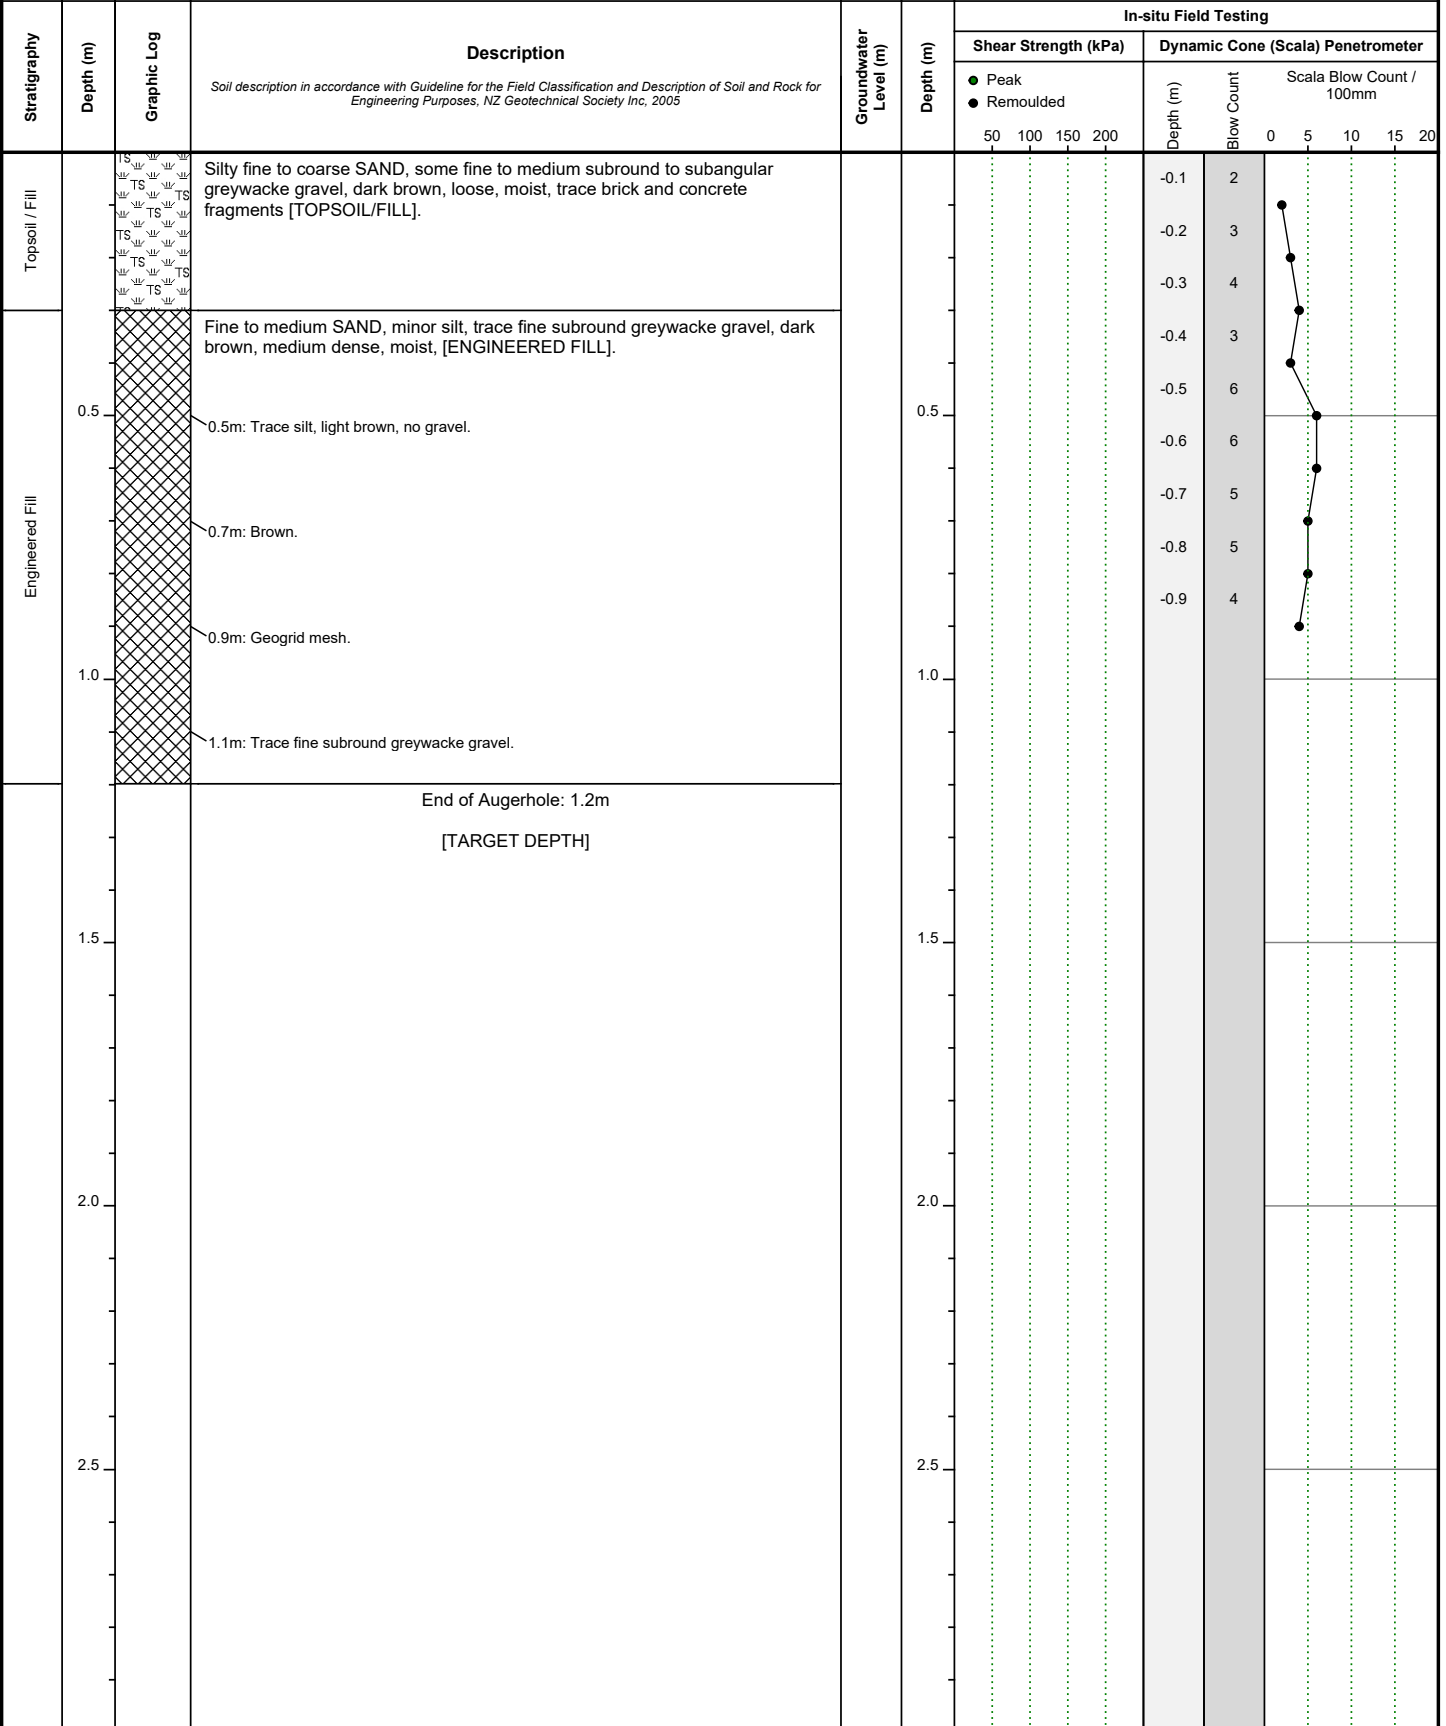
Augerhole No.: LOT 21- HA02

Target depth achieved.      In-situ testing in accordance with the following standards:  
 Scala Penetrometer Testing: NZS 4402:1988, Test 6.5.2, Dynamic Cone Penetrometer  
 Shear Vane Testing: Guideline for Hand Held Shear Vane Test, NZGS, August 2001
