Date: 13 June 2023  
Project No: LTC21220-A

**RE: SHALLOW SOIL TEST REPORT  
FUTURE RESIDENTIAL FOUNDATIONS  
LOT 5, 115 EUREKA STREET, ARANUI**

**Test Location Plan**

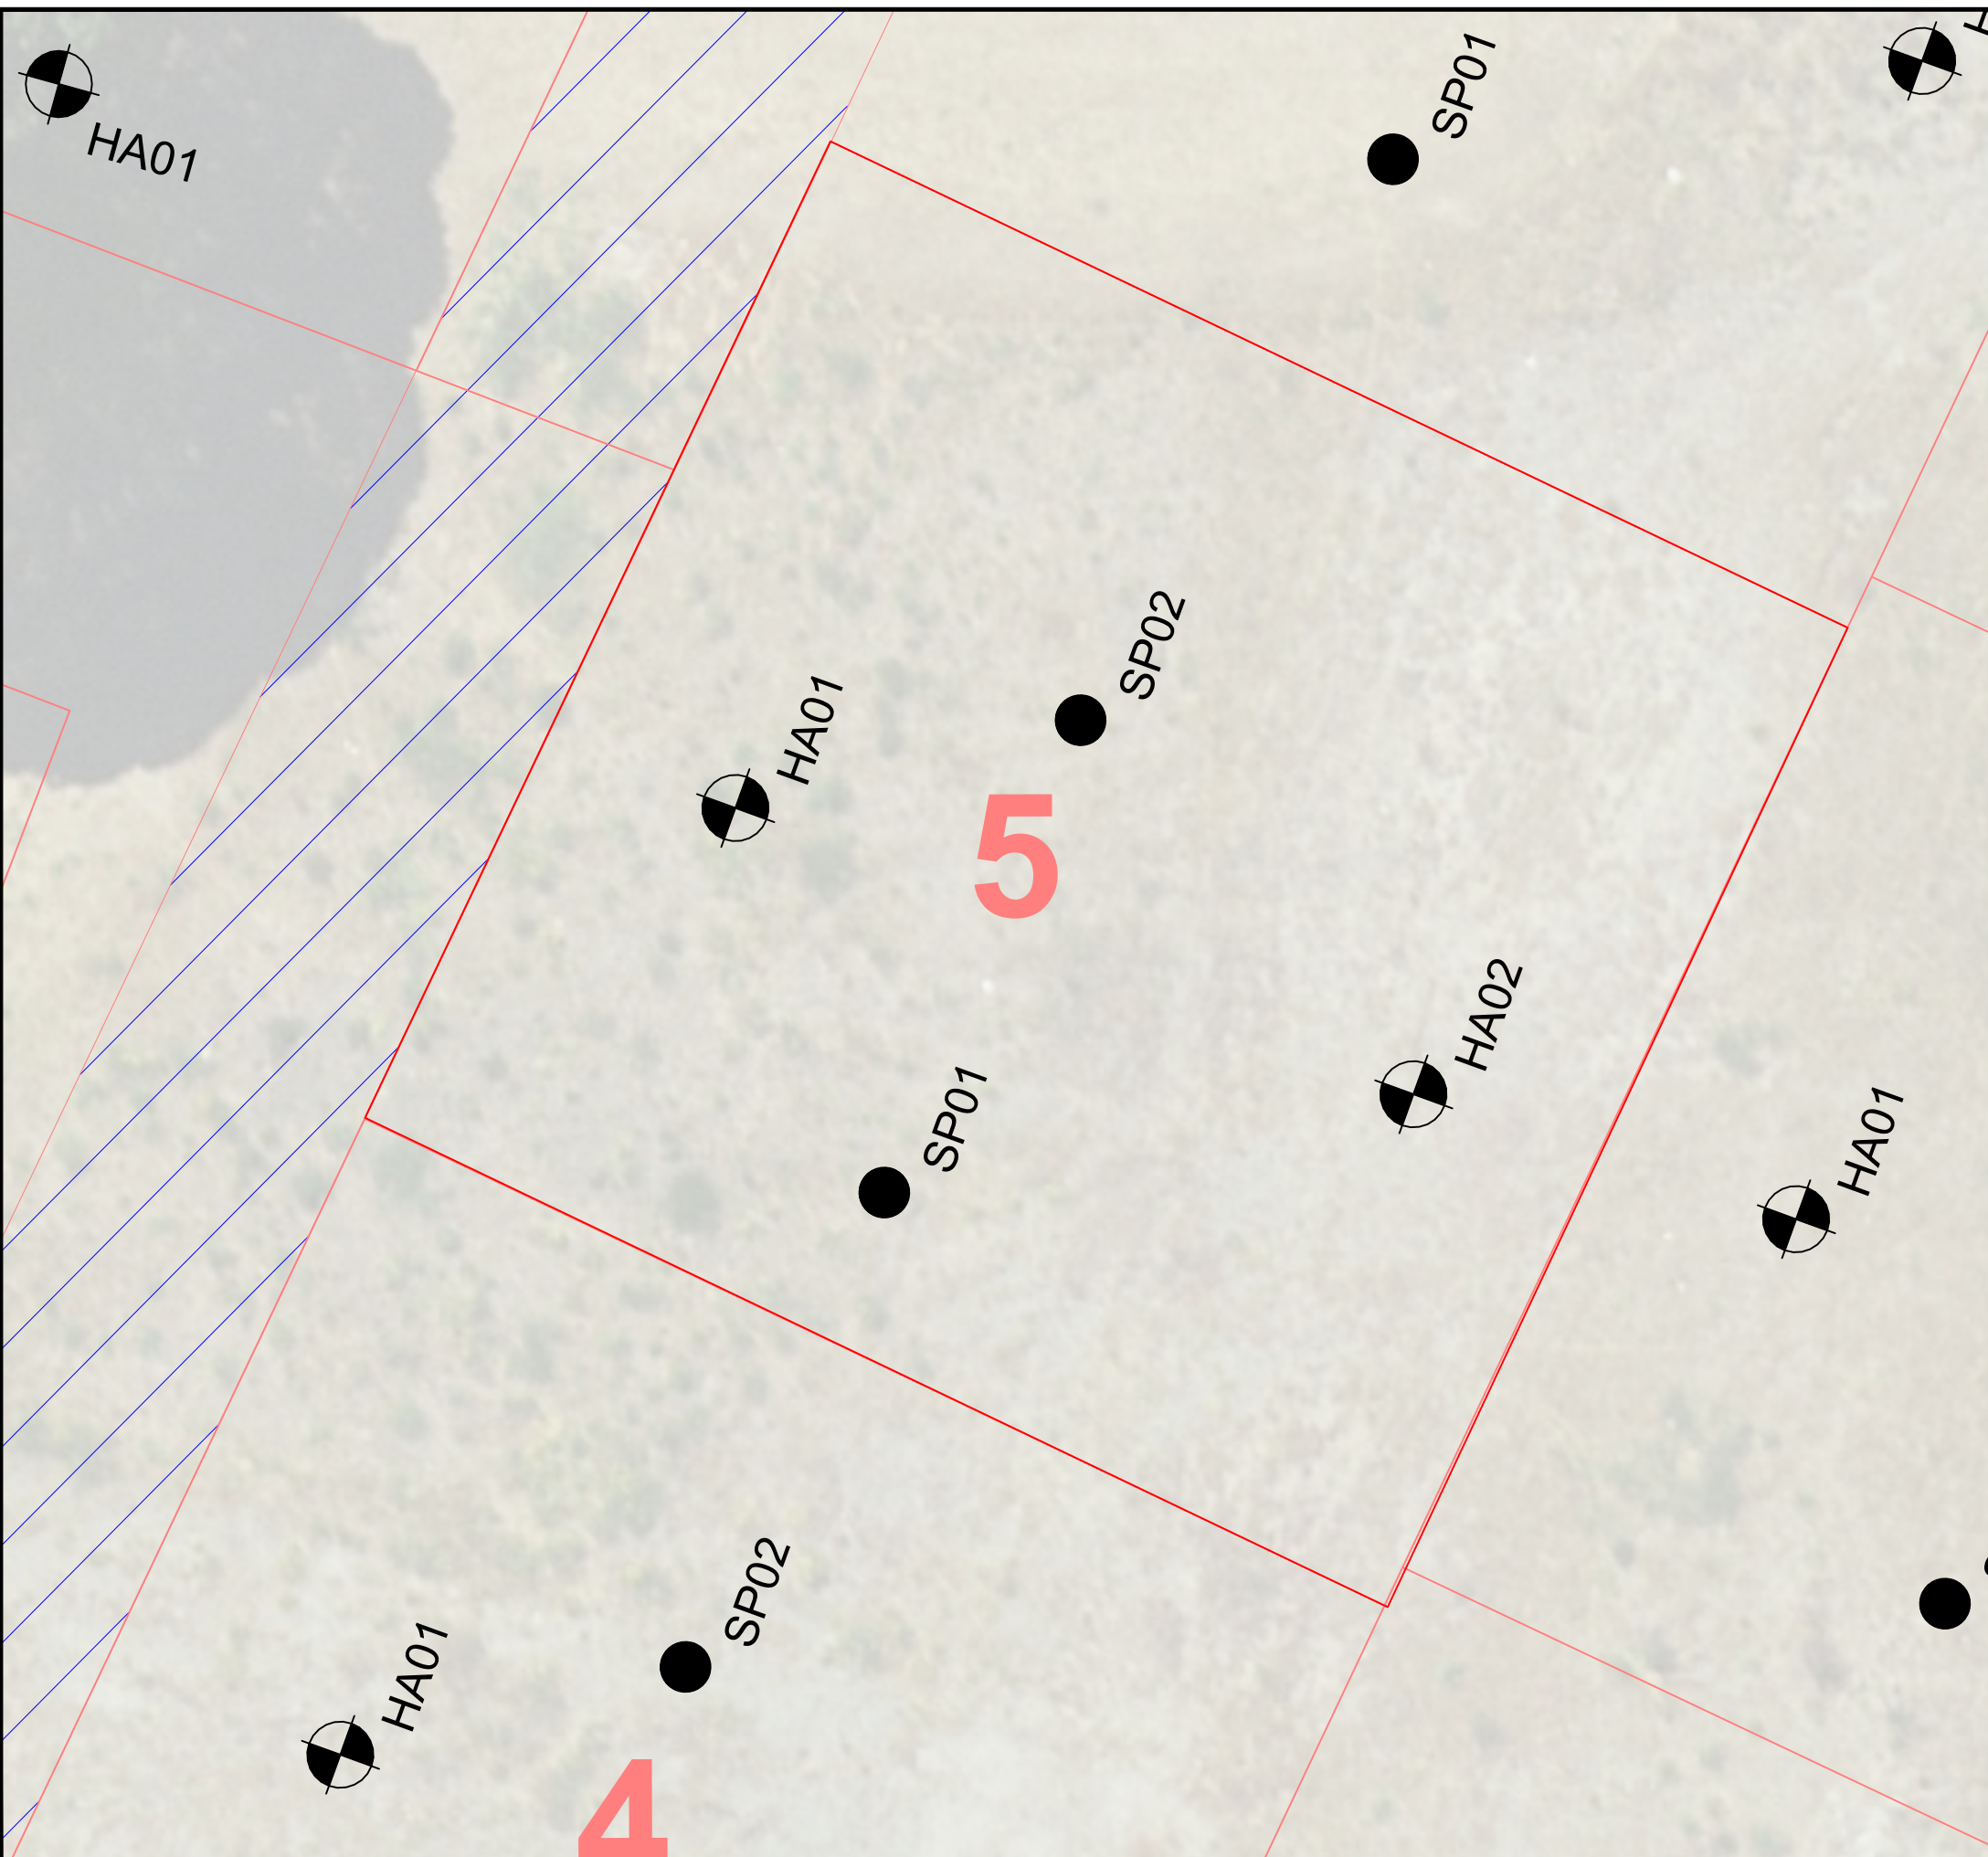
LandTech investigated the site on 8 June 2023, conducting two hand augers with corresponding Scala Penetrometer tests (SPs) and two additional SPs. The locations of the hand auger and SPs were measured using inferred lot boundaries and are approximate only. The test locations are shown on our LandTech *Test Location Plan*, Drawing No. Lot 5/ TLP, attached to this report.

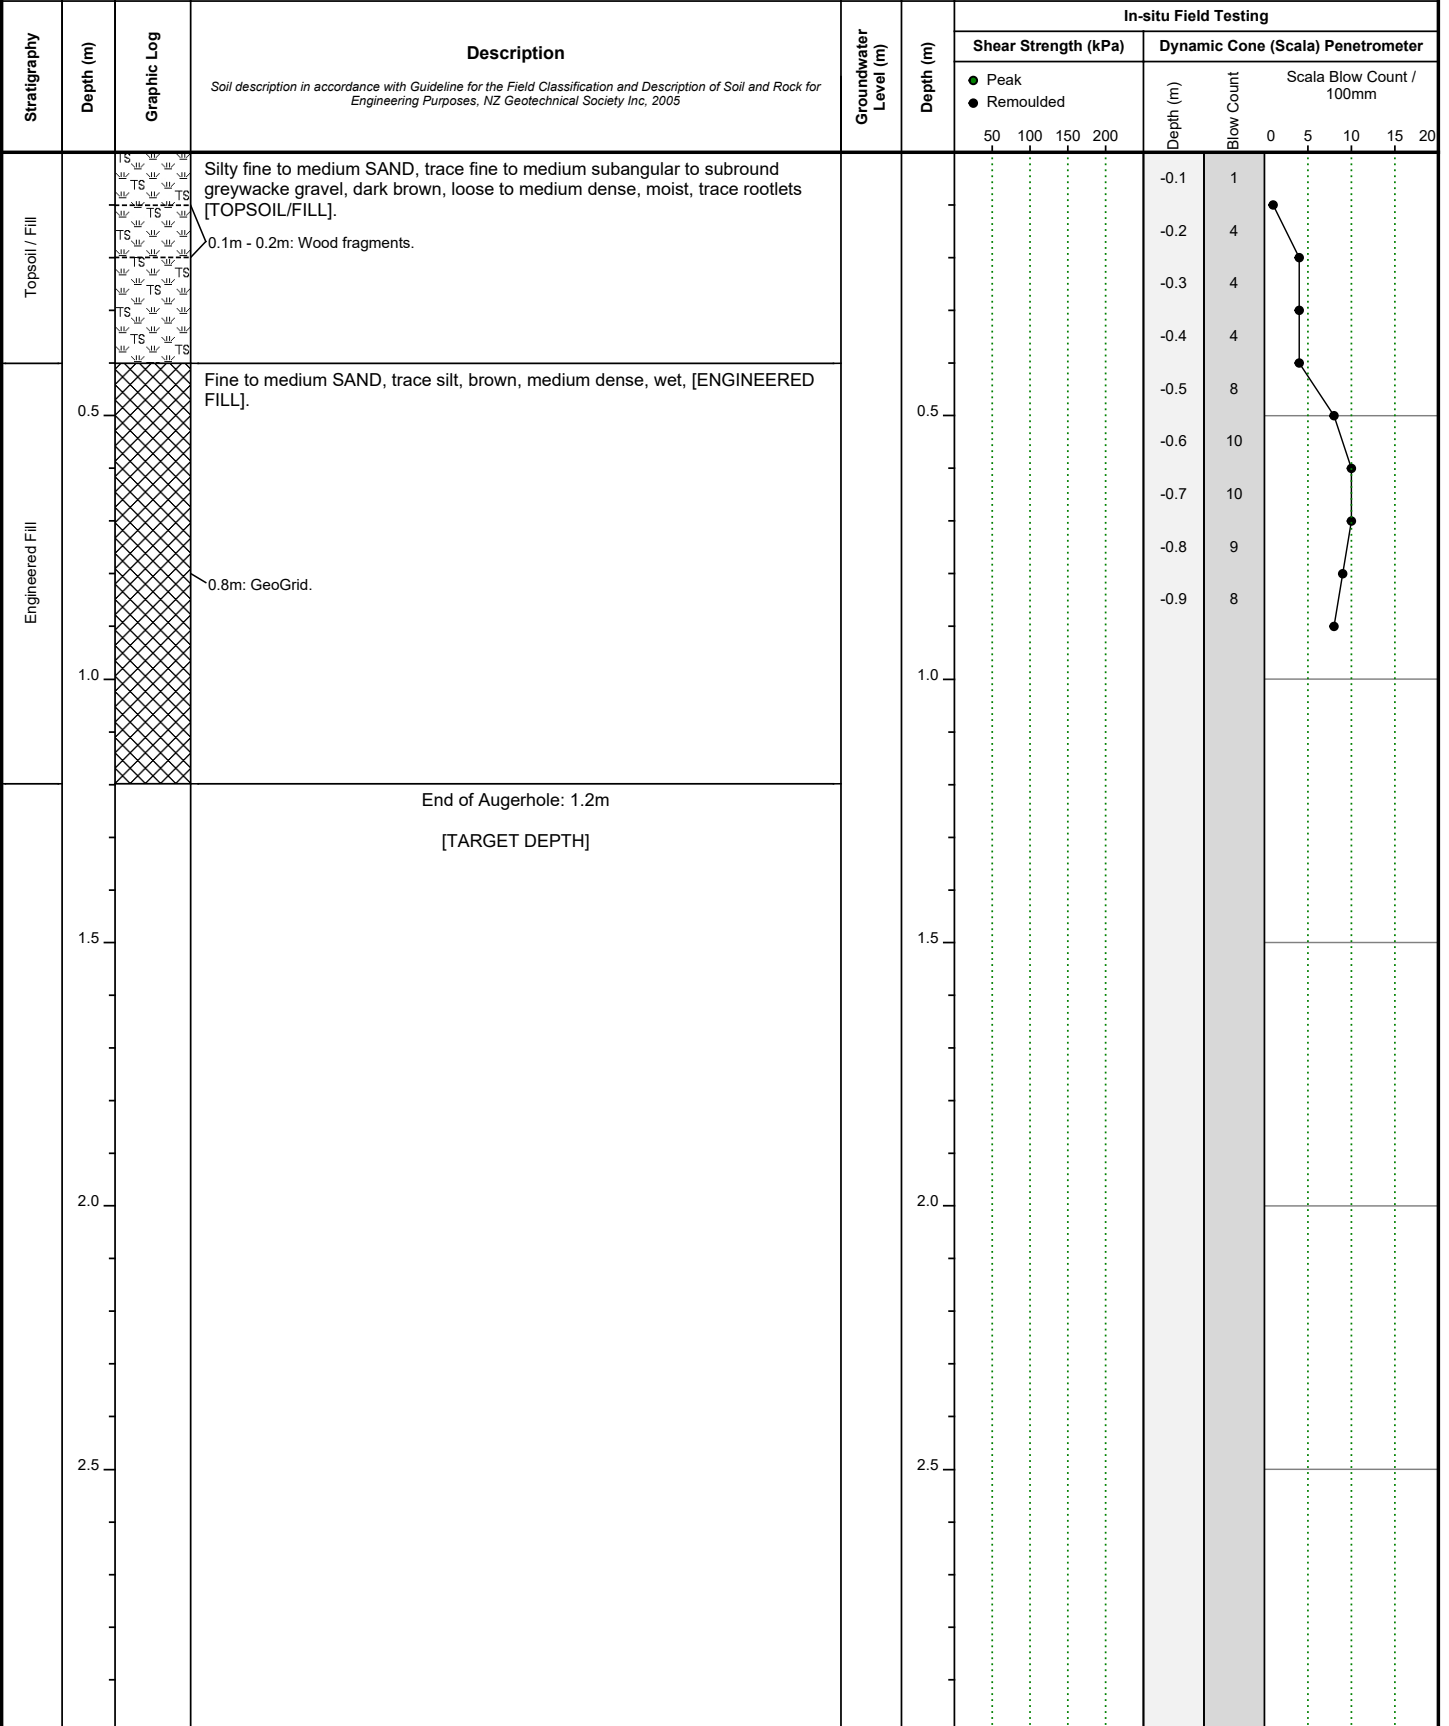
**Augerhole No.:** Lot 5 - HA01

Topsoil was encountered within the hand augers from the ground surface to 0.4m depth, which was typically a dark brown silty sand material with a trace of gravel. Engineered fill was encountered below the topsoil to the base of auger holes, which was a compacted brown sand material with a trace of silt. The hand augers were terminated at 1.2m depth below ground level to avoid damage to the geotextile layer which was installed at 1.5m depth below ground level. Groundwater was not encountered during testing.

Target depth achieved.

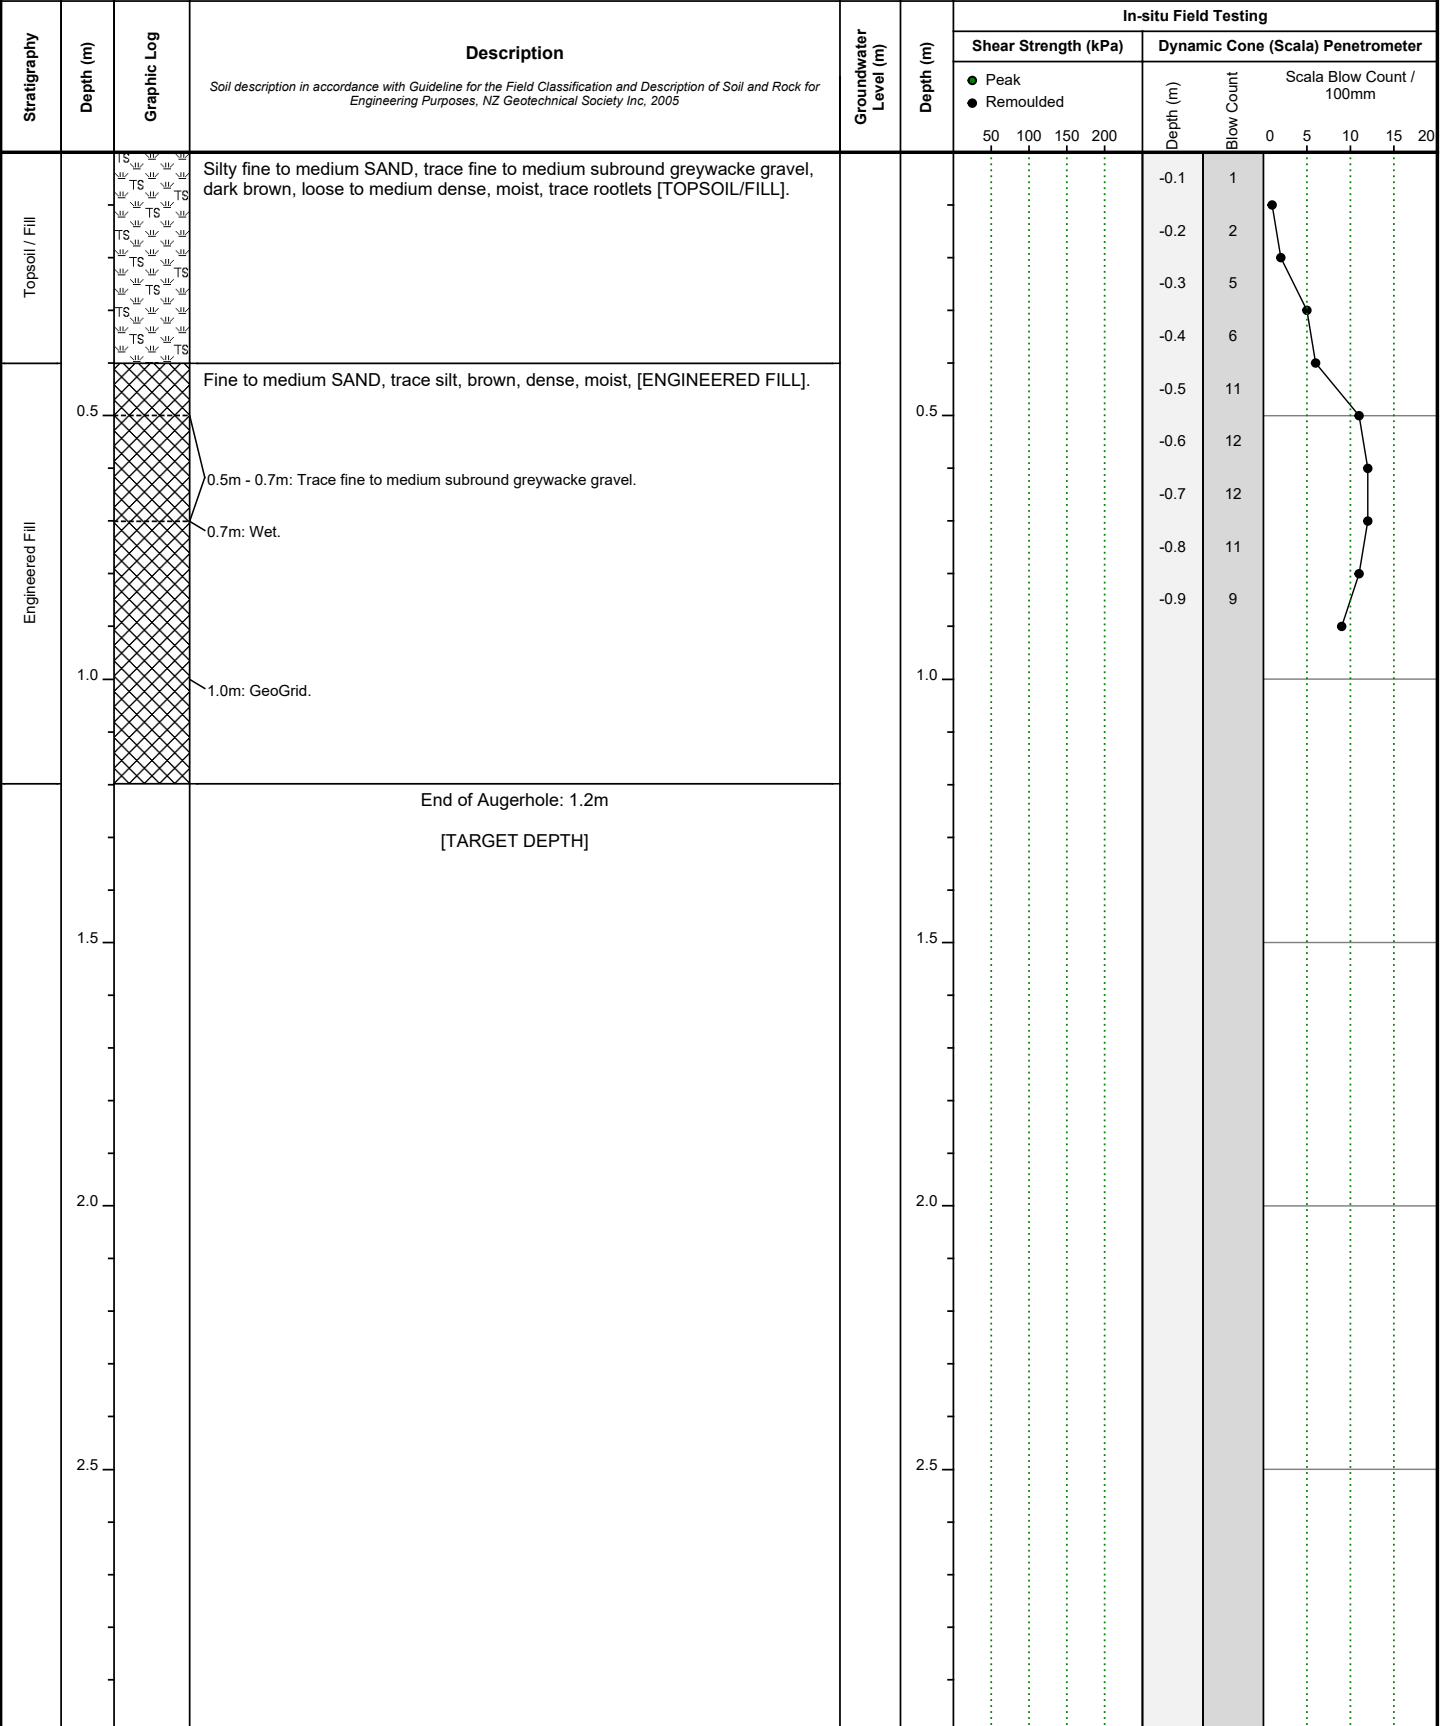
Augerhole No.: Lot 5 - HA02

Target depth achieved.      In-situ testing in accordance with the following standards:  
 Scala Penetrometer Testing: NZS 4402:1988, Test 6.5.2, Dynamic Cone Penetrometer  
 Shear Vane Testing: Guideline for Hand Held Shear Vane Test, NZGS, August 2001

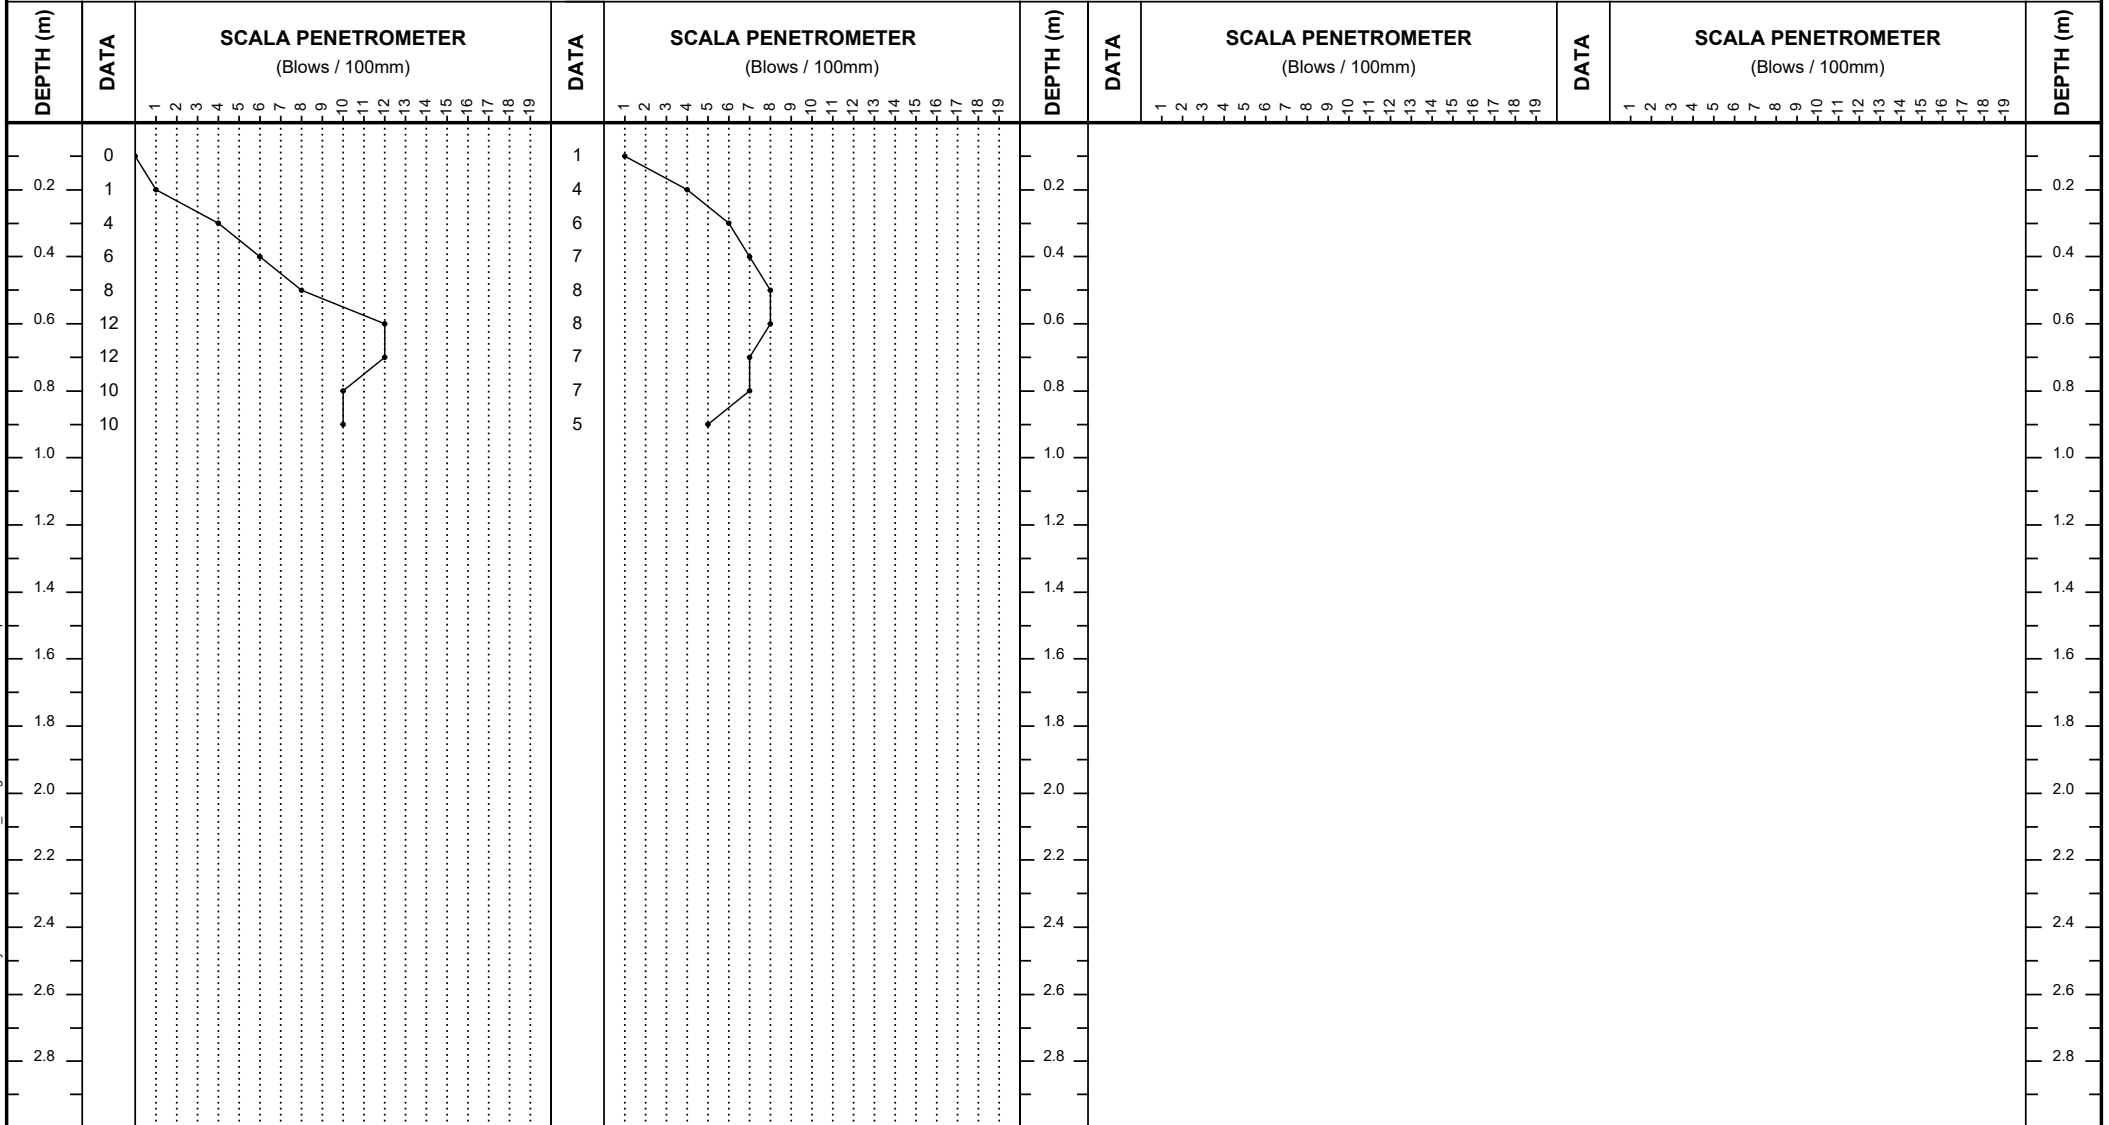
Lot 5 - SP01

SPs at each of the four locations returned results between 4 and 12 blows per 100mm penetration below the topsoil and within the engineered fill layer. SPs were terminated at 0.9m depth to confirm near surface bearing capacities, and to avoid damage to the geogrids and geotextile. In addition, the density of the engineered fill and bearing capacity of its underlying subgrade have been confirmed via extensive geotechnical inspection and fill compaction testing during subdivision earthworks.
