Date: 30 August 2023  
Project No: LTC21220-A  
Revision: B

**RE: SHALLOW SOIL TEST REPORT  
FUTURE RESIDENTIAL FOUNDATIONS  
LOT 17, 115 EUREKA STREET, ARANUI**

**Test Location Plan**  
 Lot 17, 115 Eureka Street,  
 ARANUI, CHRISTCHURCH

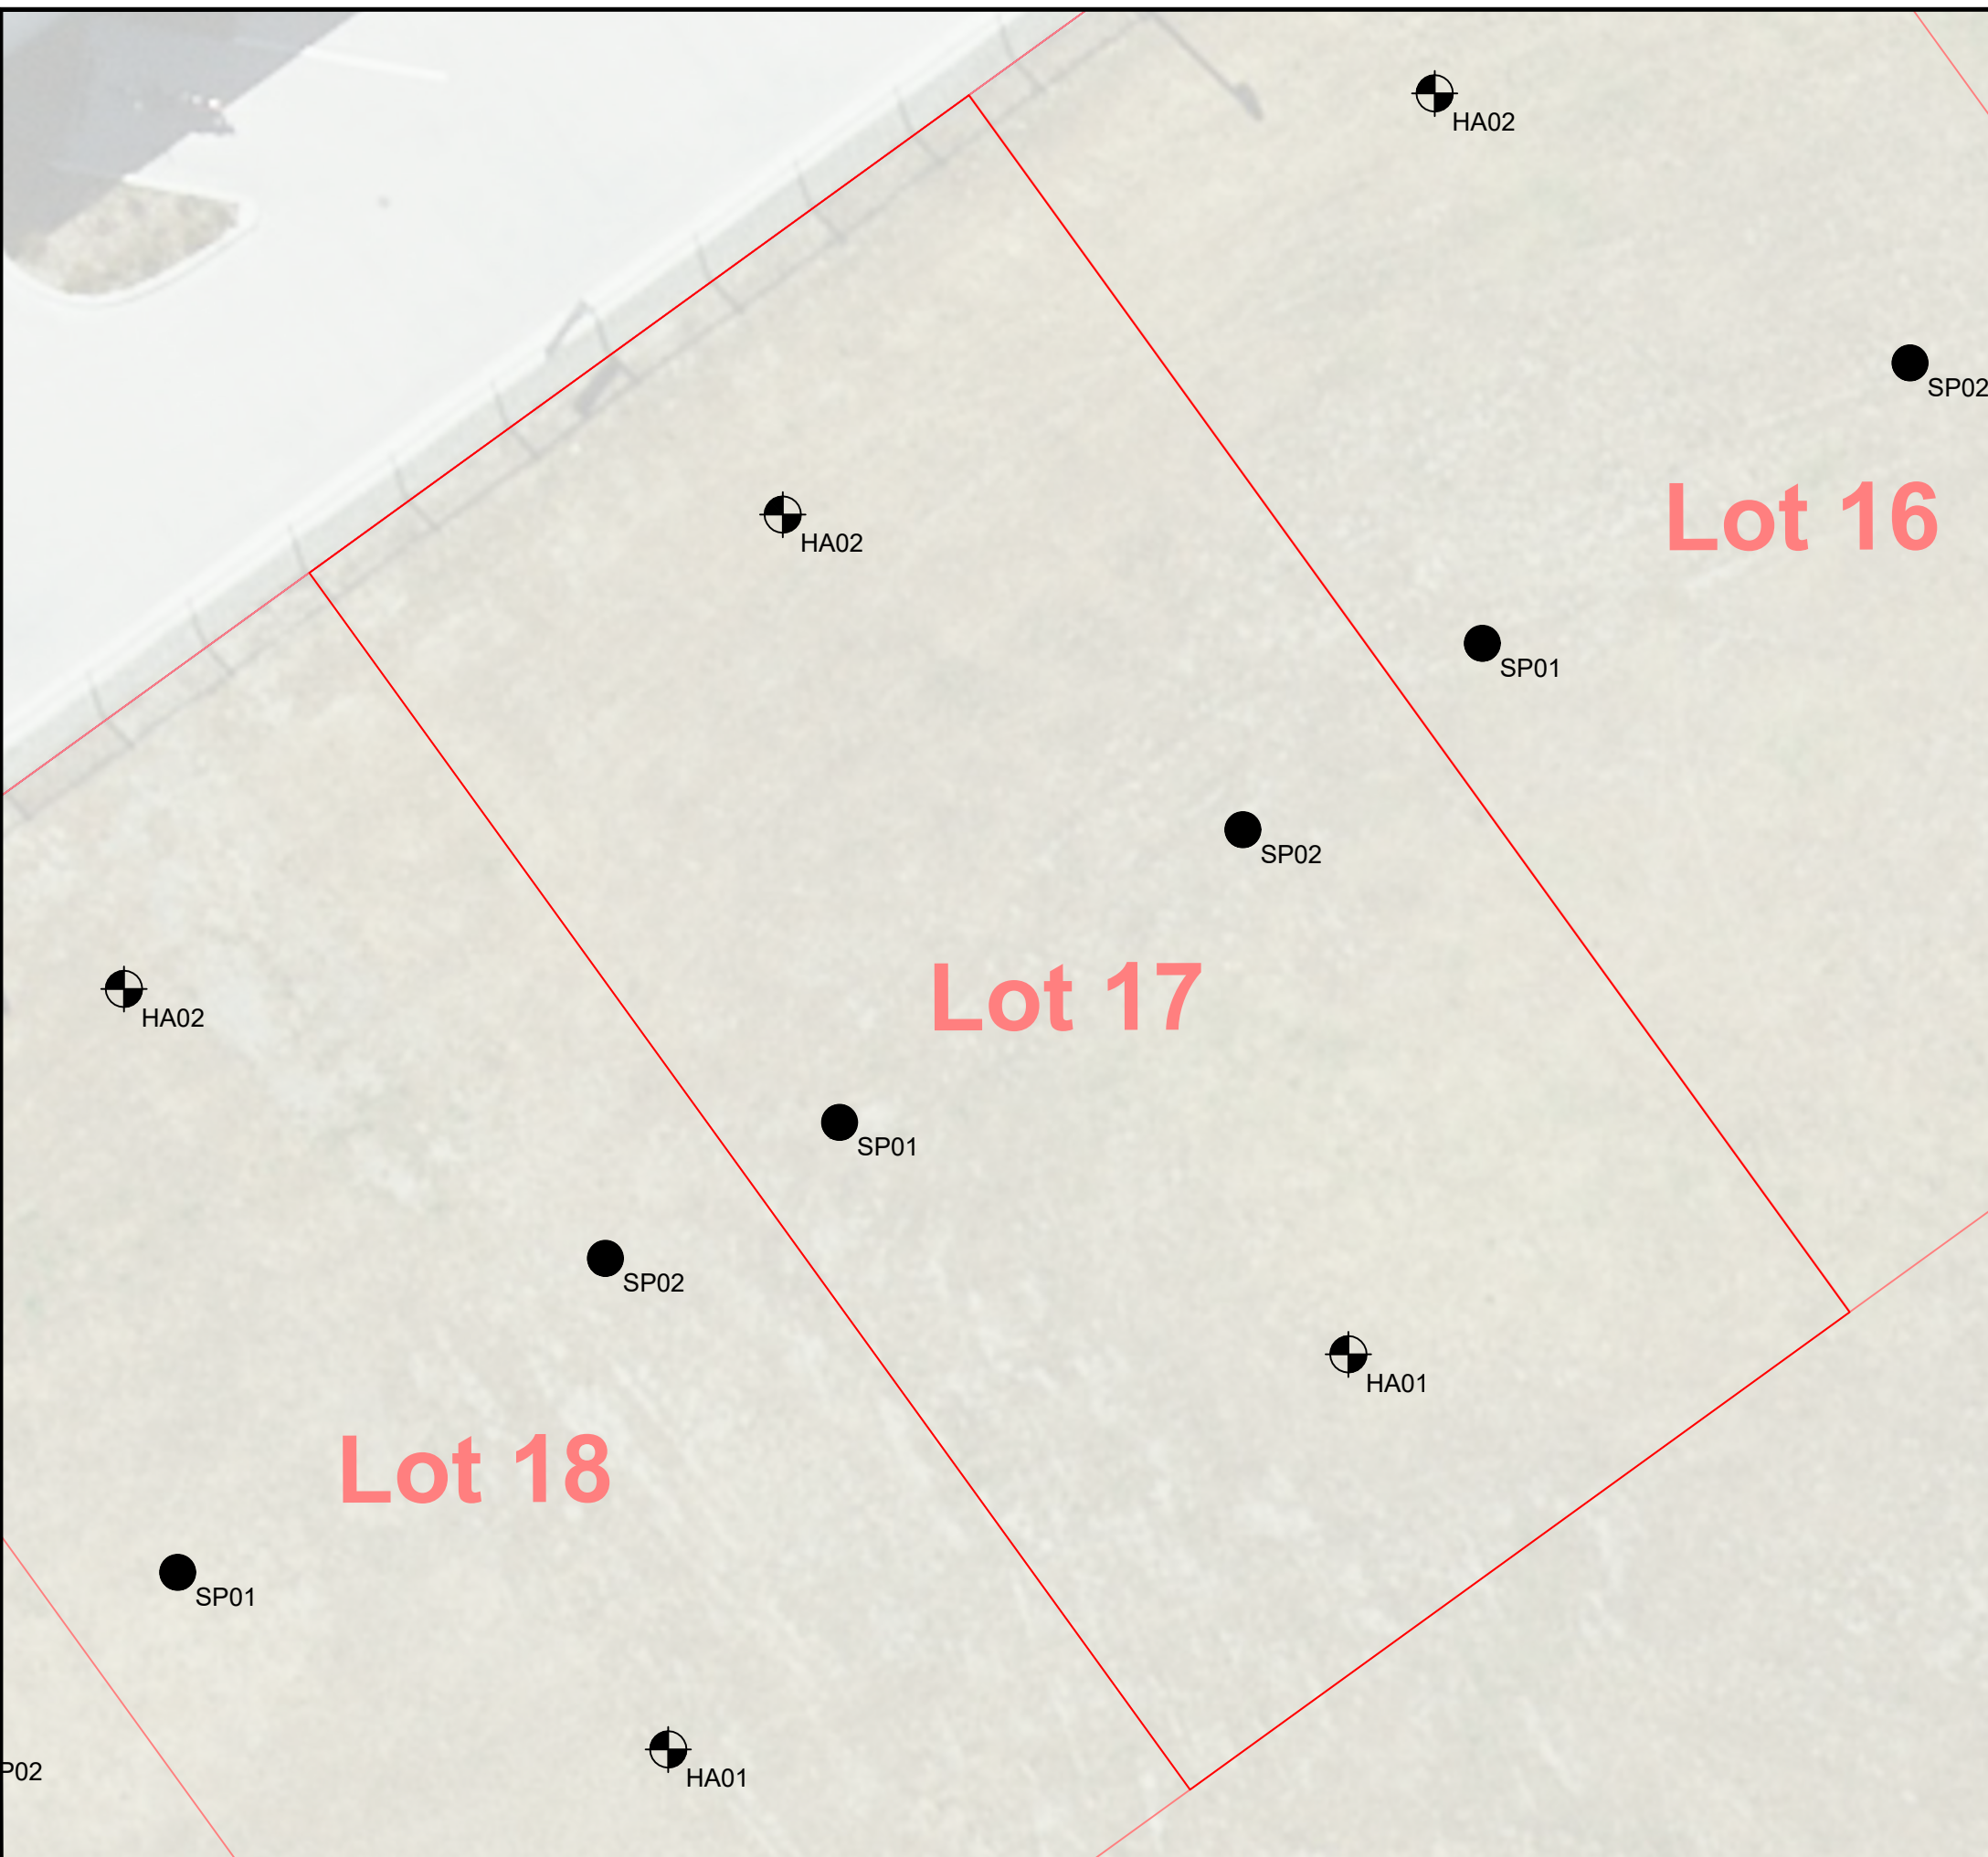
LandTech investigated the site on 1 June 2023, conducting two hand augers with corresponding Scala Penetrometer tests (SPs) and two additional SPs. The locations of the hand auger and SPs were measured using inferred lot boundaries and are approximate only. The test locations are shown on our LandTech *Test Location Plan*, Drawing No. Lot 17/ TLP, attached to this report.

-   HA01 LandTech Consulting Ltd. augerhole locations, drilled 01 June 2023
-   SP01 LandTech Consulting Ltd. DCP test location, tested 01 June 2023
-   Proposed boundary
-   Existing boundary

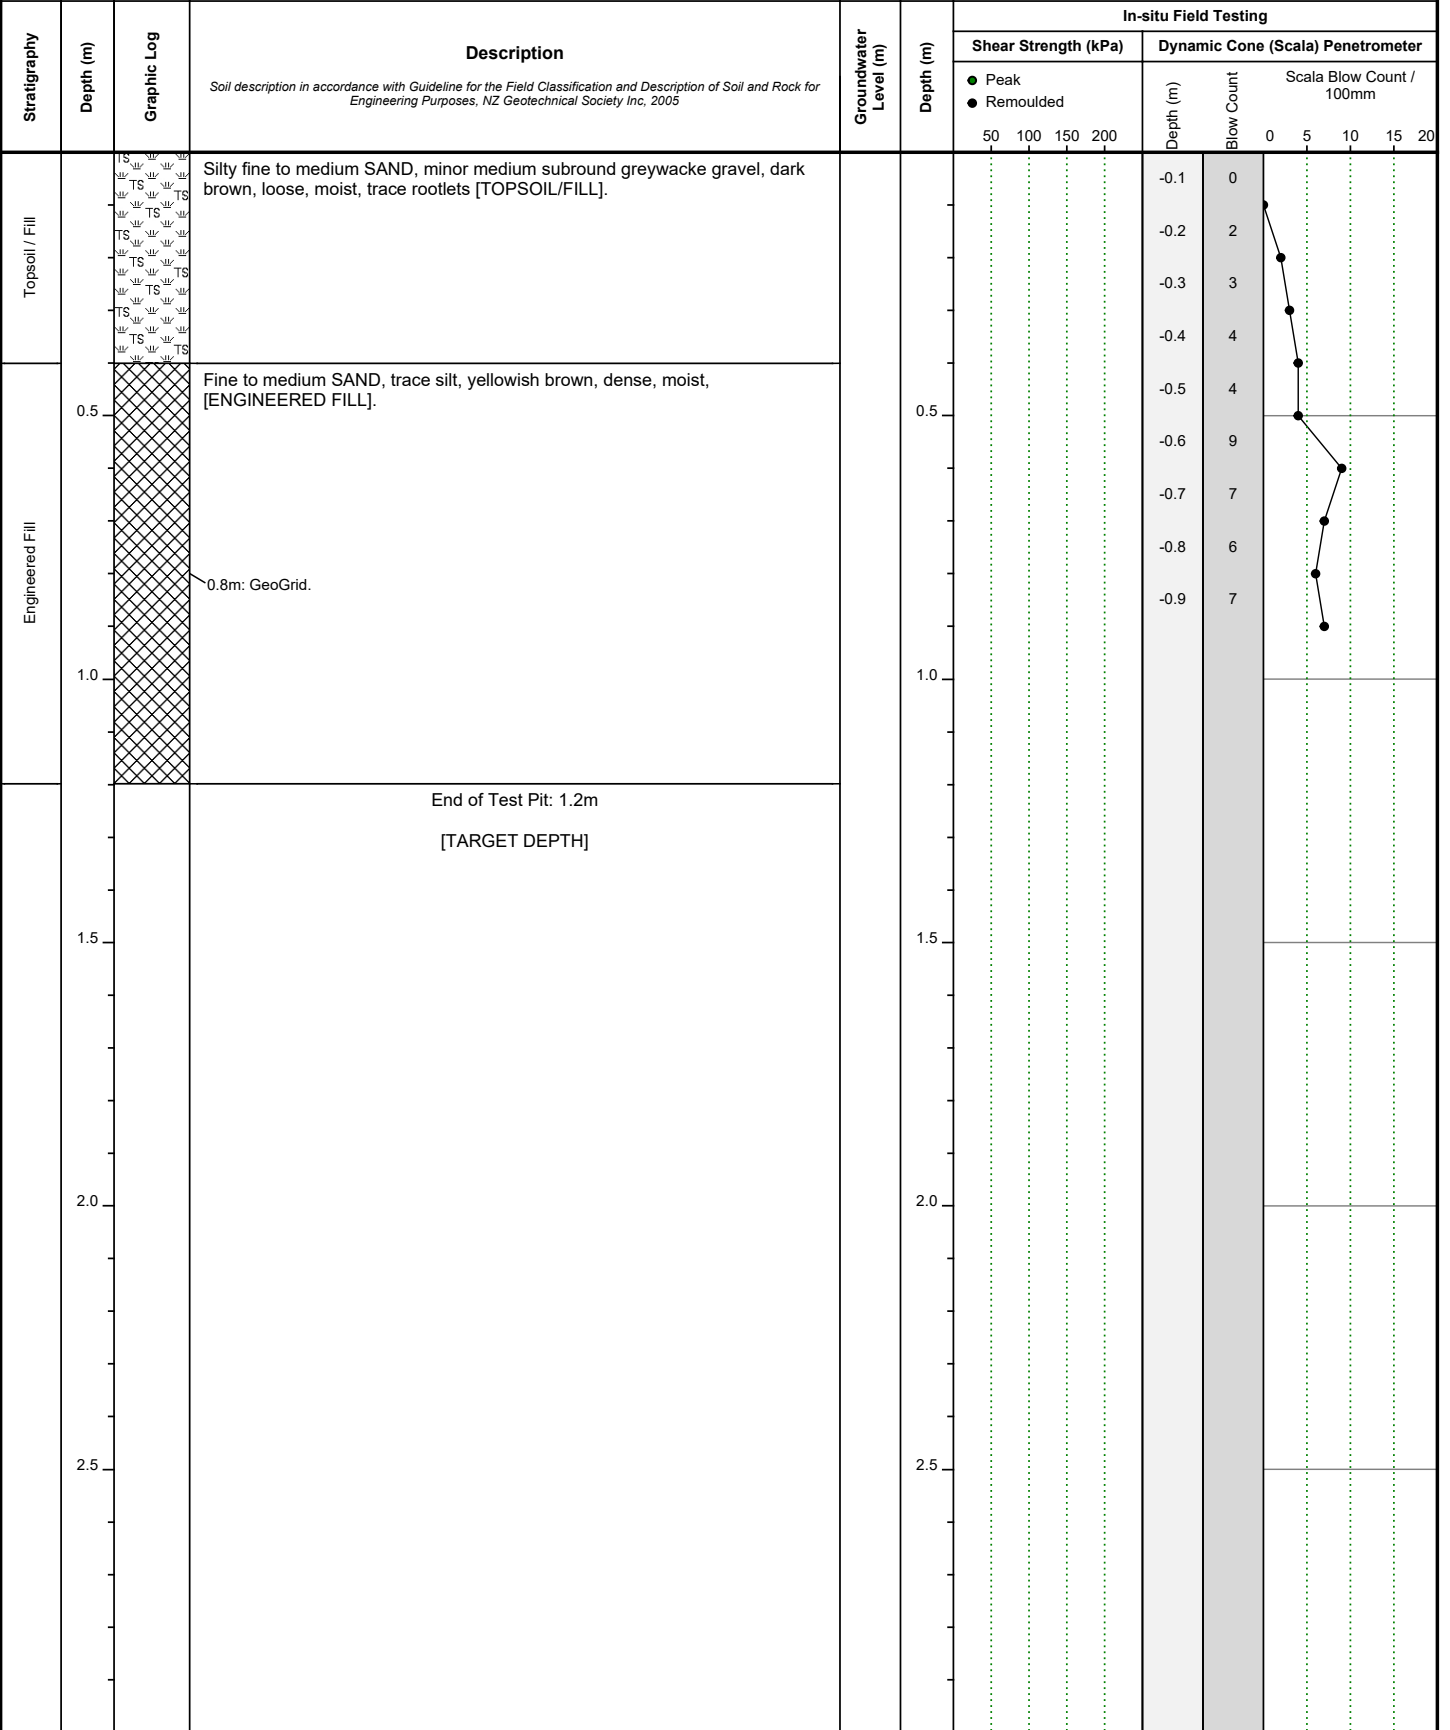
**Test Pit No.:** Lot 17 - HA01

Topsoil was encountered within the hand augers from the ground surface to 0.4m depth, which was typically a dark brown silty sand material with some gravel. Engineered fill was encountered below the topsoil to the base of auger holes, which was a compacted yellowish brown sand material with a trace of silt. The hand augers were terminated at 1.2m depth below ground level to avoid damage to the geotextile layer which was installed at 1.5m depth below ground level. Groundwater was not encountered during testing.

**Project No.:** LTC21220-A      **Coordinates:** NZTM2000: E1576281.63, N5183012.61      **Logged By:** RM  
**Drill Type:** 50mm Hand Auger      **Reduced Level:** 2.83m (LVD1937)      **Shear Vane No.:**  
**Date Started:** 01-Jun-23      **Ground Conditions:** Near level, Topsoil.      **Calibration Factor:**  
**Date Finished:** 01-Jun-23      **Groundwater Level (m):** Not Encountered      **Calibration Date:**

Target depth achieved.      *In-situ testing in accordance with the following standards:*  
 Scala Penetrometer Testing: NZS 4402:1988, Test 6.5.2, Dynamic Cone Penetrometer  
 Shear Vane Testing: Guideline for Hand Held Shear Vane Test, NZGS, August 2001

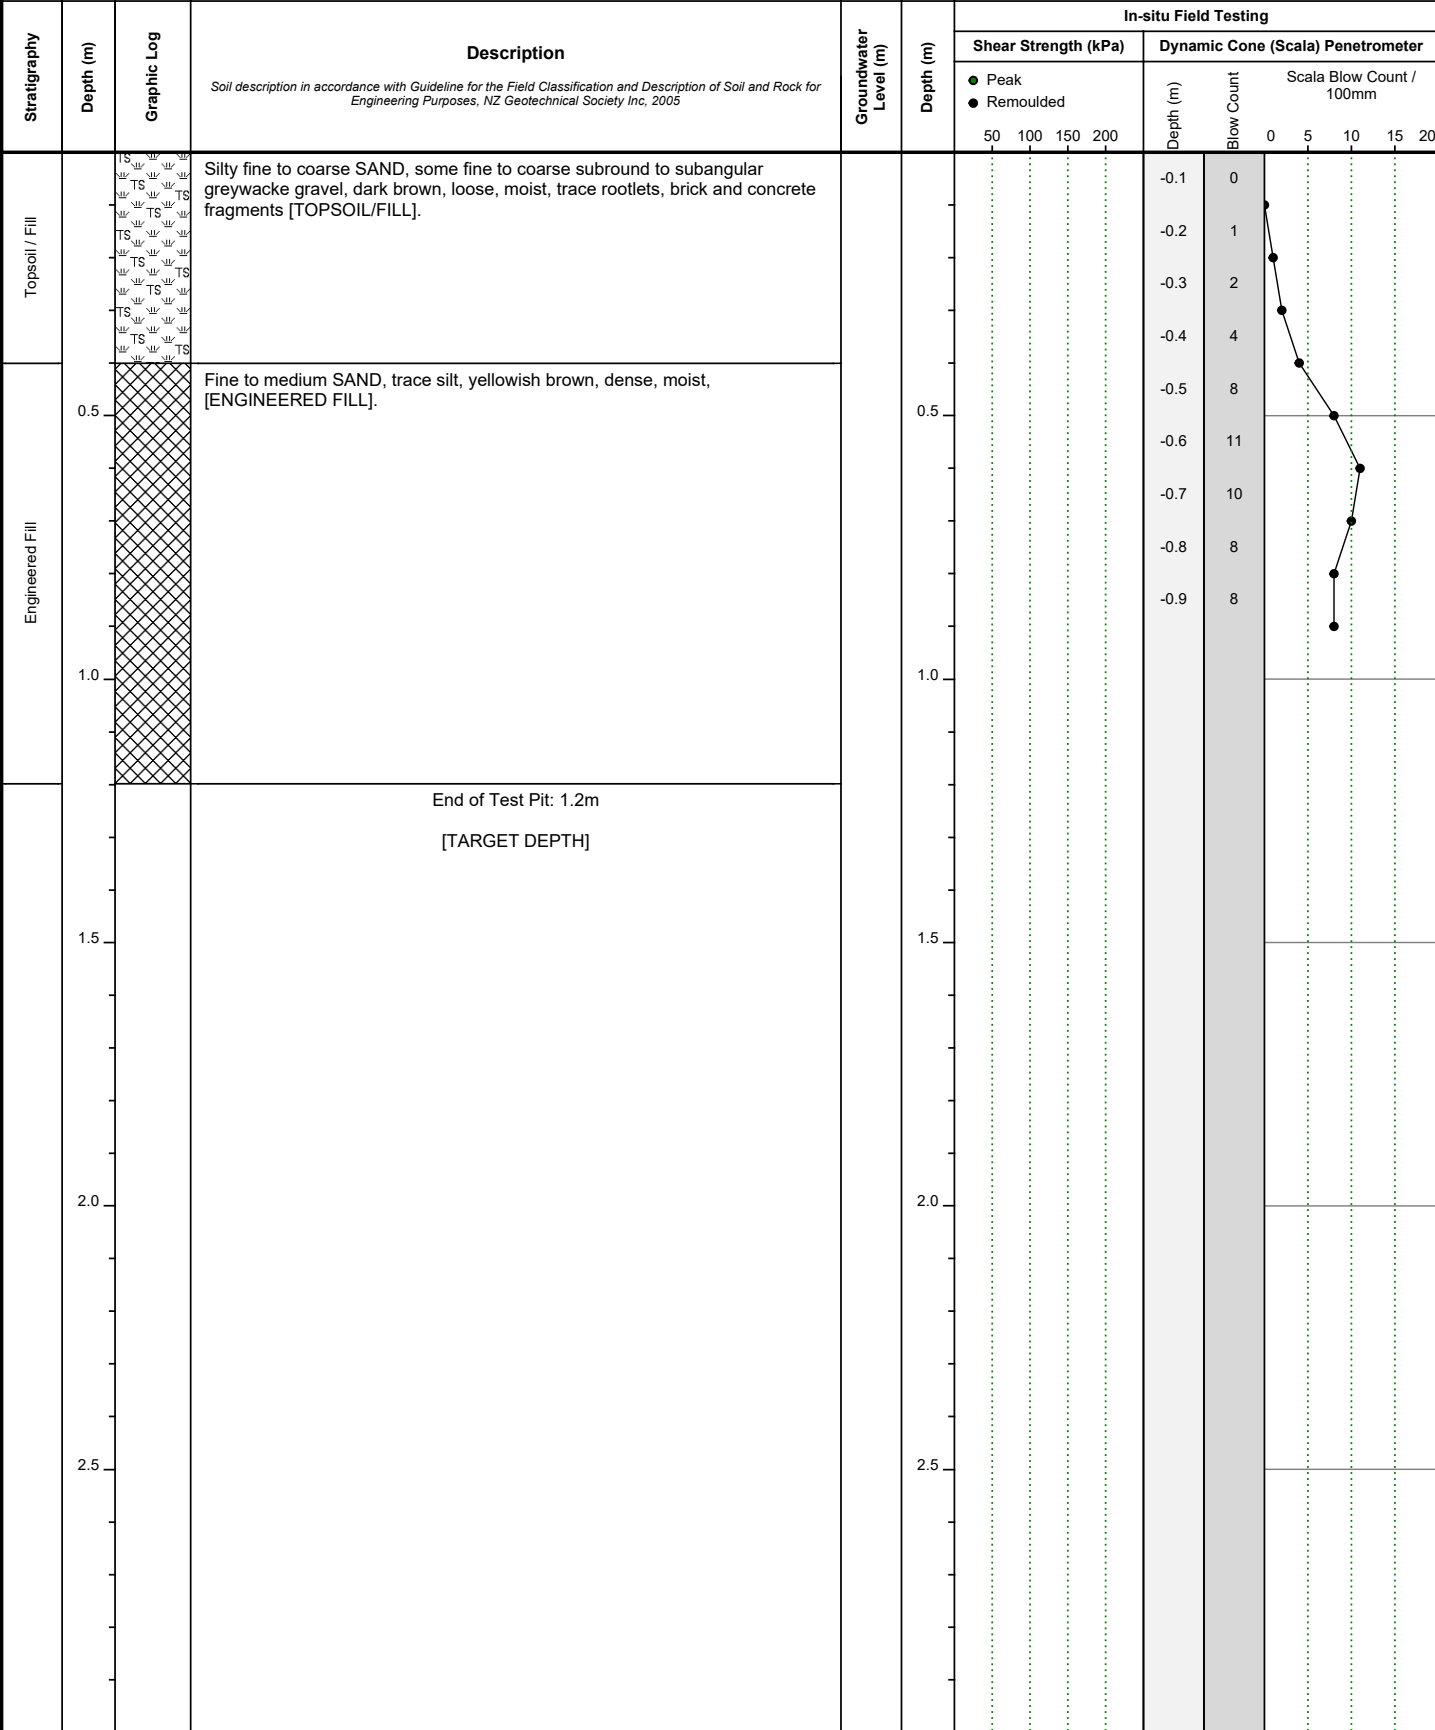
Test Pit No.: Lot 17 - HA02

Project No.: LTC21220-A      Coordinates: NZTM2000: E1576271.39, N5183027.81      Logged By: RM  
 Drill Type: 50mm Hand Auger      Reduced Level: 2.83m (LVD1937)      Shear Vane No.:  
 Date Started: 01-Jun-23      Ground Conditions: Near level, Topsoil.      Calibration Factor:  
 Date Finished: 01-Jun-23      Groundwater Level (m): Not Encountered      Calibration Date:

In-situ testing in accordance with the following standards:  
 Scala Penetrometer Testing: NZS 4402:1988, Test 6.5.2, Dynamic Cone Penetrometer  
 Shear Vane Testing: Guideline for Hand Held Shear Vane Test, NZGS, August 2001

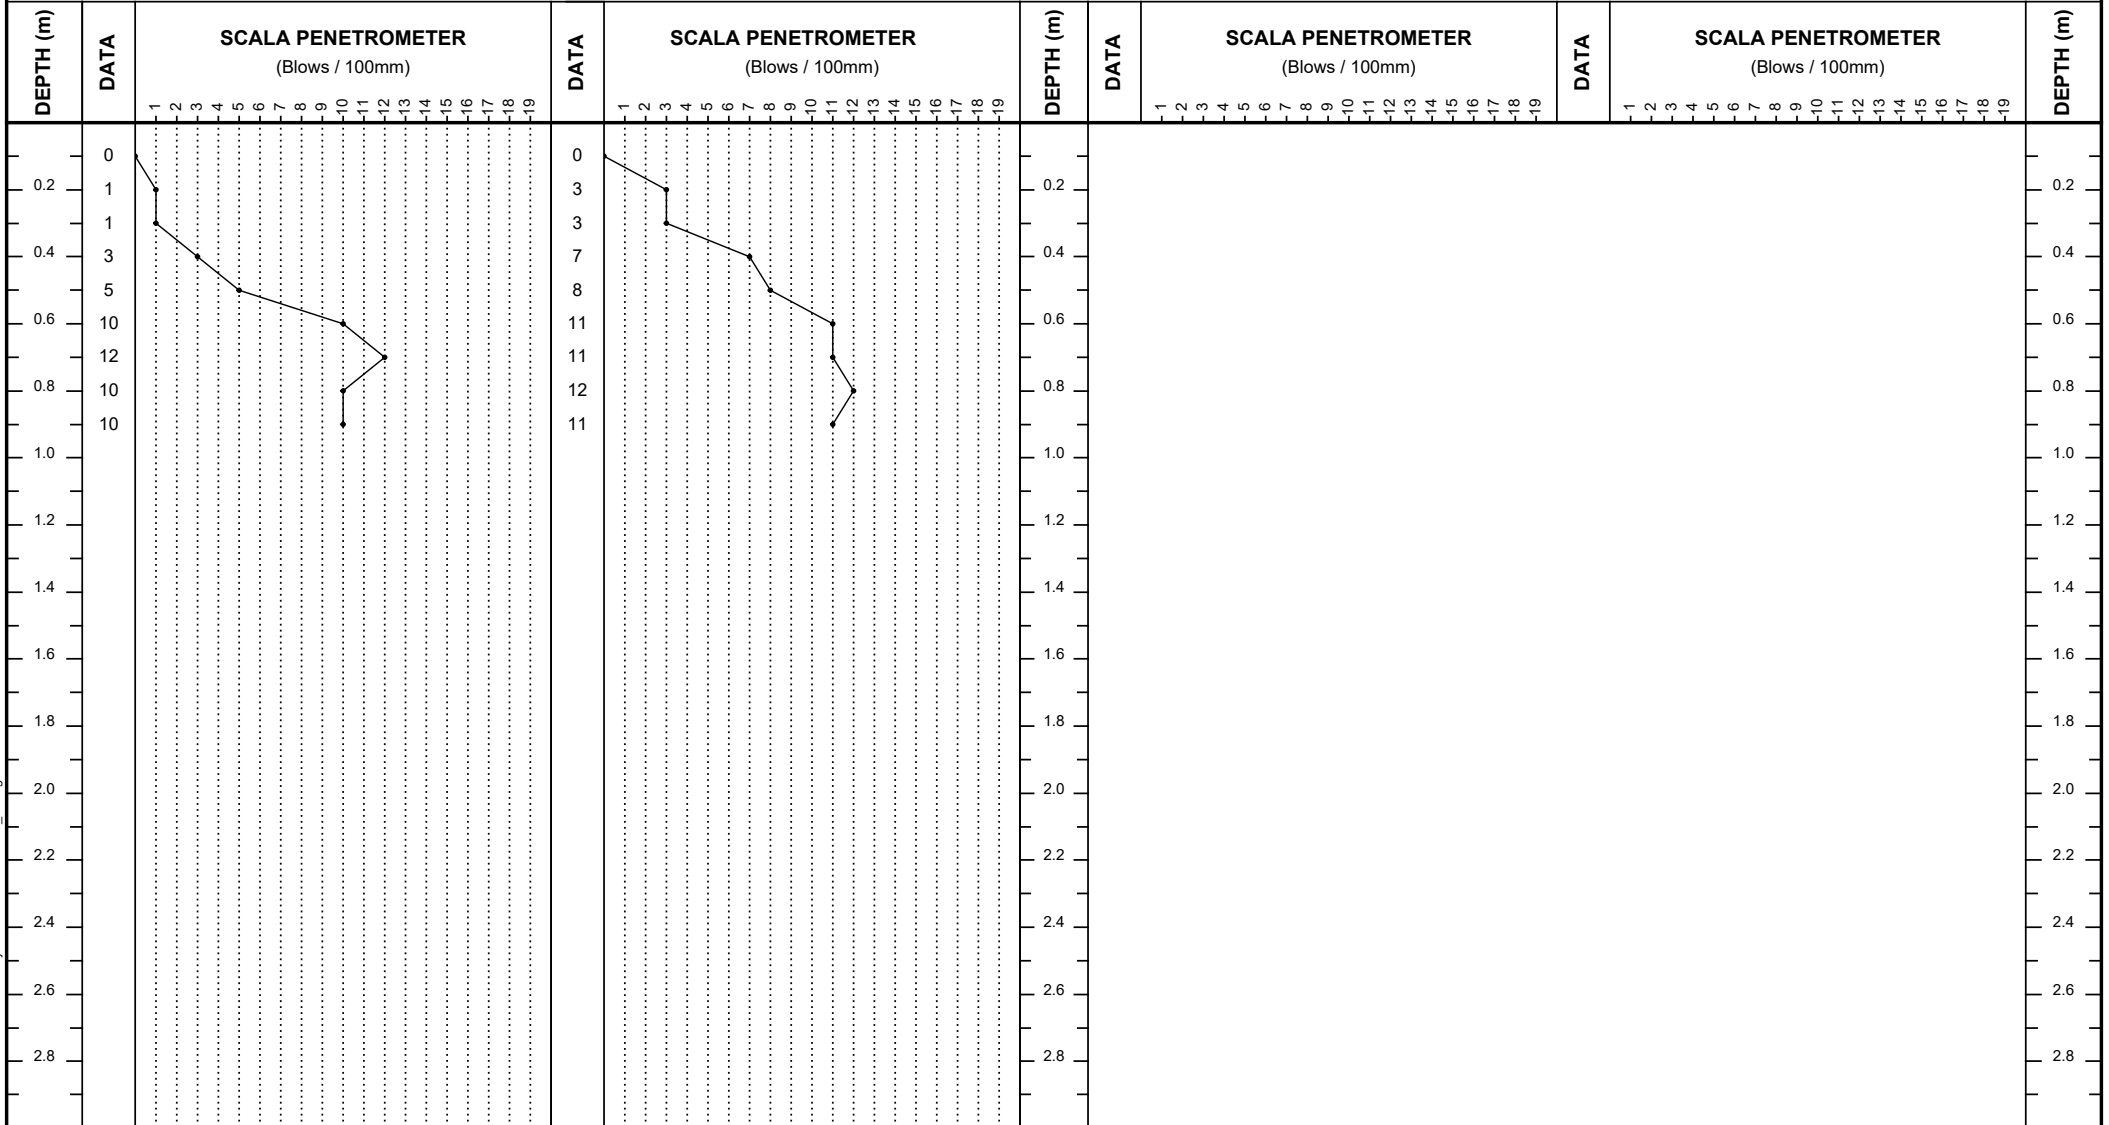
**LOT 17- SP01**

SPs at each of the four locations returned results between 3 and 12 blows per 100mm penetration below the topsoil and within the engineered fill layer. SPs were terminated at 0.9m depth to confirm near surface bearing capacities, and to avoid damage to the geogrids and geotextile. In addition, the density of the engineered fill and bearing capacity of its underlying subgrade have been confirmed via extensive geotechnical inspection and fill compaction testing during subdivision earthworks.

Tested By: KY  
 Ground Conditions: Near level, Topsoil.  
 Coordinates: NZTM2000 E 1576279.65  
 N 5183022.07  
 Test Date: 01-Jun-23

Tested By: KY  
 Ground Conditions: Near level, Topsoil.  
 Coordinates: NZTM2000 E 1576272.29  
 N 5183016.84  
 Test Date: 01-Jun-23

From our previous investigation in support of the subdivision, we concluded that TC2 foundations in accordance with MBIE Guidelines (December 2012) may be used at this site following subdivision earthworks and ground remediation (reinforced engineered fill raft). Our current lot-specific shallow soil testing confirms such foundations remain appropriate. In particular, we confirm Option 4 enhanced slab foundations are required.

All foundations must be embedded to a minimum depth of 0.4m below ground level, where an Ultimate Bearing Capacity of 200kPa and a strength reduction factor of ( $\phi_s$ ) 0.5 is available. Foundations excavations should expose engineered fill of appropriate bearing capacity. All topsoil and unsuitable materials should be removed below foundations and floor slab areas, and where required layers of compacted hardfill should be placed to the underside of foundations.
