Date: 30 August 2023  
Project No: LTC21220-A  
Revision: B

**RE: SHALLOW SOIL TEST REPORT  
FUTURE RESIDENTIAL FOUNDATIONS  
LOT 18, 115 EUREKA STREET, ARANUI**

**Test Location Plan**  
 Lot 18, 115 Eureka Street,  
 ARANUI, CHRISTCHURCH

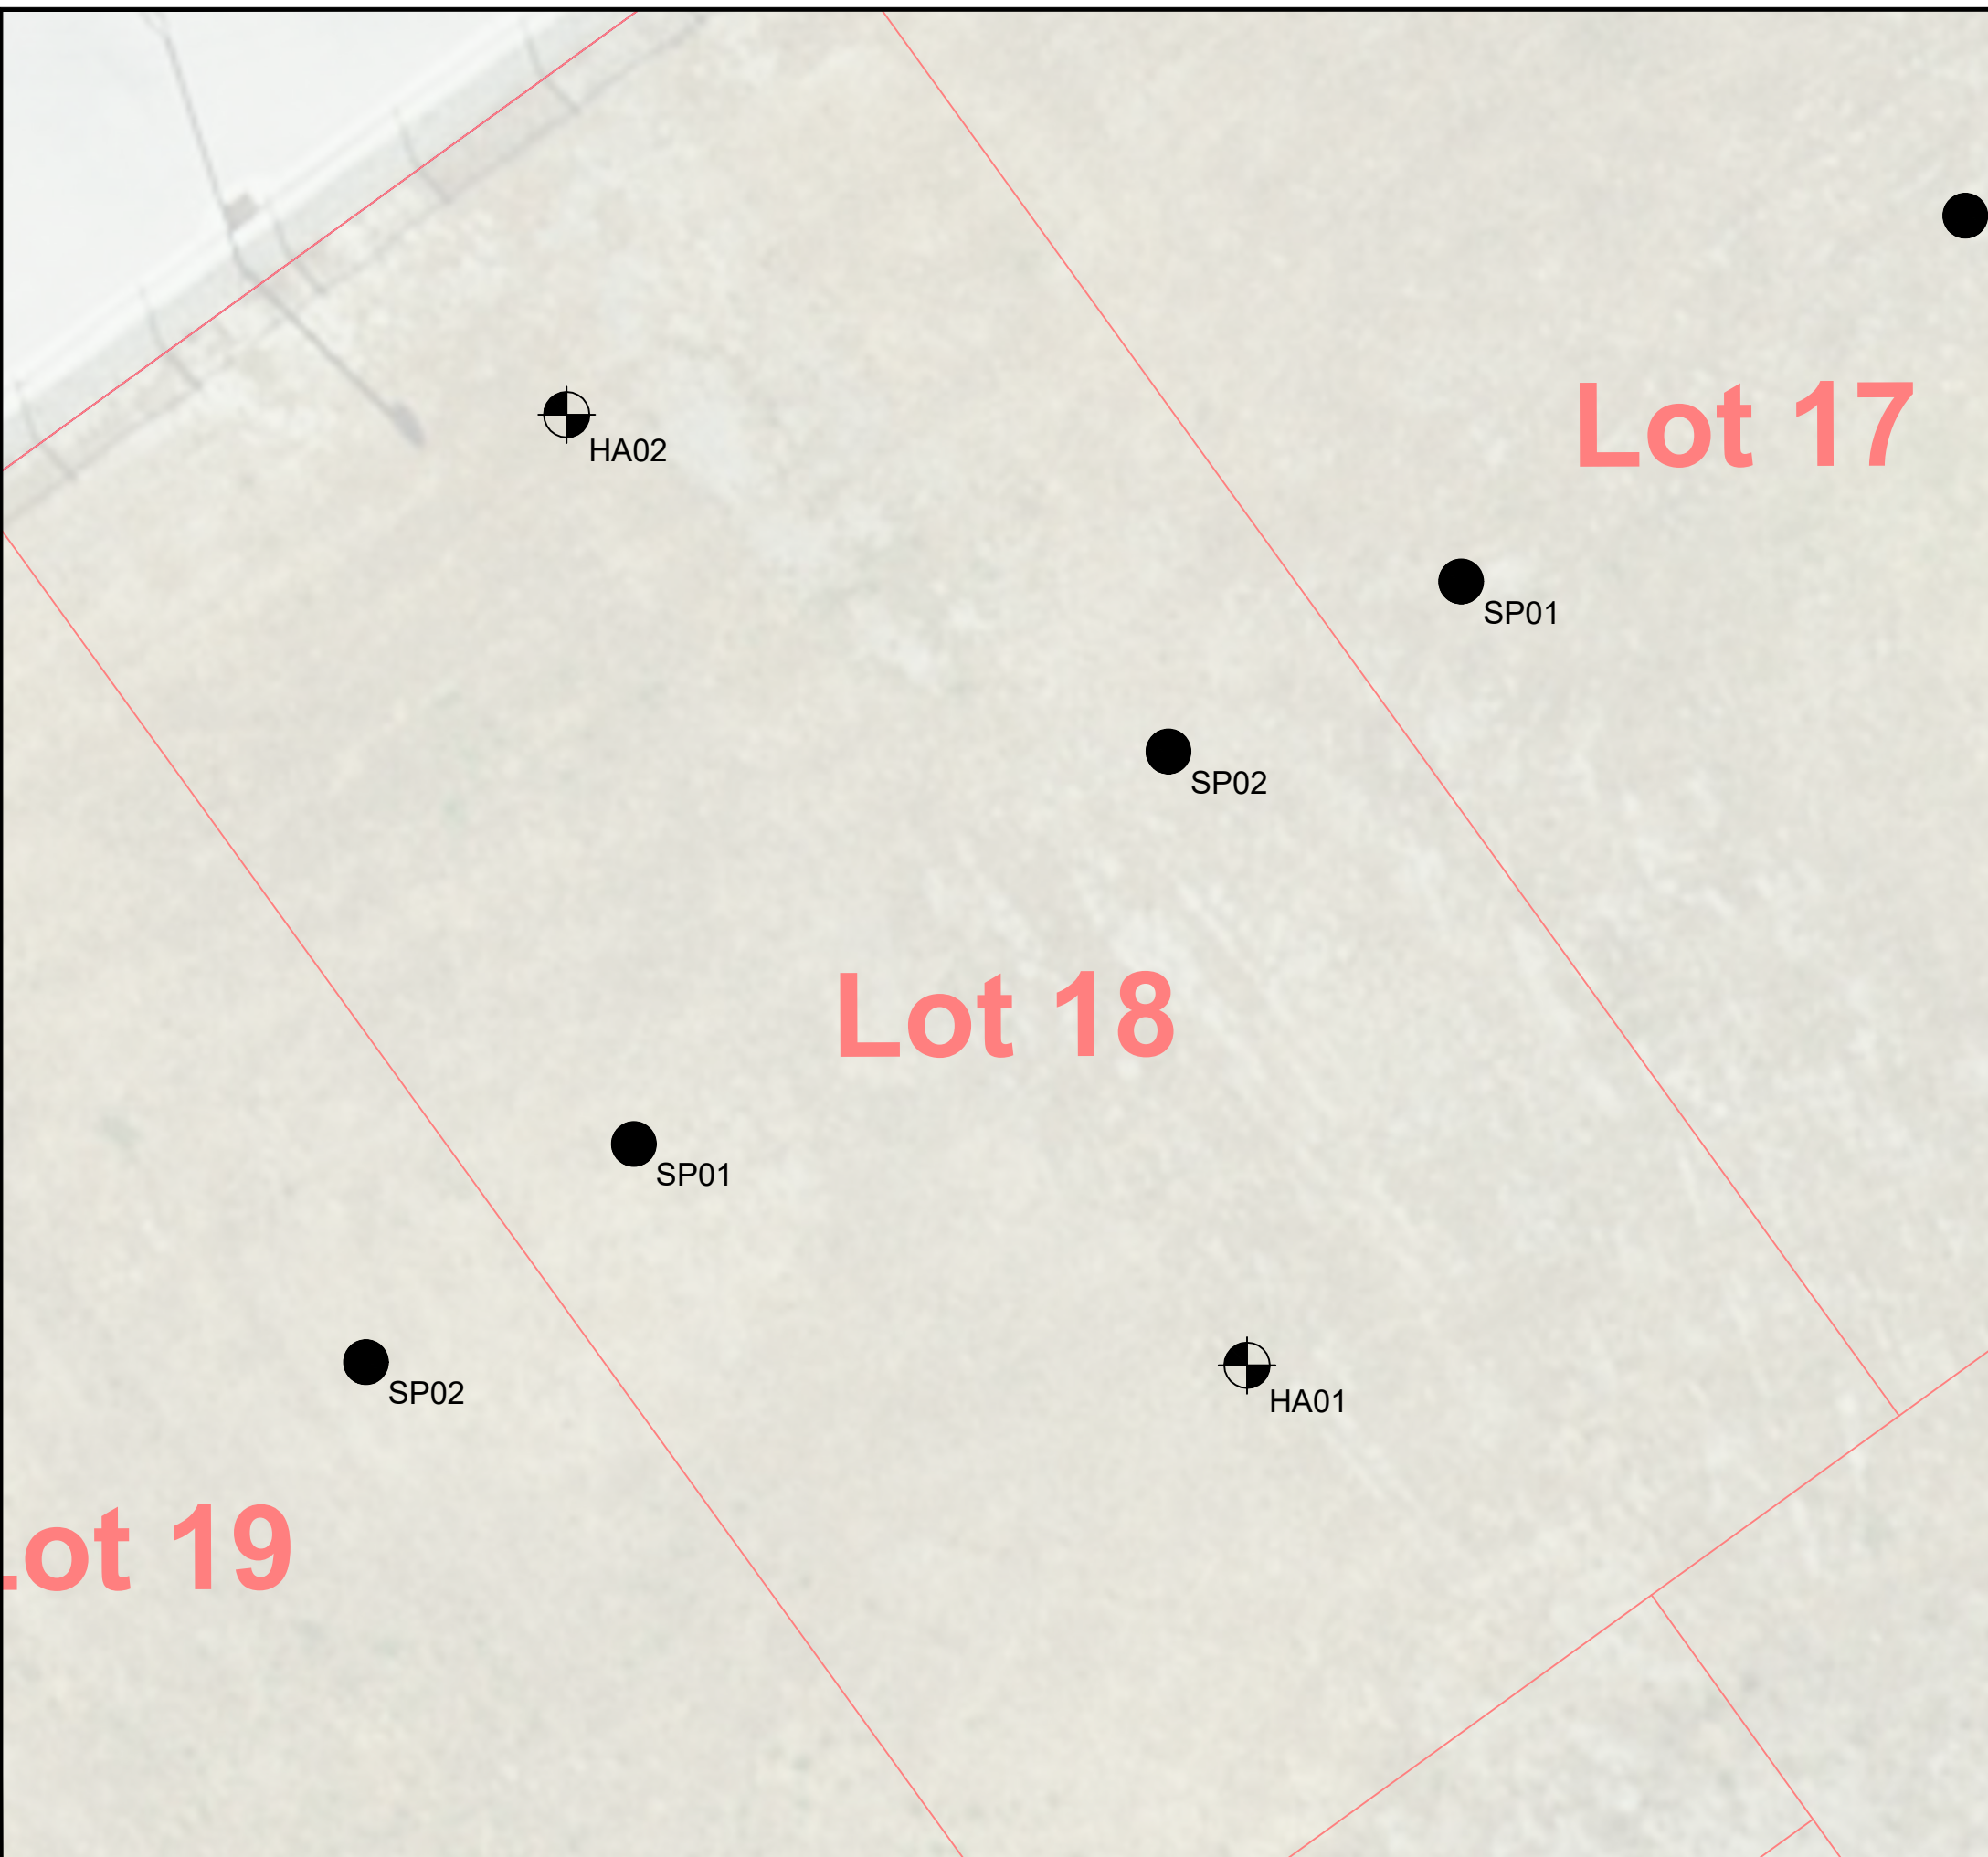
LandTech investigated the site on 27 April 2023, conducting two hand augers with corresponding Scala Penetrometer tests (SPs) and two additional SPs. The locations of the hand auger and SPs were measured using inferred lot boundaries and are approximate only. The test locations are shown on our LandTech *Test Location Plan*, Drawing No. Lot 18/ TLP, attached to this report.

-   HA01 LandTech Consulting Ltd. augerhole locations, drilled 27 April 2023
-   SP01 LandTech Consulting Ltd. DCP test location, tested 27 April 2023
-   Proposed boundary
-   Existing boundary

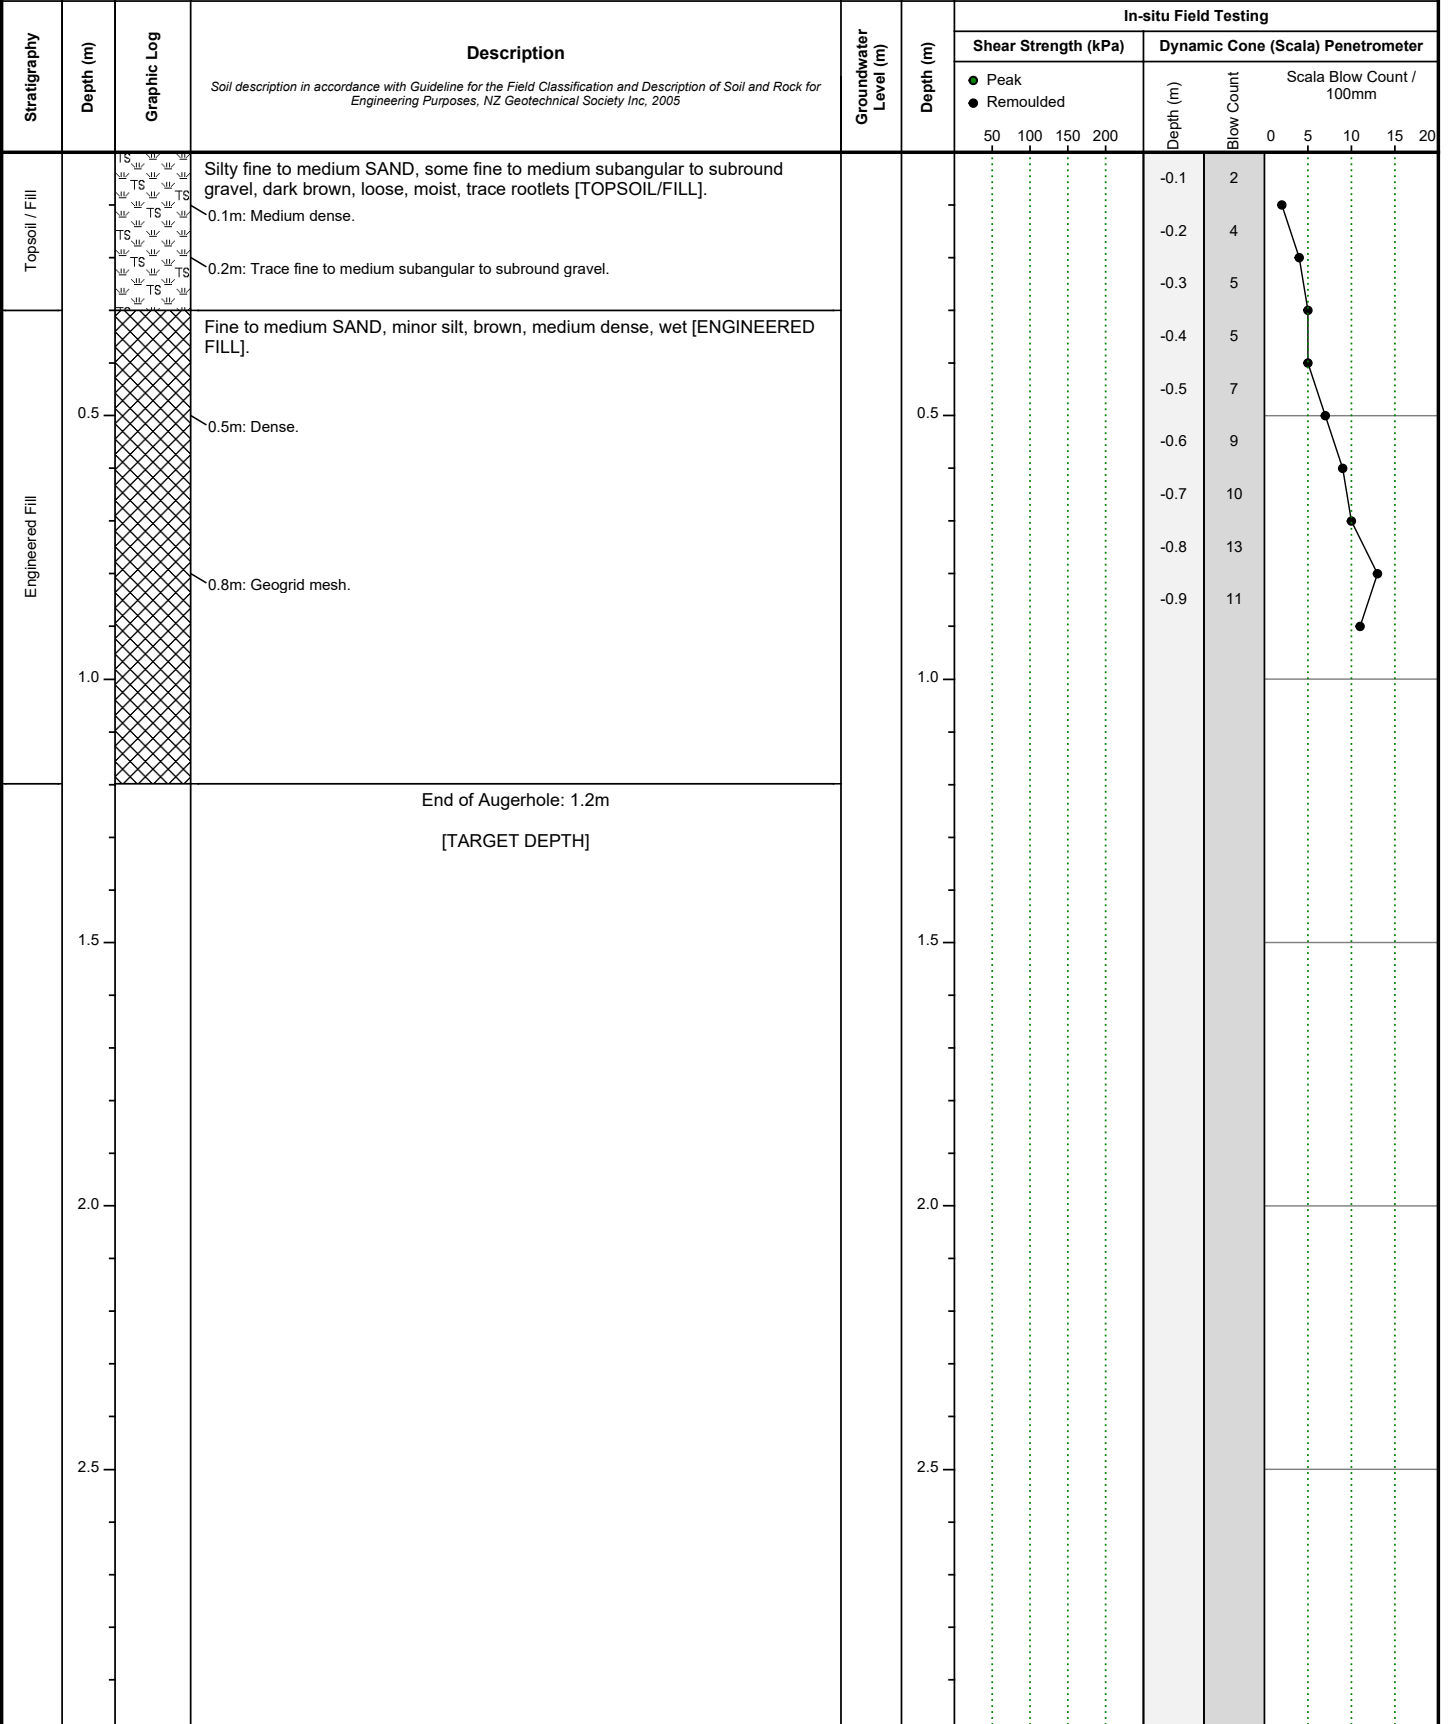
**Augerhole No.:** LOT 18 - HA01

Topsoil was encountered within the hand augers from the ground surface to 0.3m depth, which was typically a dark brown silty sand material with some gravel. Engineered fill was encountered below the topsoil to the base of auger holes, which was a compacted brown sand material with a minor of silt. The hand augers were terminated at 1.2m depth below ground level to avoid damage to the geotextile layer which was installed at 1.5m depth below ground level. Groundwater was not encountered during testing.

Target depth achieved.

From our previous investigation in support of the subdivision, we concluded that TC2 foundations in accordance with MBIE Guidelines (December 2012) may be used at this site following subdivision earthworks and ground remediation (reinforced engineered fill raft). Our current lot-specific shallow soil testing confirms such foundations remain appropriate. In particular, we confirm Option 4 enhanced slab foundations are required.

All foundations must be embedded to a minimum depth of 0.3m below ground level, where an Ultimate Bearing Capacity of 200kPa and a strength reduction factor of ( $\phi_s$ ) 0.5 is available. Foundations excavations should expose engineered fill of appropriate bearing capacity. All topsoil and unsuitable materials should be removed below foundations and floor slab areas, and where required layers of compacted hardfill should be placed to the underside of foundations.

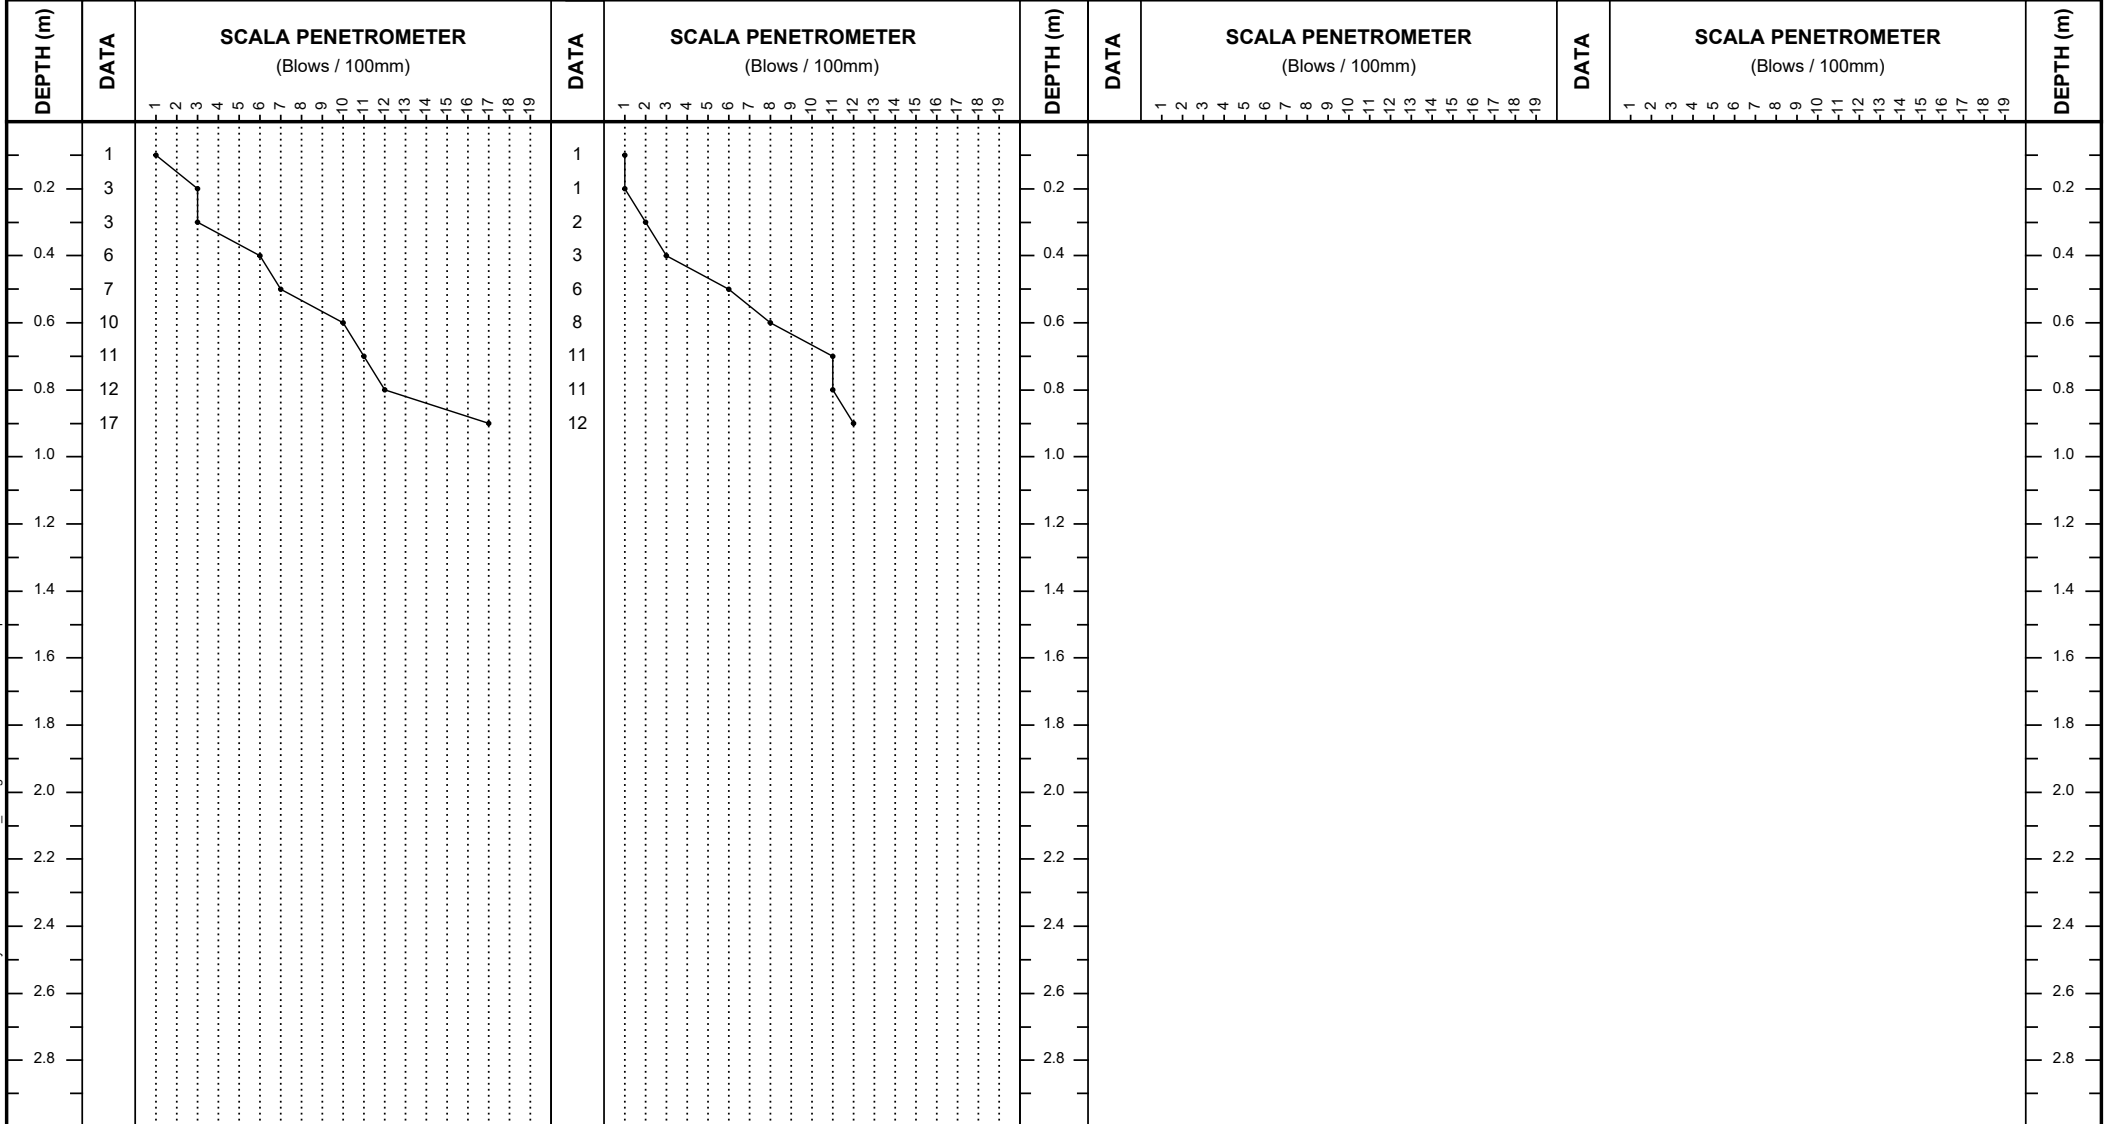
**LOT 18 - SP01**

SPs at each of the four locations returned results between 3 and 17 blows per 100mm penetration below the topsoil and within the engineered fill layer. SPs were terminated at 0.9m depth to confirm near surface bearing capacities, and to avoid damage to the geogrids and geotextile. In addition, the density of the engineered fill and bearing capacity of its underlying subgrade have been confirmed via extensive geotechnical inspection and fill compaction testing during subdivision earthworks.
