Date: 30 August 2023
Project No: LTC21220-A
Revision: B

**RE: SHALLOW SOIL TEST REPORT
FUTURE RESIDENTIAL FOUNDATIONS
LOT 26, 115 EUREKA STREET, ARANUI**

Test Location Plan
 Lot 26, 115 Eureka Street,
 ARANUI, CHRISTCHURCH

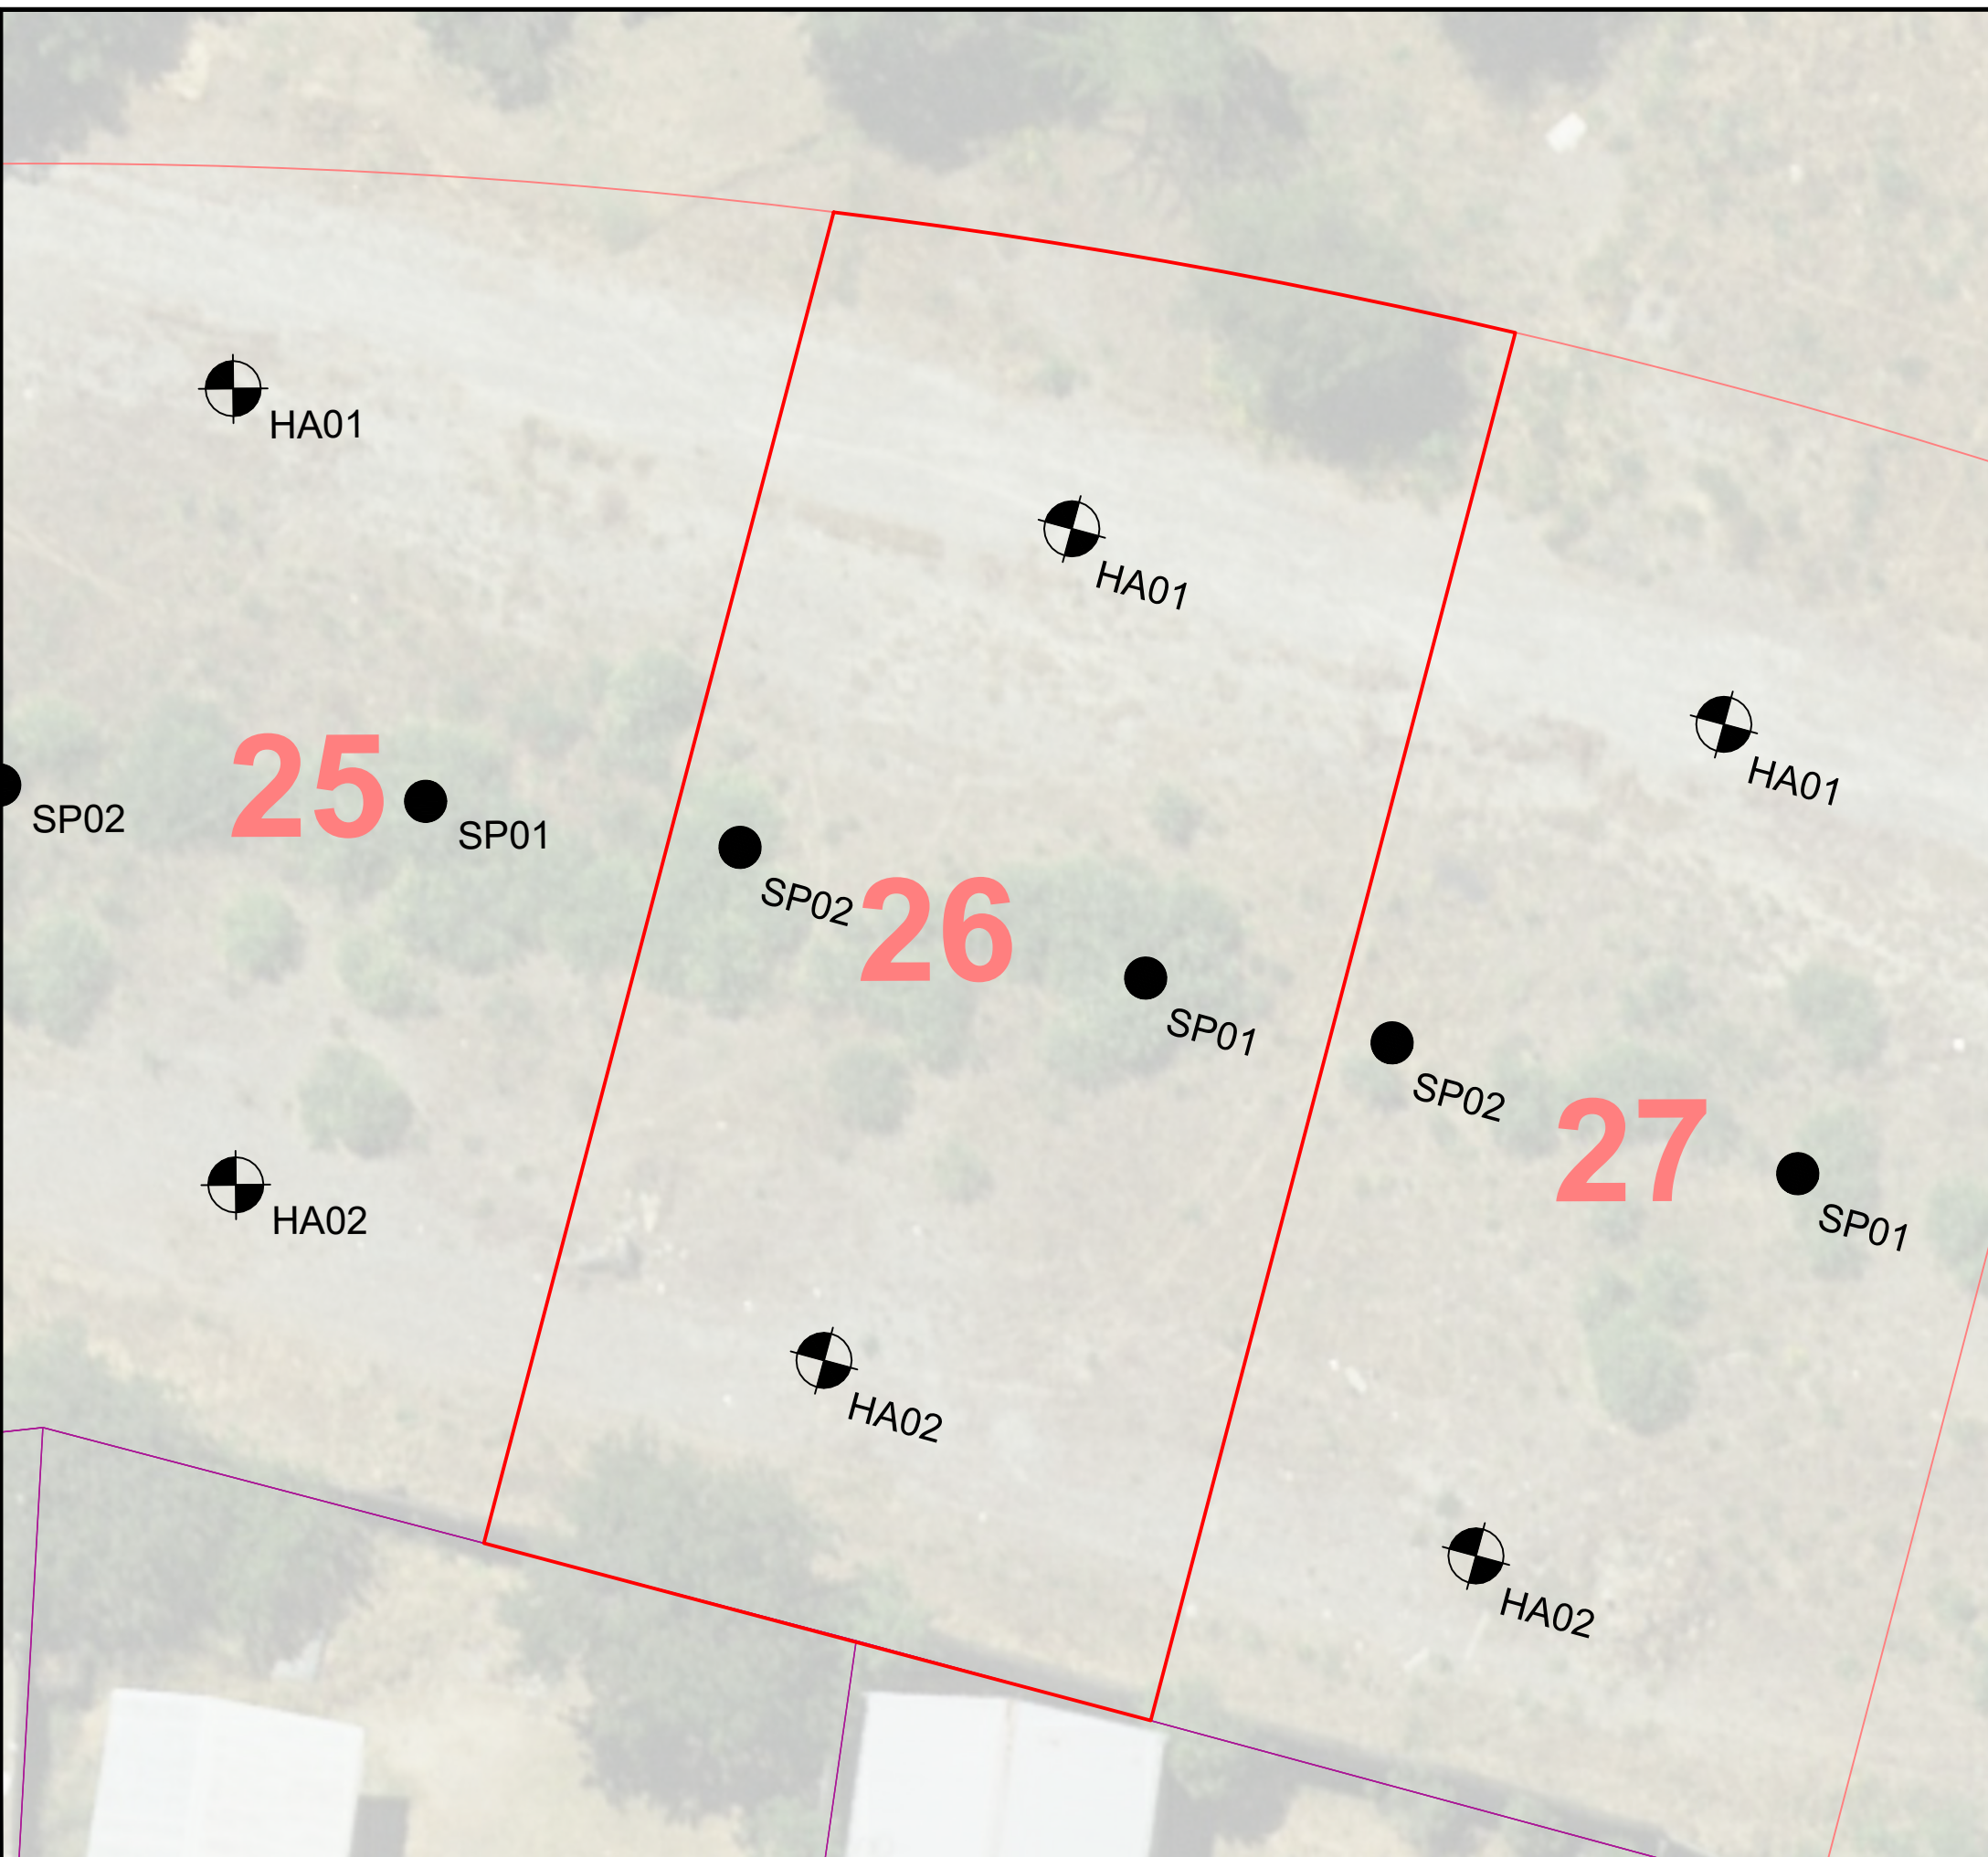
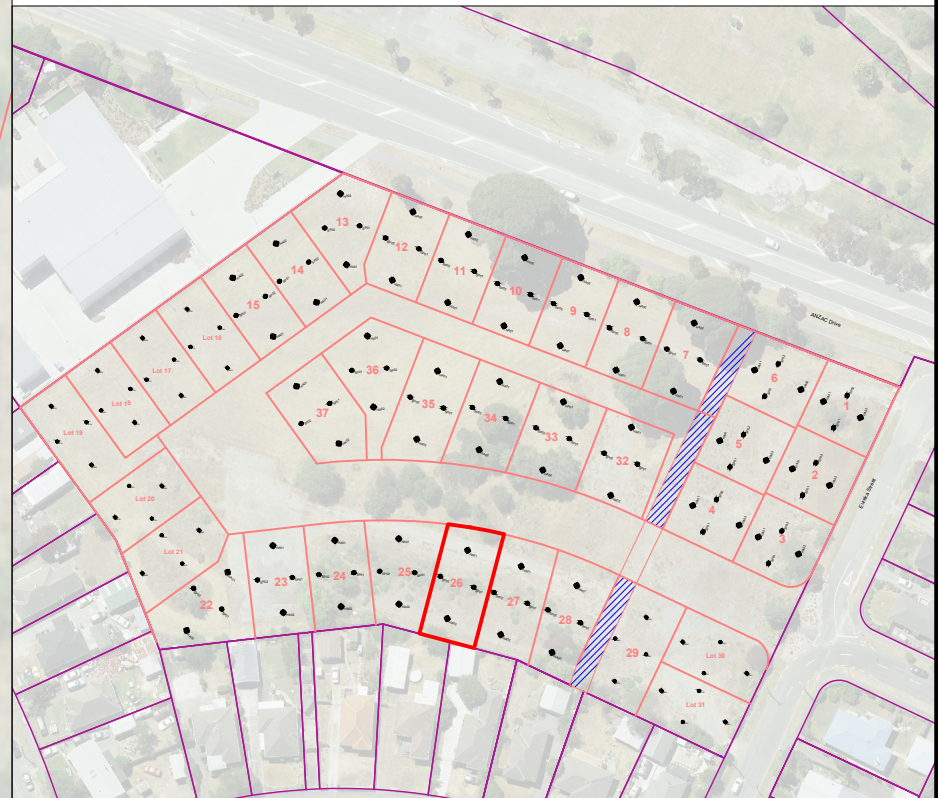
Drawing No: Lot 26/TLP	Drawn by: RM	Date: 30 August 2023
Scale: 1: 150 (A3) 1: 2000 (A3)	Checked by: D Wilson	Revision: B
Filename: LTC21220 - A - Drawings.dwg

LandTech investigated the site on 23 March 2023, conducting two hand augers with corresponding Scala Penetrometer tests (SPs) and two additional SPs. The locations of the hand auger and SPs were measured using inferred lot boundaries and are approximate only. The test locations are shown on our LandTech *Test Location Plan*, Drawing No. Lot 26/ TLP, attached to this report.

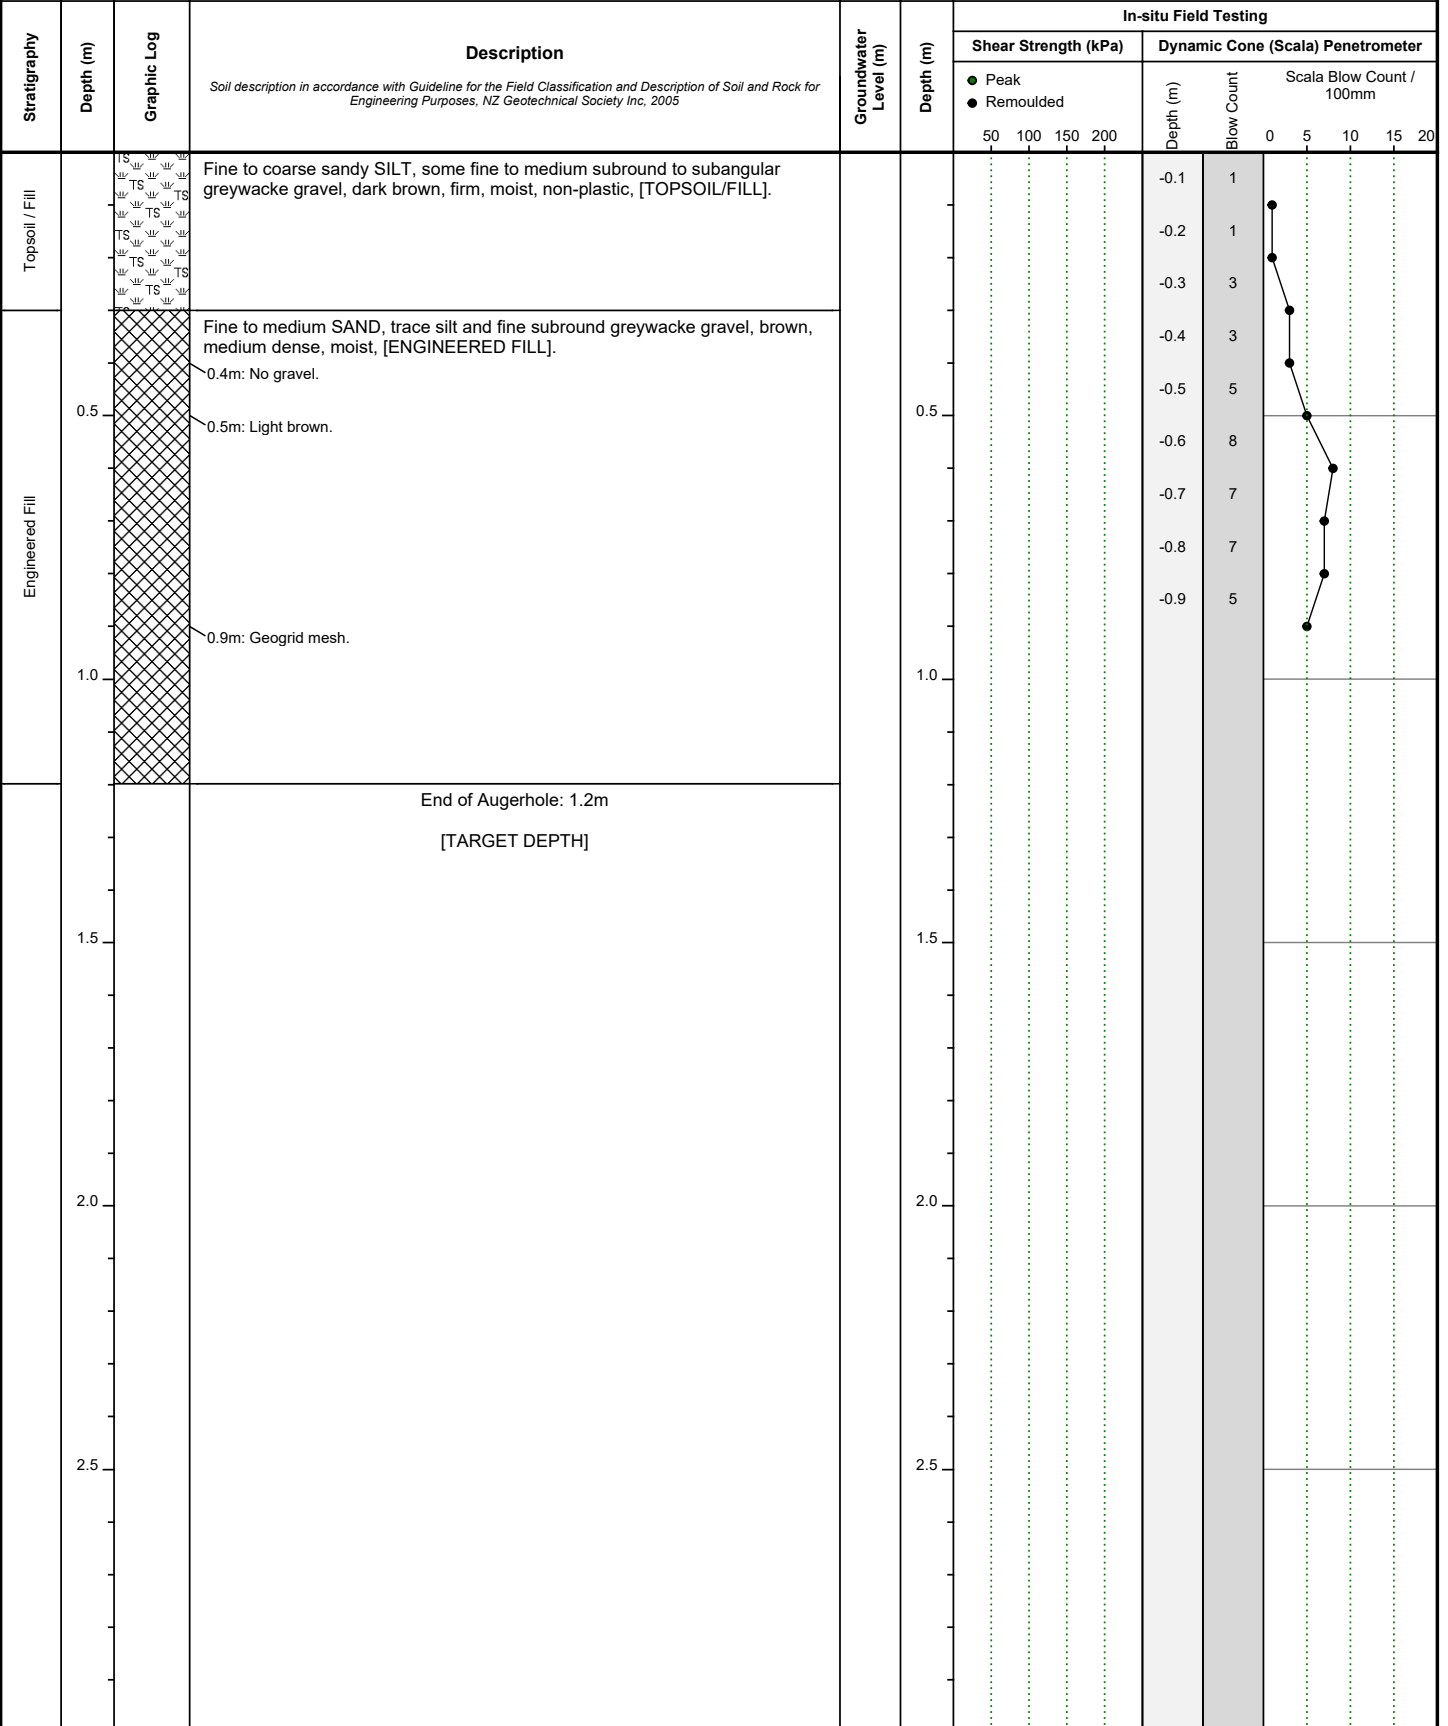
Augerhole No.: LOT 26- HA01

Topsoil was encountered within the hand augers from the ground surface to 0.3m depth, which was typically a dark brown sandy silt material with some gravel. Engineered fill was encountered below the topsoil to the base of auger holes, which was a compacted light brown sand material with a trace of silt and gravel. The hand augers were terminated at 1.2m depth below ground level to avoid damage to the geotextile layer which was installed at 1.5m depth below ground level. Groundwater was not encountered during testing.

Project No.: LTC21220-A Coordinates: NZTM2000: E1576357.39, N5182971.68 Logged By: KY
 Drill Type: 50mm Hand Auger Reduced Level: 2.83m (LVD1937) Shear Vane No.:
 Date Started: 23-Mar-23 Ground Conditions: Near level, Topsoil. Calibration Factor:
 Date Finished: 23-Mar-23 Groundwater Level (m): Not Encountered Calibration Date:

Target depth achieved. In-situ testing in accordance with the following standards:
 Scala Penetrometer Testing: NZS 4402:1988, Test 6.5.2, Dynamic Cone Penetrometer
 Shear Vane Testing: Guideline for Hand Held Shear Vane Test, NZGS, August 2001

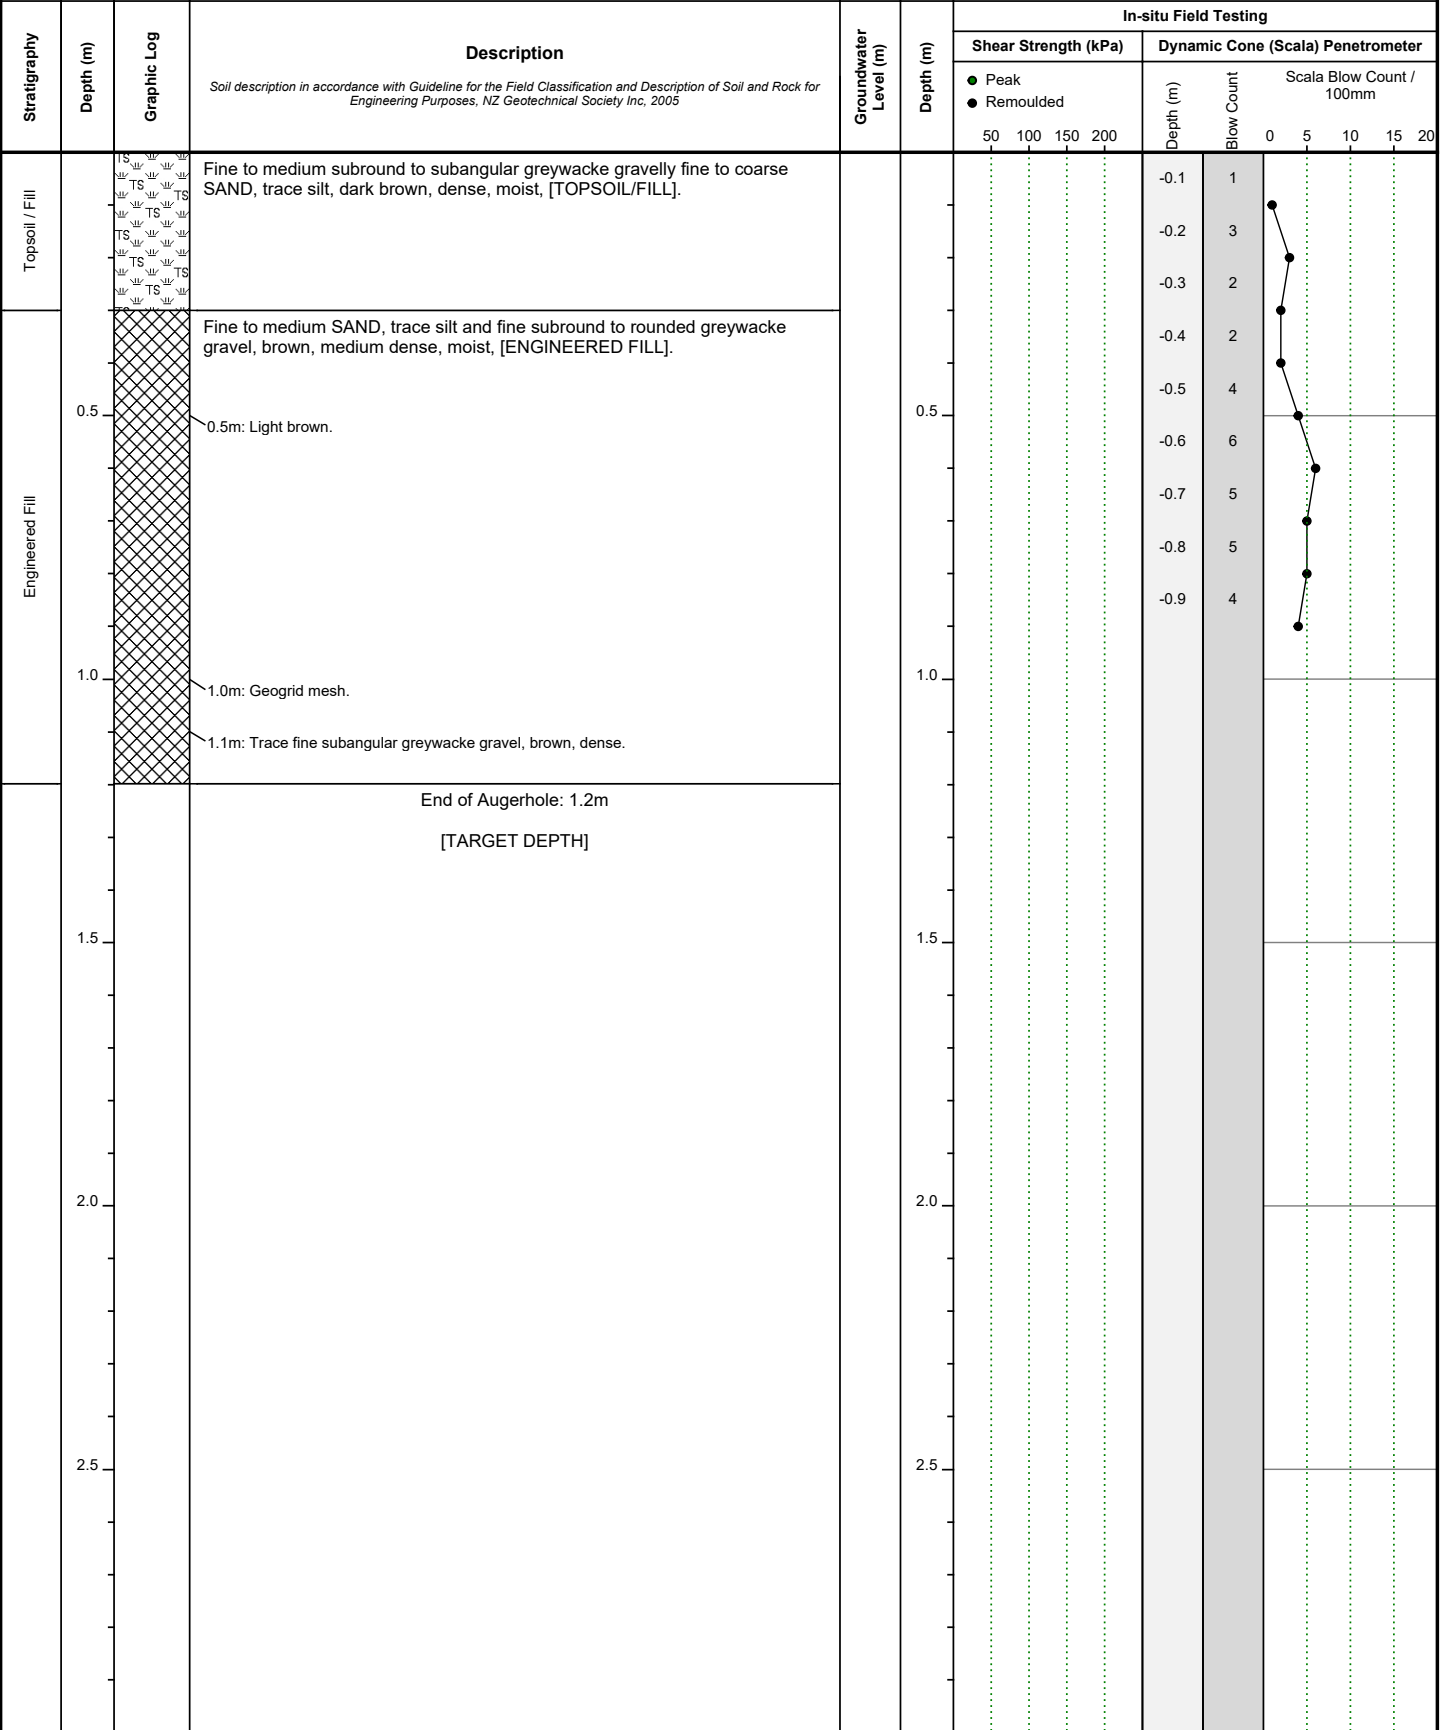
Augerhole No.: LOT 26- HA02

Project No.: LTC21220-A Coordinates: NZTM2000: E1576352.00, N5182953.62 Logged By: KY
 Drill Type: 50mm Hand Auger Reduced Level: 2.83m (LVD1937) Shear Vane No.:
 Date Started: 23-Mar-23 Ground Conditions: Near level, Topsoil. Calibration Factor:
 Date Finished: 23-Mar-23 Groundwater Level (m): Not Encountered Calibration Date:

Target depth achieved.

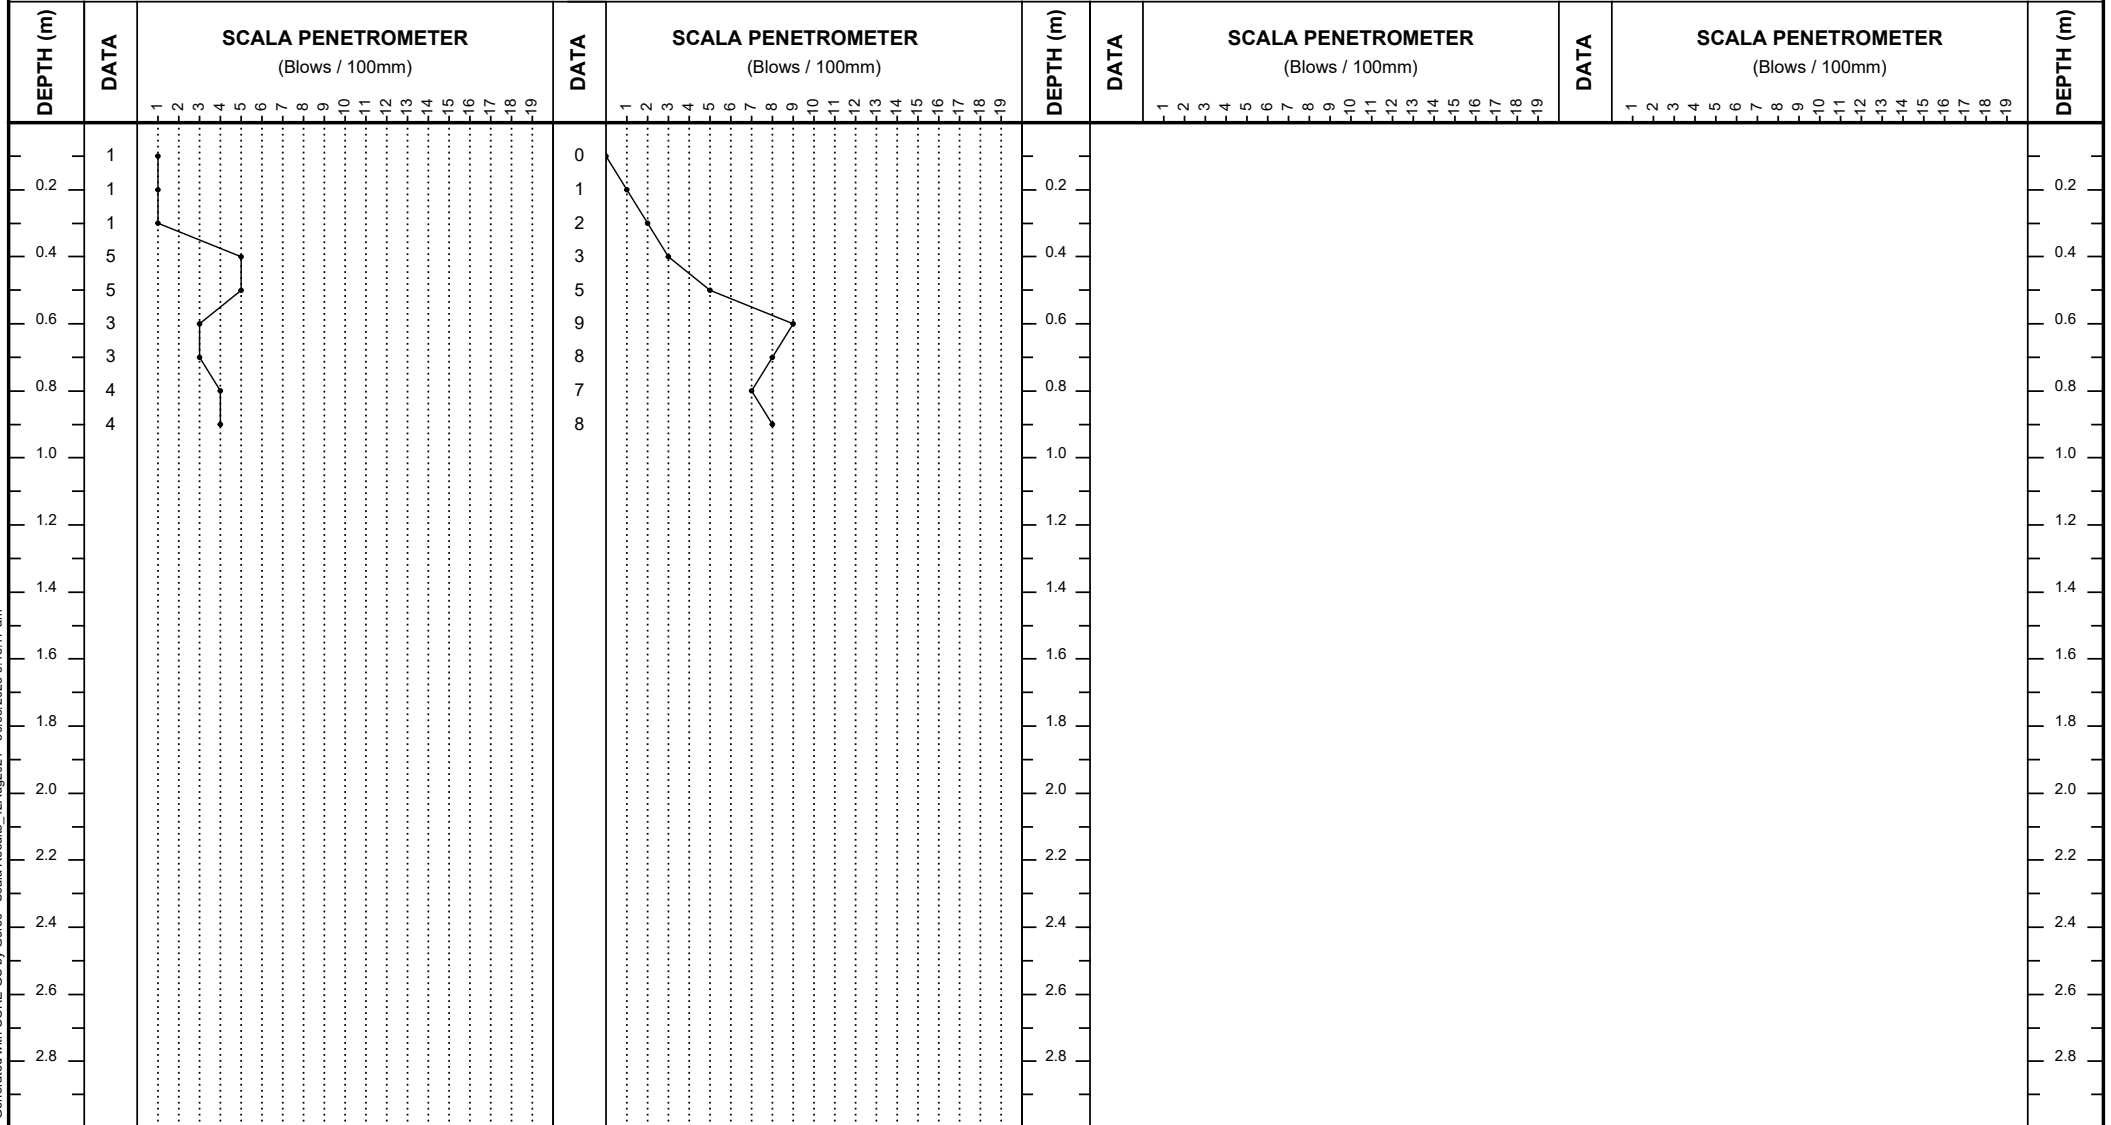
LOT 26- SP01

SPs at each of the four locations returned results between 2 and 9 blows per 100mm penetration below the topsoil and within the engineered fill layer. SPs were terminated at 0.9m depth to confirm near surface bearing capacities, and to avoid damage to the geogrids and geotextile. In addition, the density of the engineered fill and bearing capacity of its underlying subgrade have been confirmed via extensive geotechnical inspection and fill compaction testing during subdivision earthworks.

Tested By: KY
 Ground Conditions: Near level, Topsoil.
 Coordinates: NZTM2000 E 1576358.99
 N 5182961.92
 Test Date: 23-Mar-23

Tested By: KY
 Ground Conditions: Near level, Topsoil.
 Coordinates: NZTM2000 E 1576350.18
 N 5182964.76
 Test Date: 23-Mar-23
