Date: 30 August 2023  
Project No: LTC21220-A  
Revision: B

**RE: SHALLOW SOIL TEST REPORT  
FUTURE RESIDENTIAL FOUNDATIONS  
LOT 30, 115 EUREKA STREET, ARANUI**

**Test Location Plan**  
 Lot 30, 115 Eureka Street,  
 ARANUI, CHRISTCHURCH

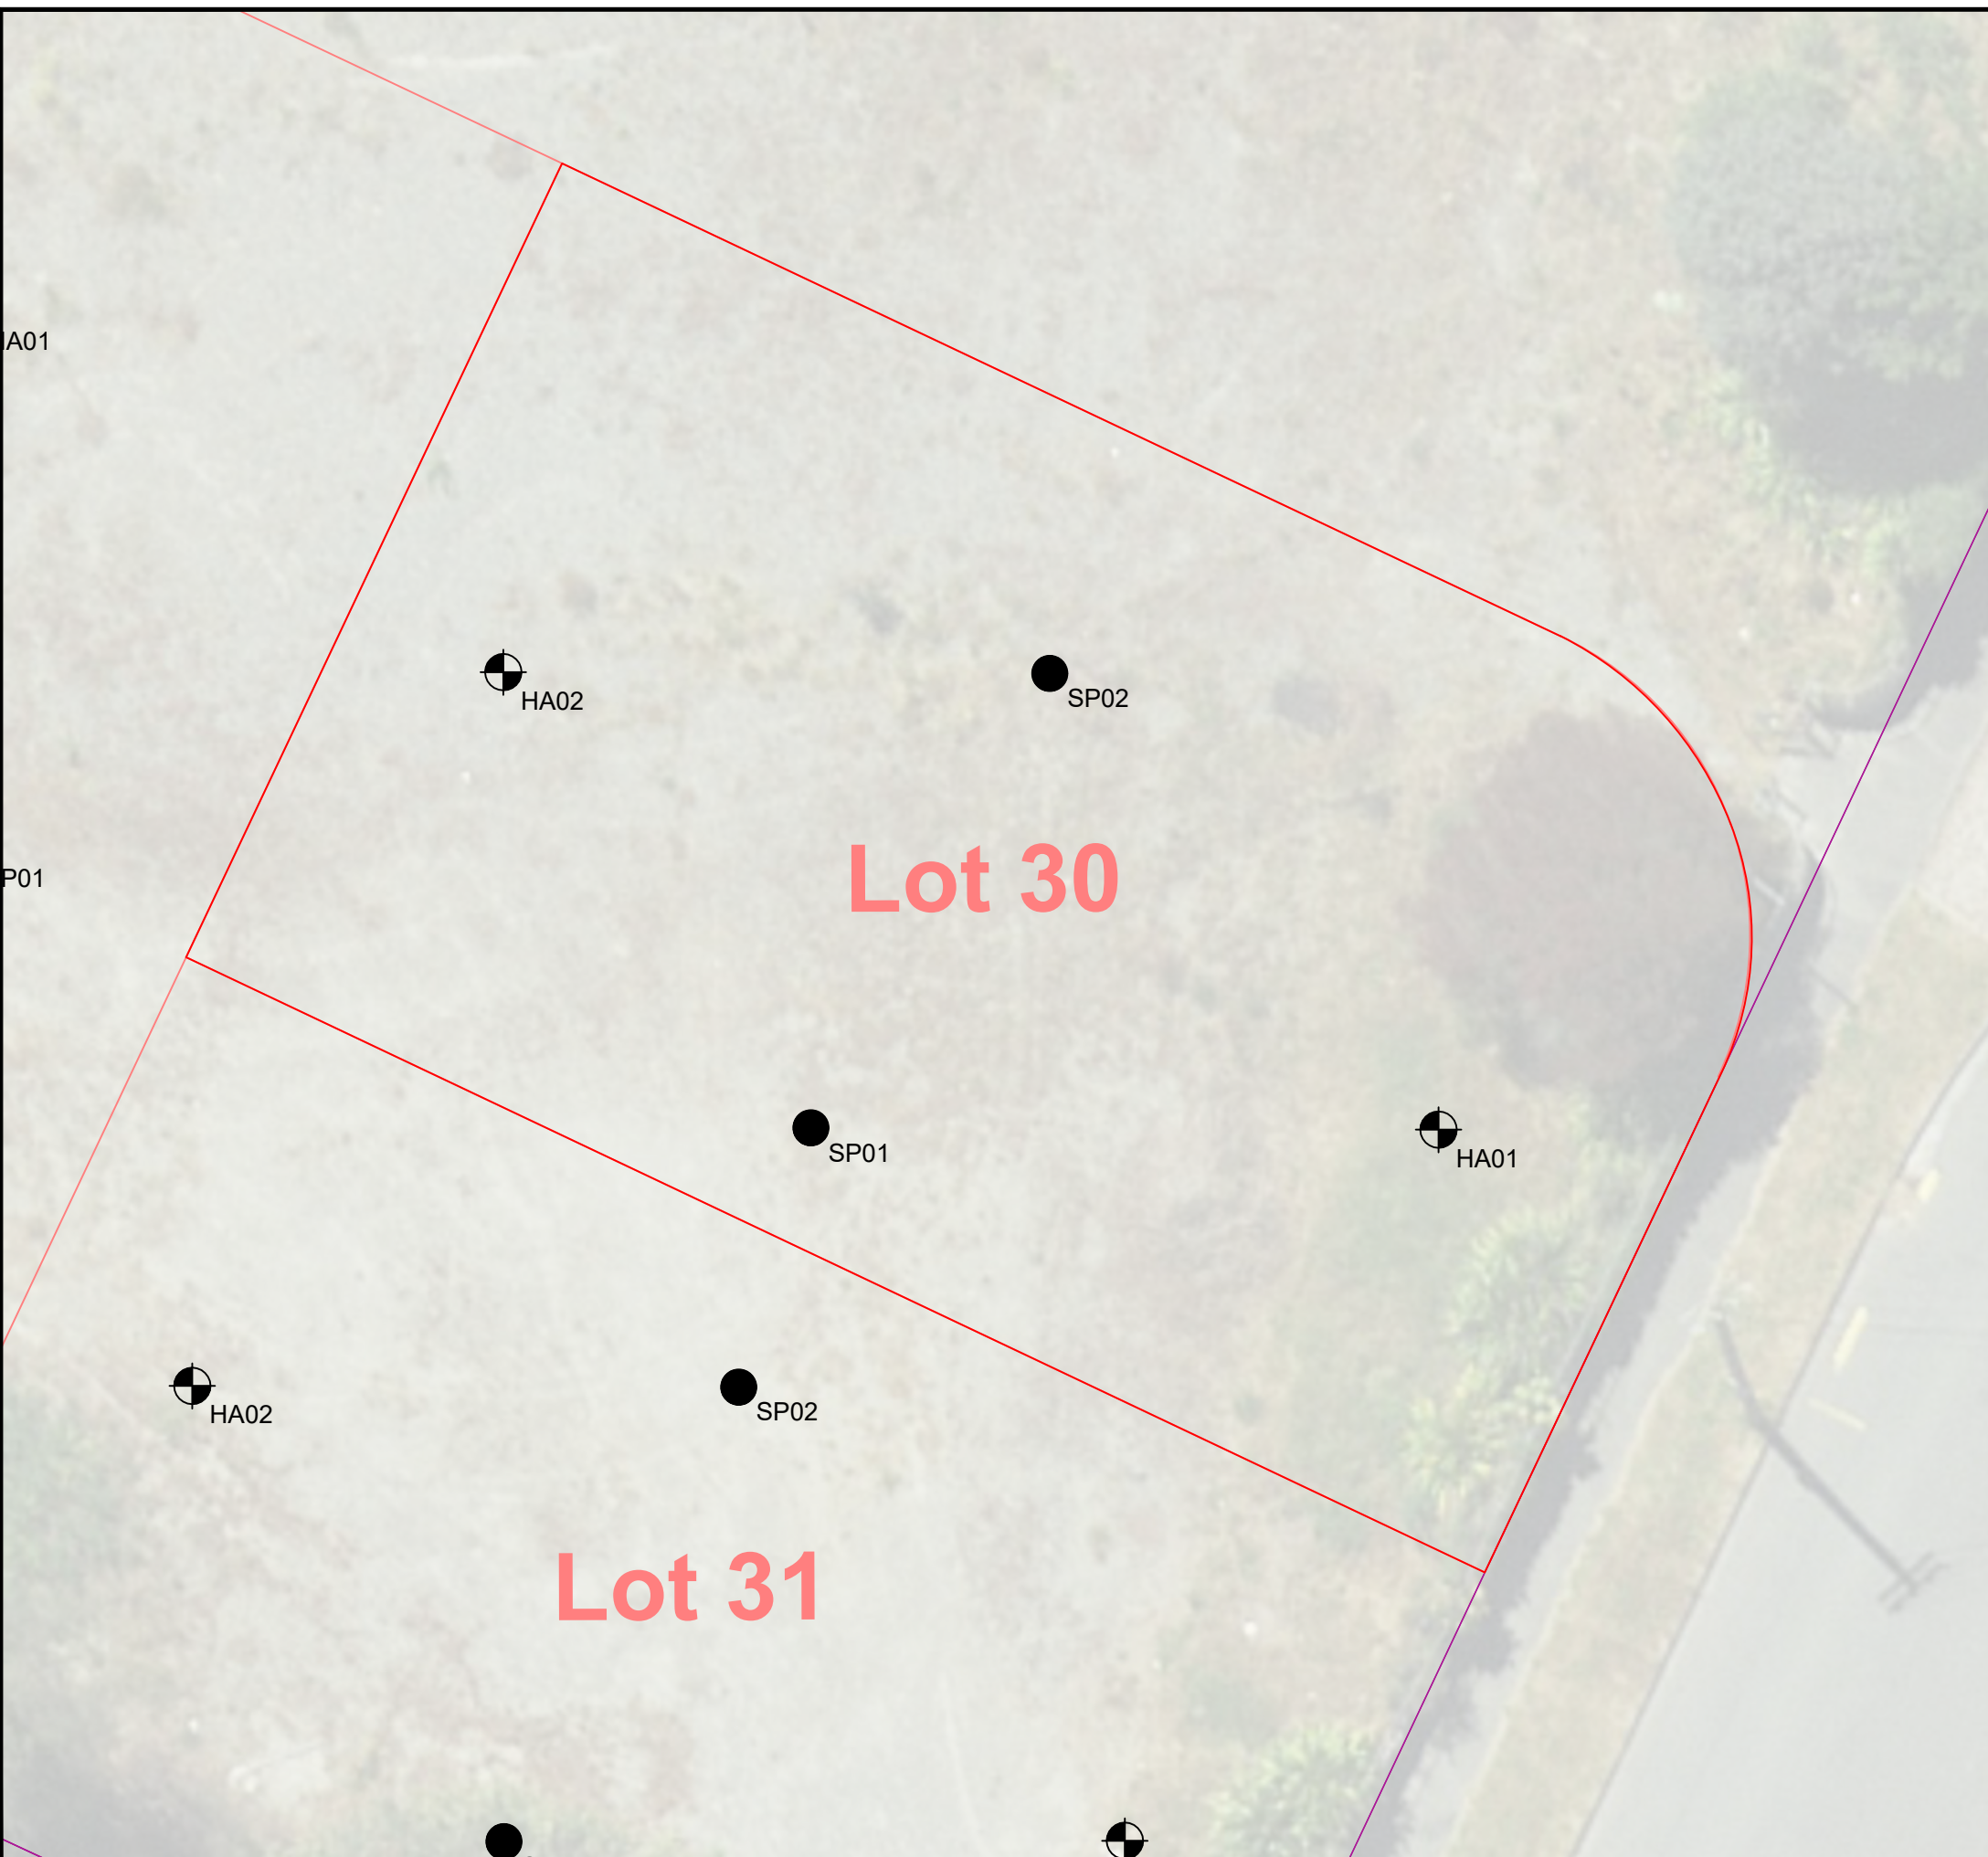
LandTech investigated the site on 8 June 2023, conducting two hand augers with corresponding Scala Penetrometer tests (SPs) and two additional SPs. The locations of the hand auger and SPs were measured using inferred lot boundaries and are approximate only. The test locations are shown on our LandTech *Test Location Plan*, Drawing No. Lot 30/ TLP, attached to this report.

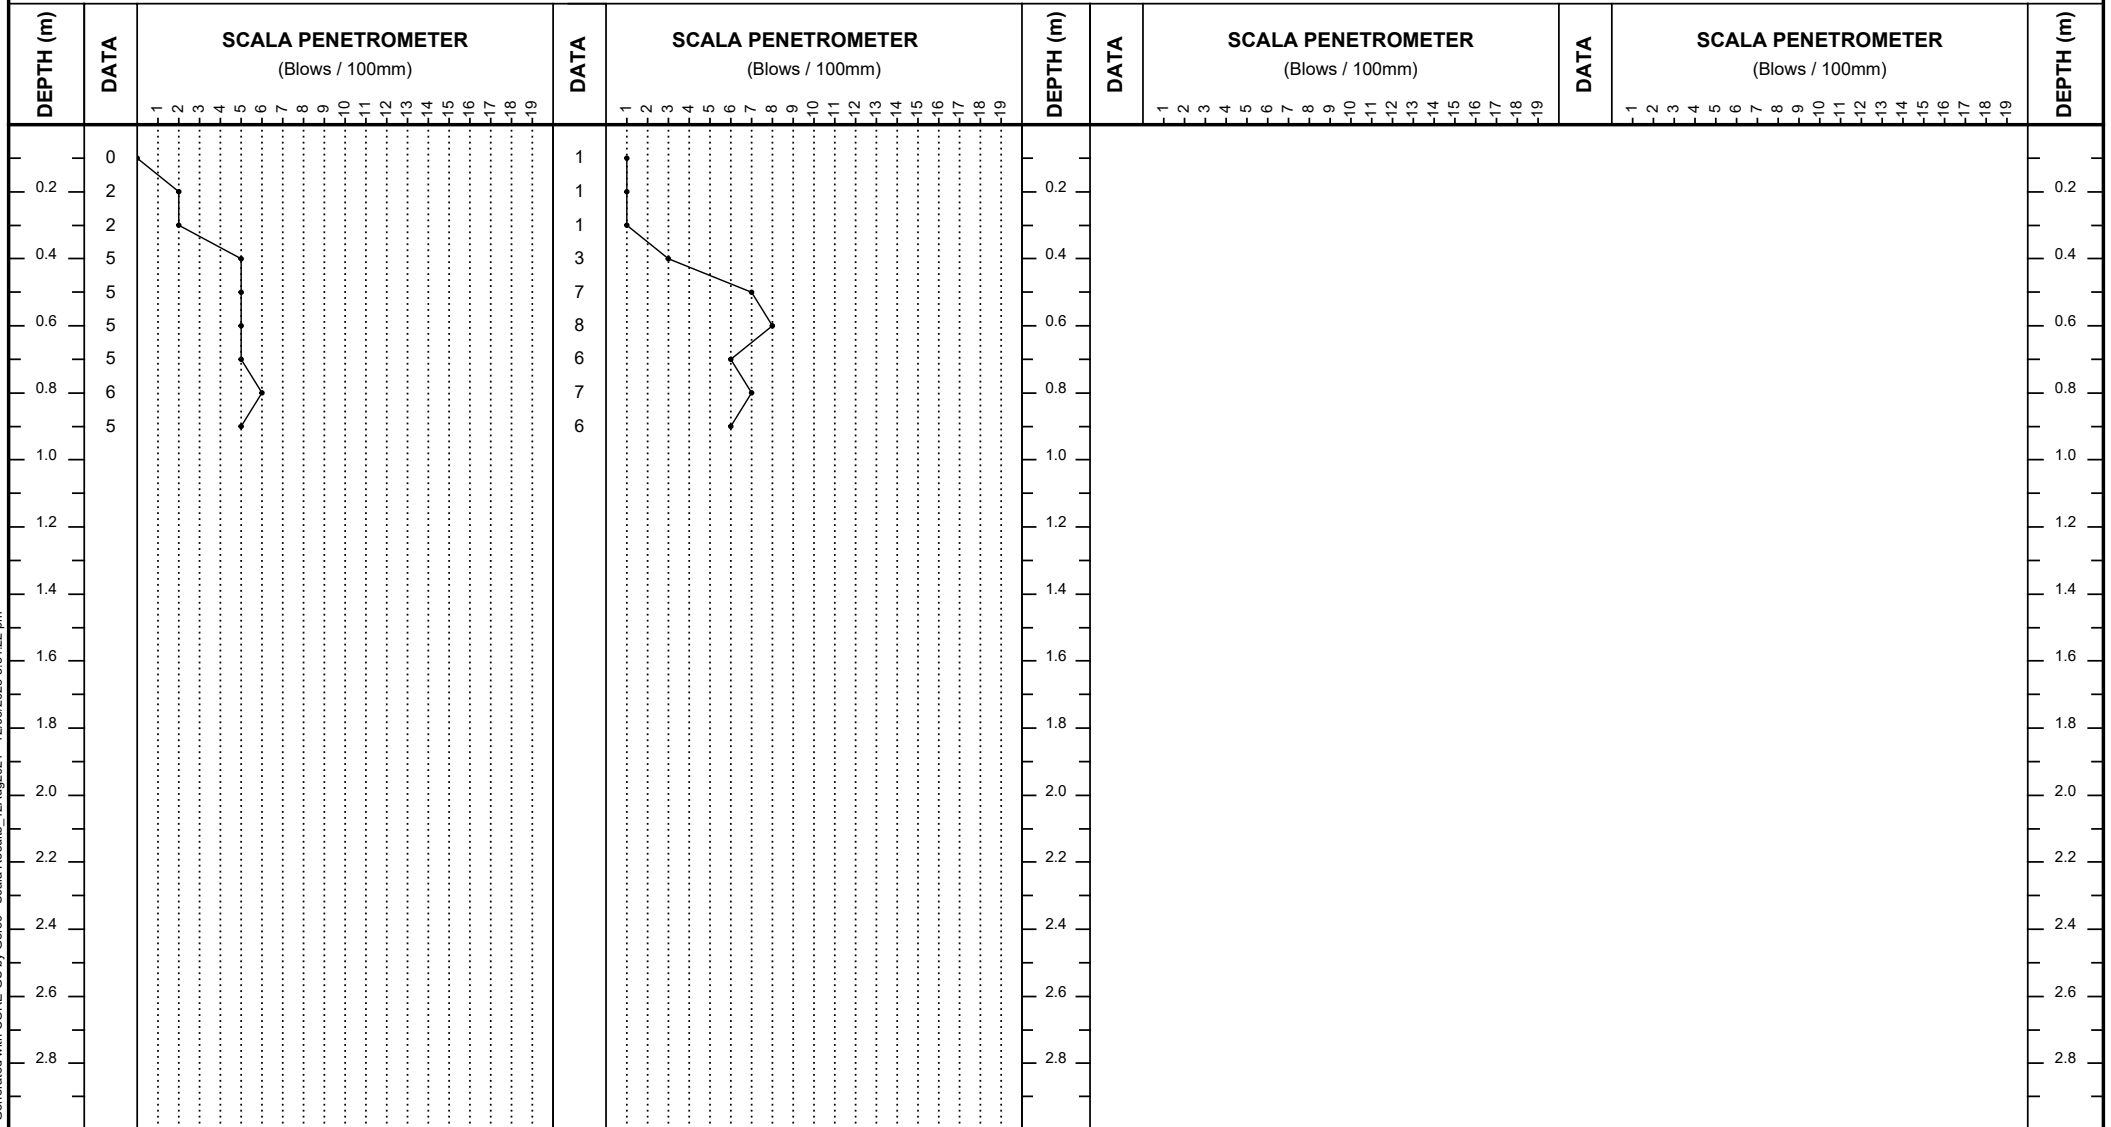
SPs at each of the four locations returned results between 1 and 24 blows per 100mm penetration below the topsoil and within the engineered fill layer. SPs were terminated at 0.9m depth to confirm near surface bearing capacities, and to avoid damage to the geogrids and geotextile. In addition, the density of the engineered fill and bearing capacity of its underlying subgrade have been confirmed via extensive geotechnical inspection and fill compaction testing during subdivision earthworks.

Lot 30 - SP01

Lot 30 - SP02
