**RE: SHALLOW SOIL TEST REPORT
FUTURE RESIDENTIAL FOUNDATIONS
LOT 29, 115 EUREKA STREET, ARANUI**

Test Location Plan
 Lot 29, 115 Eureka Street,
 ARANUI, CHRISTCHURCH

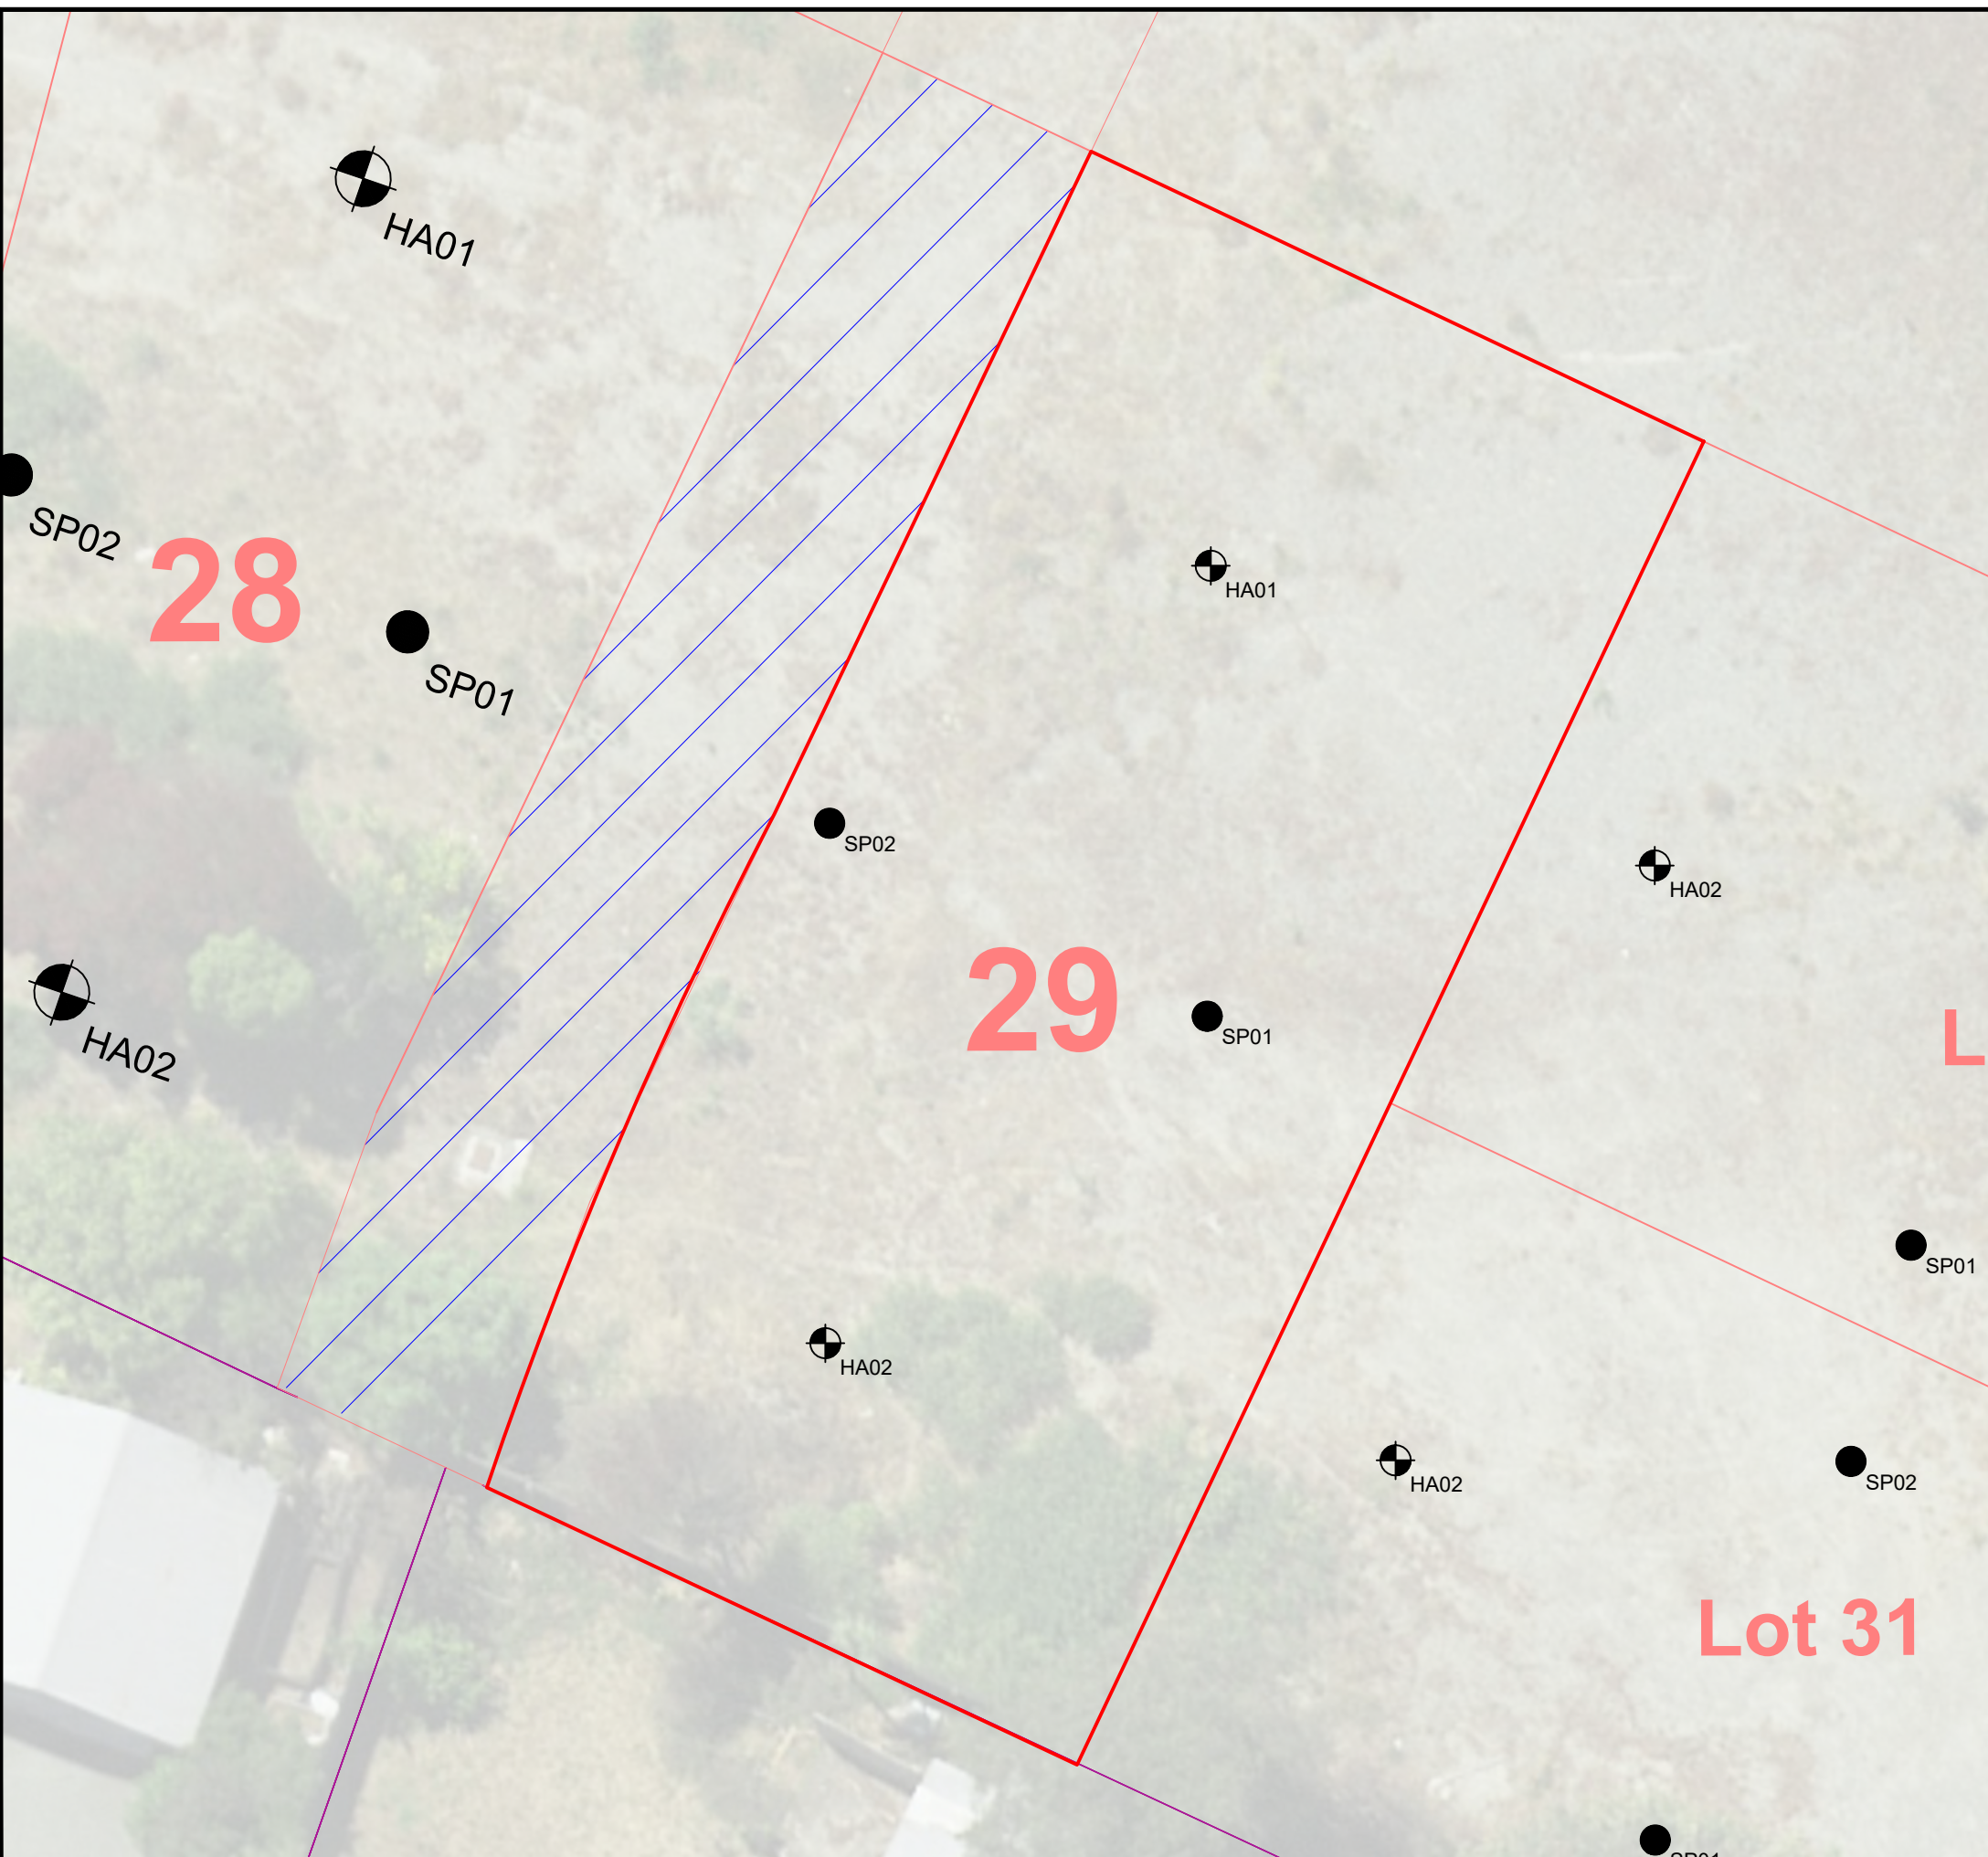
-   HA01 LandTech Consulting Ltd. augerhole locations, drilled 23 March 2023
-   SP01 LandTech Consulting Ltd. DCP test location, tested 23 March 2023
-   Proposed boundary
-   Existing boundary

LandTech investigated the site on 23 March 2023, conducting two hand augers with corresponding Scala Penetrometer tests (SPs) and two additional SPs. The locations of the hand auger and SPs were measured using inferred lot boundaries and are approximate only. The test locations are shown on our LandTech *Test Location Plan*, Drawing No. Lot 29/ TLP, attached to this report.

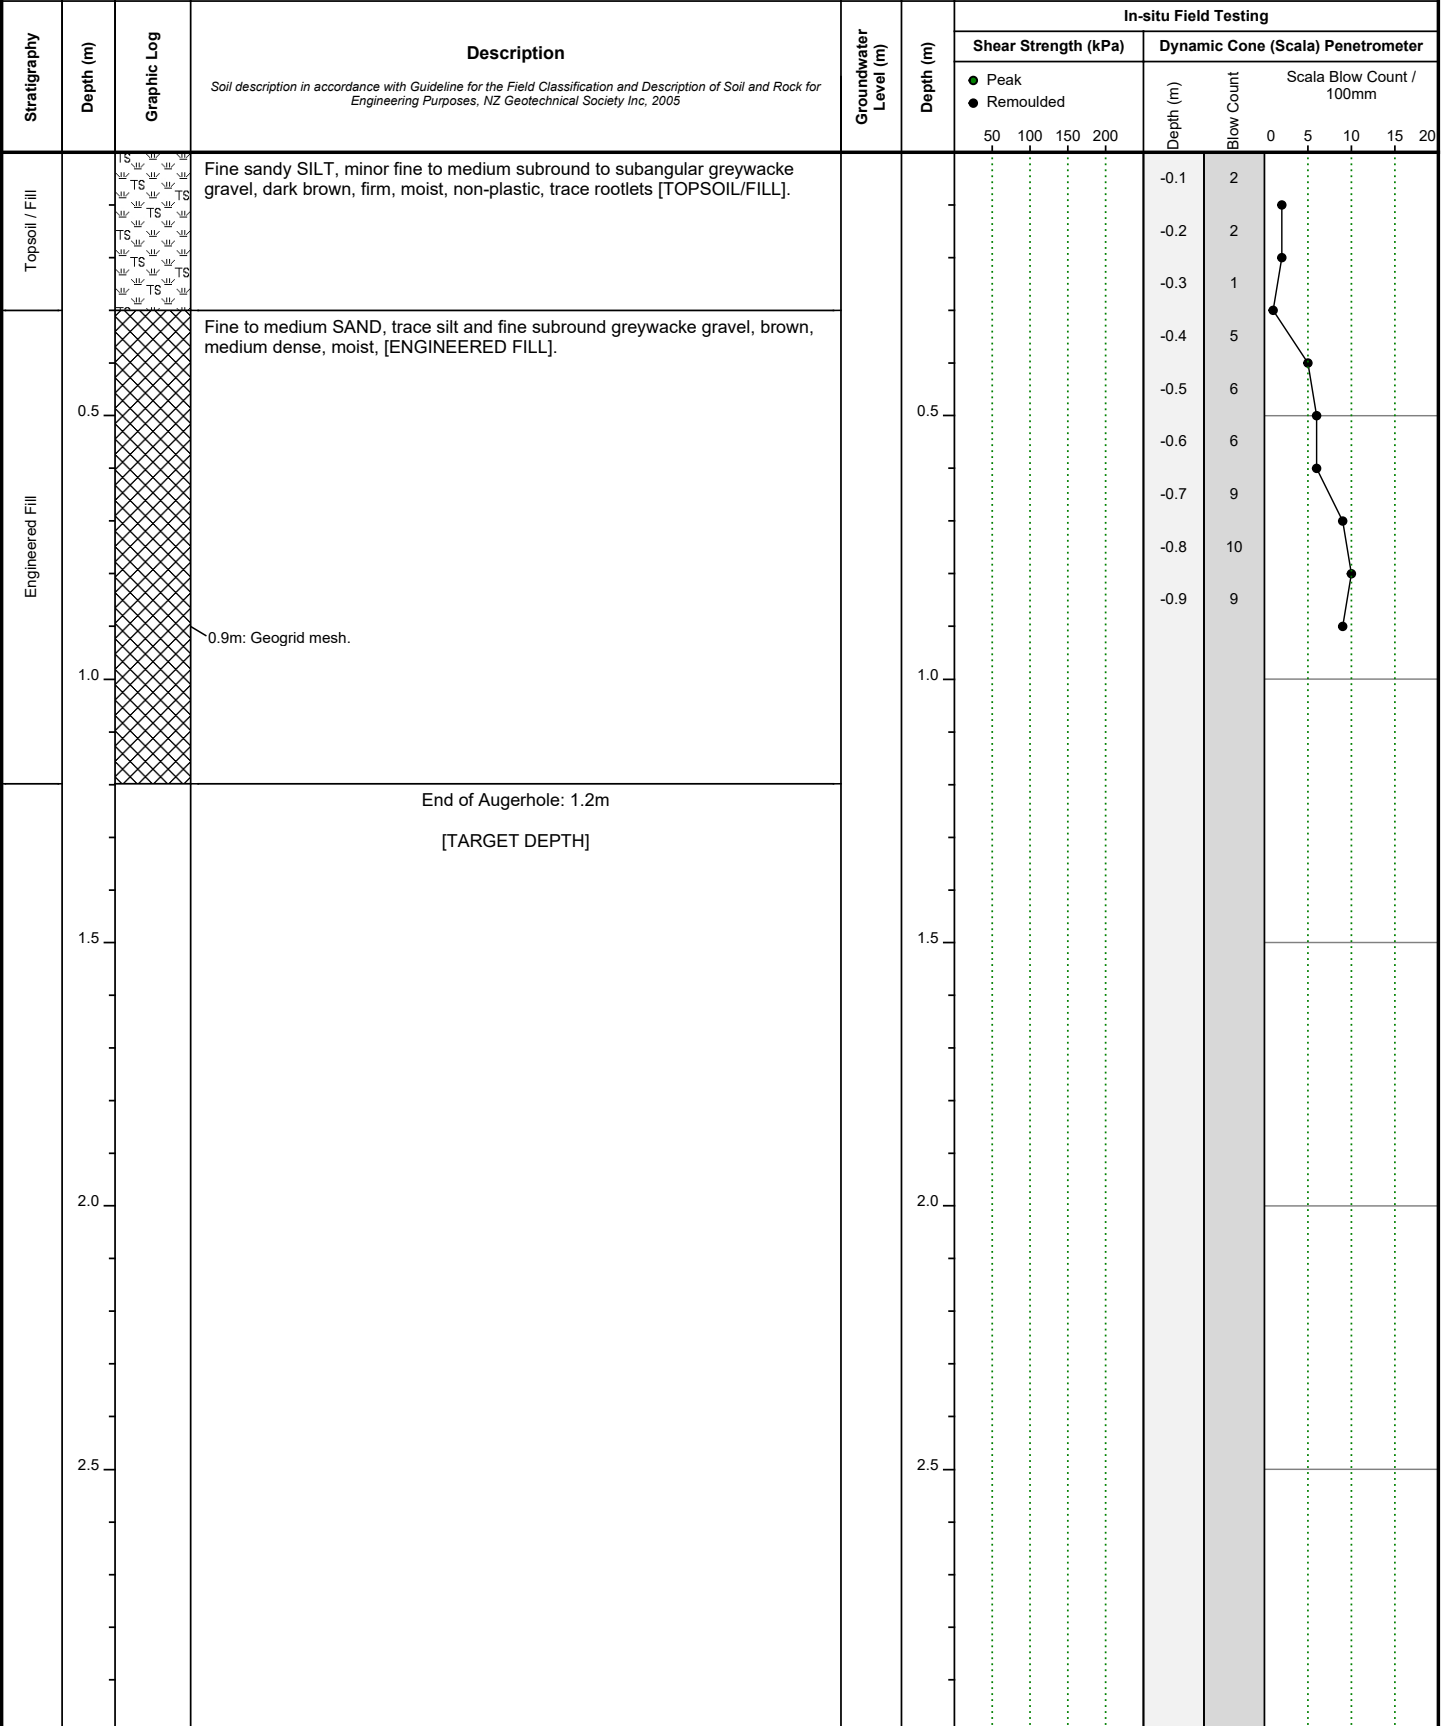
Augerhole No.: LOT 29- HA01

Project No.: LTC21220-A Coordinates: NZTM2000: E1576402.99, N5182954.41 Logged By: KY
 Drill Type: 50mm Hand Auger Reduced Level: 2.83m (LVD1937) Shear Vane No.:
 Date Started: 23-Mar-23 Ground Conditions: Near level, Topsoil. Calibration Factor:
 Date Finished: 23-Mar-23 Groundwater Level (m): Not Encountered Calibration Date:

In-situ testing in accordance with the following standards:
 Scala Penetrometer Testing: NZS 4402:1988, Test 6.5.2, Dynamic Cone Penetrometer
 Shear Vane Testing: Guideline for Hand Held Shear Vane Test, NZGS, August 2001

Target depth achieved.

Soil types and conditions within the hand augers were logged by LandTech technical staff in accordance with New Zealand Geotechnical Society *Guideline for the Description of Soil and Rock for Engineering Purposes* (2005). The hand auger logs for each hole are attached.

Topsoil was encountered within the hand augers from the ground surface to 0.3m depth, which was typically a dark brown sandy silt material with a minor of gravel. Engineered fill was encountered below the topsoil to the base of auger holes, which was a compacted brown sand material with a trace of silt and gravel. The hand augers were terminated at 1.2m depth below ground level to avoid damage to the geotextile layer which was installed at 1.5m depth below ground level. Groundwater was not encountered during testing.

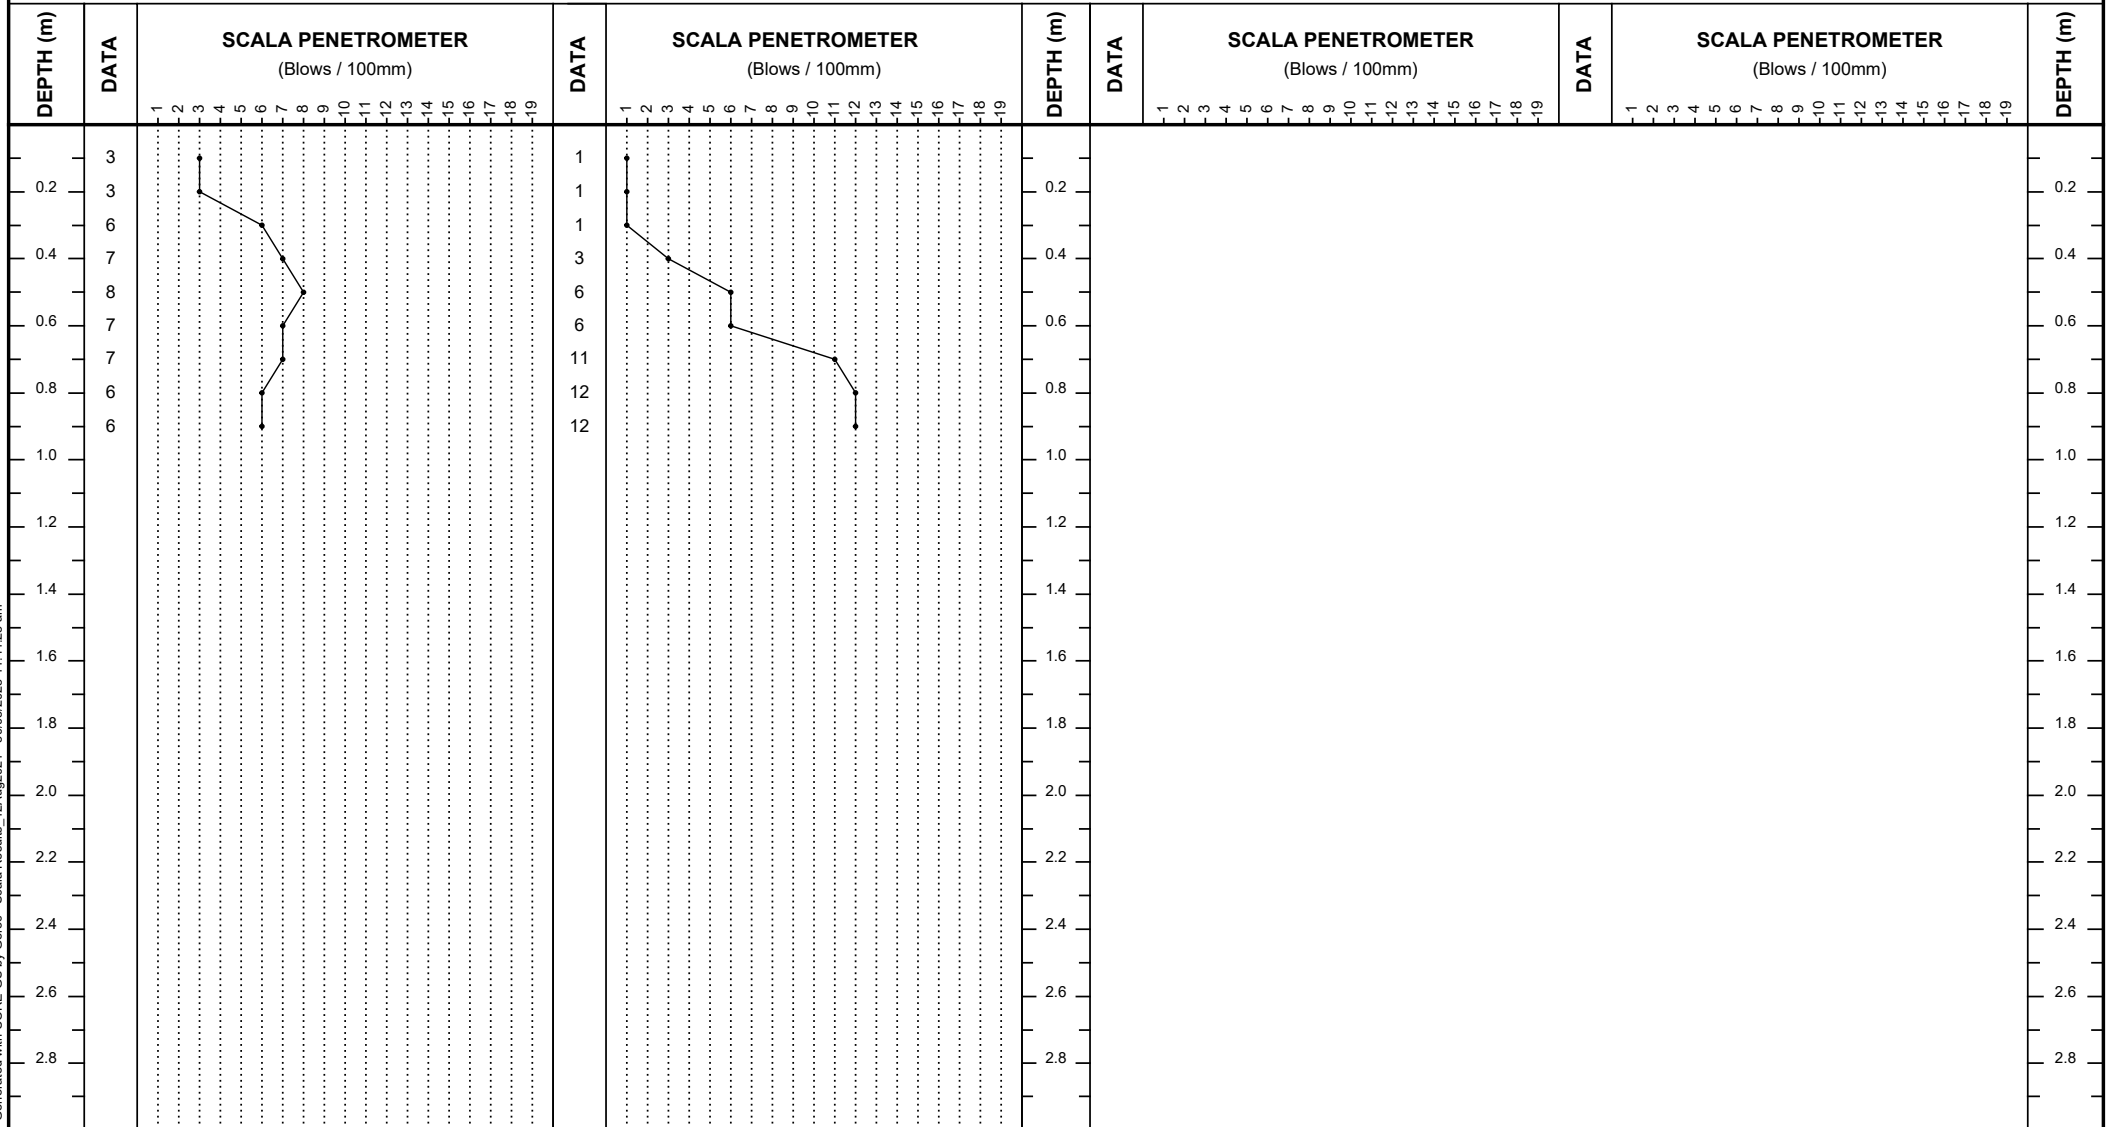
Tested By: KY
 Ground Conditions: Near level, Topsoil.
 Coordinates: NZTM2000 E 1576404.59
 N 5182944.65
 Test Date: 23-Mar-23

Tested By: KY
 Ground Conditions: Near level, Topsoil.
 Coordinates: NZTM2000 E 1576395.78
 N 5182947.49
 Test Date: 23-Mar-23

Our SP testing was carried out in accordance with NZS 4402:1988, Test 6.5.2, *Dynamic Cone Penetrometer*. The SP results are also attached.

SPs at each of the four locations returned results between 3 and 12 blows per 100mm penetration below the topsoil and within the engineered fill layer. SPs were terminated at 0.9m depth to confirm near surface bearing capacities, and to avoid damage to the geogrids and geotextile. In addition, the density of the engineered fill and bearing capacity of its underlying subgrade have been confirmed via extensive geotechnical inspection and fill compaction testing during subdivision earthworks.
